That's right, chopper caretakers. TM 55-1520-210-20PMP (26 Apr 68) says engine mount bearings get replaced if allowable play limits—0.006-in radial, 0.012-in axial—are exceeded.

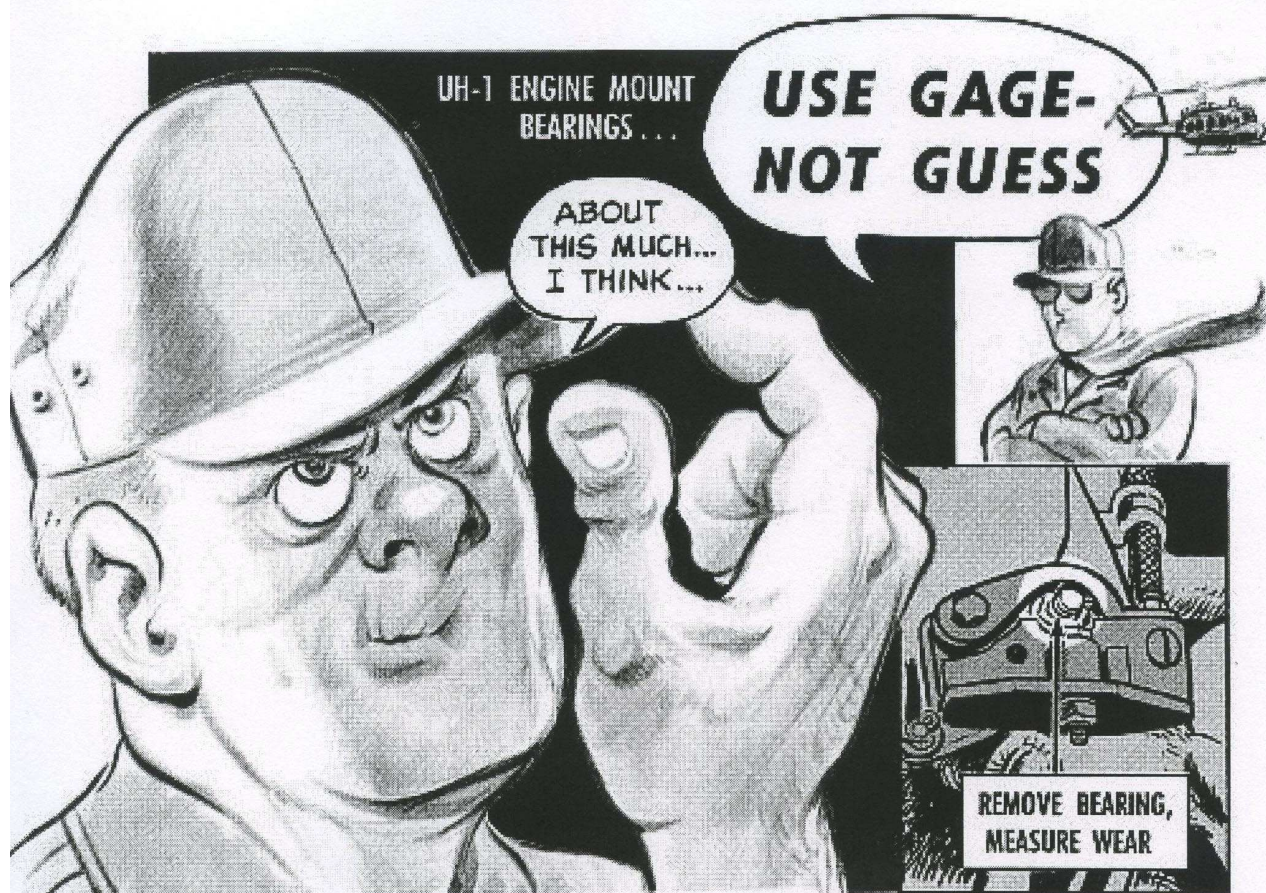
That excessive bearing play can be just a teenie-weenie bit—like maybe 0.001 inch—and hard to measure with tripod engine mount handshake. It's enough, tho, to cause the hydraulic lines to break, loosen, or leak—not to mention a gut rattling ride. And a birdman without hydraulic power boost is in for a maxi-size case of puckeritis. Maybe worse!

So sharpen your peepers and use a gage to measure bearing play when pulling the 100-hr inspection. Ch 6 (22 Apr 68) to TM 55-1520-210-20 has the inspection poop . . . para 5-31. If you have to replace the bearings, let support do it!
