ALERT SERVICE BULLETIN

UH-1H-11-07

**MODEL AFFECTED:** UH-1H

**SUBJECT:** MAIN ROTOR HUB INBOARD STRAP FITTING 204-012-102-005/-009, ONE TIME MAGNETIC PARTICLE INSPECTION OF.

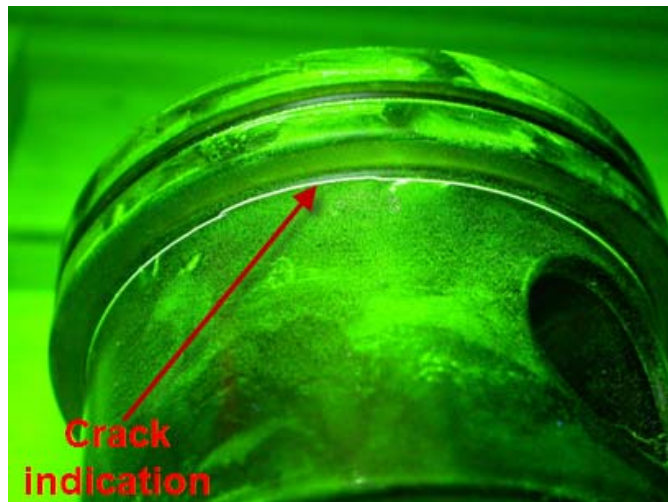
**FIGURE 1**

Bell Helicopter has determined that main rotor hub inboard strap fittings may fracture as a result of a non-conformance. The possibility exists that cracks occurred during the quenching operation which were not detected during manufacturing inspections. Additionally, some 204-012-102-005 fittings were shot-peened and the resultant material rollover at the edges of the parts may not have been properly removed during manufacture. This raised material may lead to the formation of fatigue cracks.

4. Perform magnetic particle inspection on 204-012-102-005 and -009 inboard strap fittings IAW applicable maintenance manual. Refer to figure 1 for typical quench crack and location found during magnetic particle inspection. Additionally, carefully inspect all edges of the 204-012-102-005 fittings for cracks:

**Typical crack indication and location.**

- a. If cracks are found on either the -005 or -009 fittings, the fitting is unserviceable and must be replaced, proceed to step 7.
  - b. If no cracks are found on the -005 fitting, proceed to step 5 for an additional inspection. If no cracks are found on the -009 fitting, proceed to step 6.

7. If cracks are found on installed fittings or stock spares, or the 204-012-102-005 fitting cannot be reworked within limits of step 5, return affected parts to Bell Helicopter. Refer to the Information Letter GEN-04-98 REV C. Report any discrepancy to Bell Helicopter Military Technical Support at [mts-medium@bellhelicopter.textron.com](mailto:mts-medium@bellhelicopter.textron.com).
