ALERT SERVICE BULLETIN

UH-1H-13-09
14 January 2013

SUBJECT: MAIN ROTOR BLADE, P/N 204-011-250-113, GRIP PAD AND GRIP PLATES, INSPECTION OF

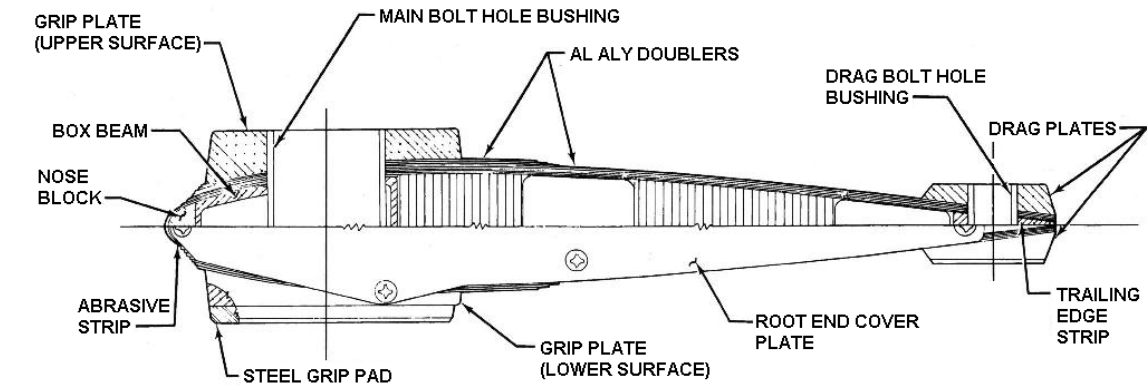
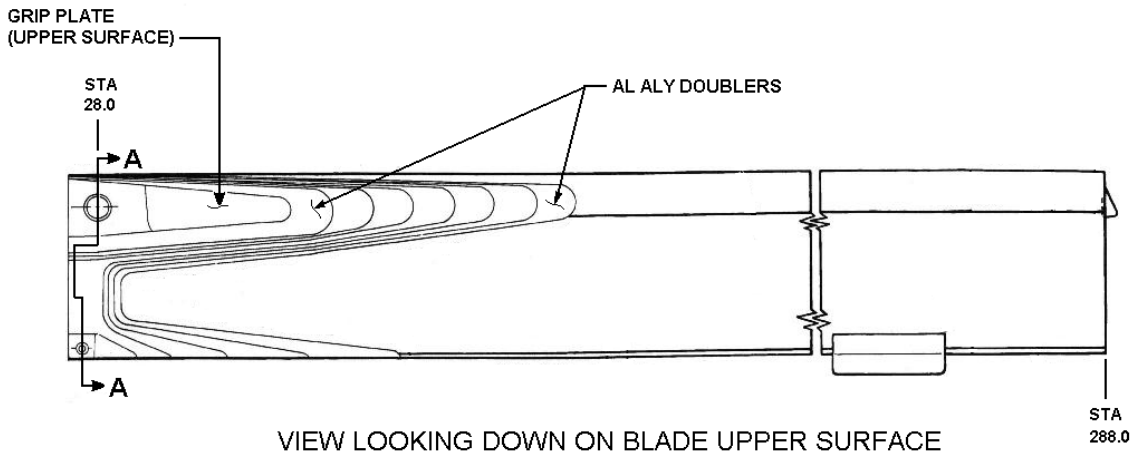
FIGURE 1

Bell Helicopter recently evaluated a UH-1H main rotor blade with multiple fatigue cracks around the blade retention bolt hole. The cracks initiated as a result of a void between the lower grip plate and grip pad. In addition a substantial void was also found at the outboard doubler tip on the lower blade surface.

1. Prepare helicopter for maintenance.
2. Refer to Figure 1. Clean blade upper and lower grip plates and the lower grip pad per TM 55-1520-210-23-1, Chapter 5.
 - a. Visually inspect grip pad and plates for cracks.
 - b. Visually inspect grip pad and grip plate bond lines for voids, loose or damaged adhesive squeeze-out. Hair line cracks in the paint finish and loose adhesive squeeze-out could be indication of voids.
 - c. If any of the discrepancies above are found, remove blade and inspect damaged/suspect areas.

SECTION A - A
SECTION THRU MAIN AND DRAG BOLT HOLES
AND VIEW OF ROOT END OF BLADE

3. Carefully trim or scrape away any loose or damaged squeeze-out at bond lines as required. Trimmed areas must be sanded smooth using 280 grit, or finer, abrasive paper.

4. Visually inspect all suspect areas as follows:
 - a. Cracks in the grip pad or grip plates are not acceptable. If cracks are found in the pad or plates, forward to a blade repair facility for repair evaluation.

- b. Single edge voids in the grip pad or grip plate bond lines on any one side which are no more than 0.060 inch in depth and 2.0 inch in length are acceptable but must be sealed.

- c. Edge voids in excess of the above limits are not field repairable. Forward to a blade repair facility for repair evaluation.
 - d. In areas where the adhesive squeeze-out was removed, inspect for corrosion as well as edge voids. Remove light surface corrosion per TM 55-1520-210-23-1, Chapter 5.

- e. Seal acceptable edge voids and repair areas of removed squeeze-out with adhesive C-317 or C-322, blended to a smooth fillet with surrounding contour. Allow to cure.
