ALERT SERVICE BULLETIN

UH-1H-12-08

**MODEL AFFECTED:** UH-1H

**SUBJECT:** P/N 205-001-720-001 CABLE ASSEMBLY, ONE TIME INSPECTION FOR DEFECTIVE BODY, P/N 205-001-742-001

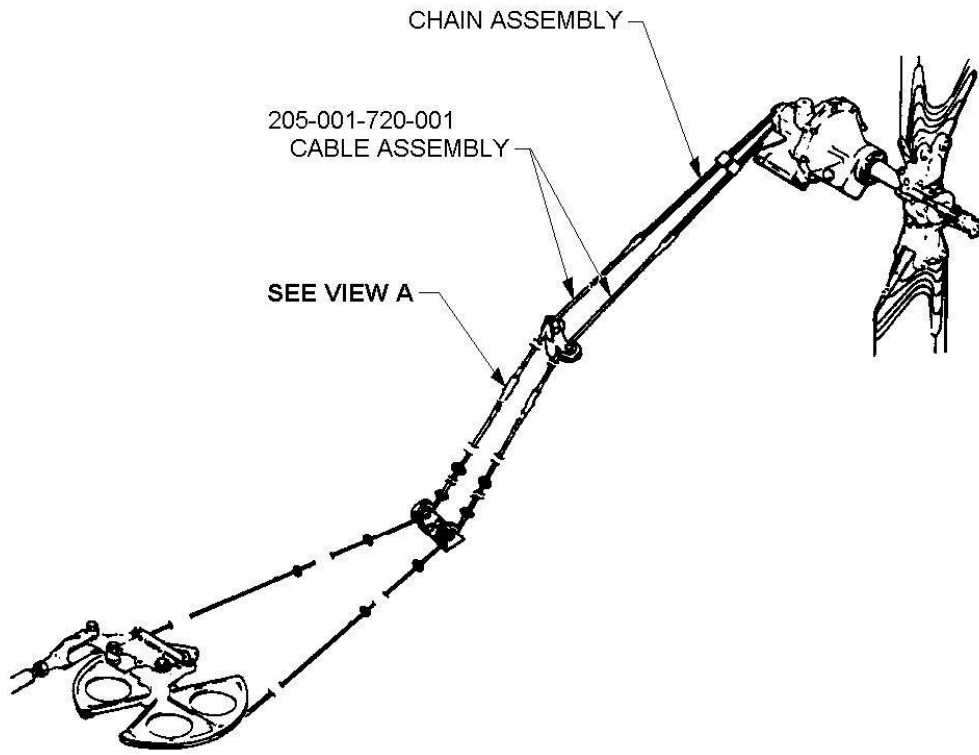
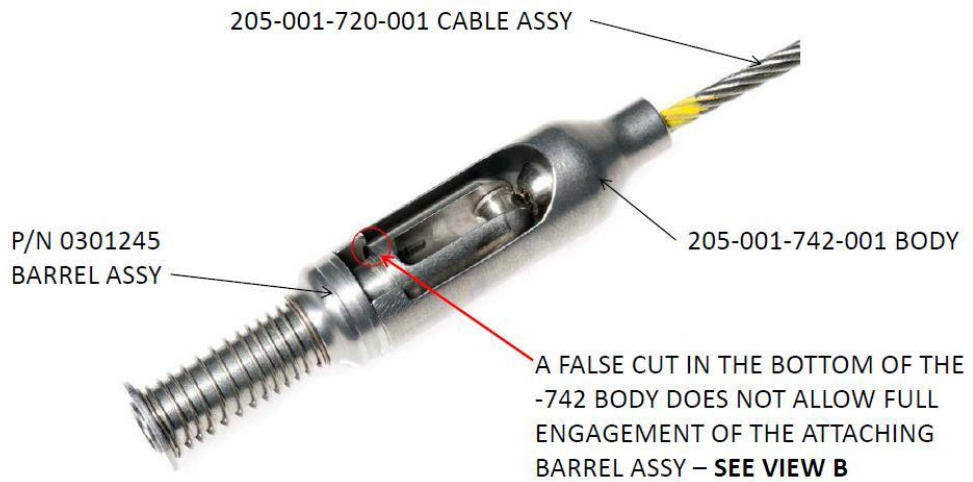
**Figure 1 (sheet 1 of 2)**

1. Prepare helicopter for maintenance.
2. Open the vertical fin tail rotor driveshaft cover.
3. Gain access to the lower ends of the P/N 205-001-720-001 Cable Assemblies at the connection to the P/N 0301245 Barrel Assembly. See Figure 1, sheet 1.

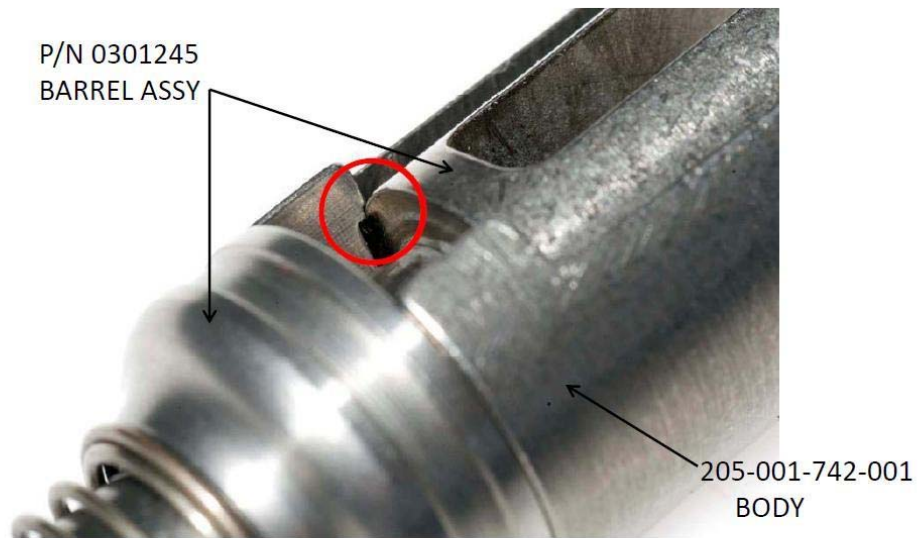
**Figure 1 (sheet 2 of 2)**

A number of P/N 205-001-720-001 Cable Assemblies have been manufactured with defective P/N 205-001-742-001 Bodies. The bodies are mismachined such that the P/N 0301245 Barrel Assembly will not fully engage in the body cavity. This ASB is a one-time inspection of all P/N 205-001-720-001 Cable Assemblies for the defective condition. Defective cable assemblies must be replaced as noted in the compliance section of this ASB. Applicability of this bulletin to any spare part shall be determined prior to its installation on an affected aircraft.

4. Refer to Figure 1, sheet 2. Inspect for the condition shown in View B that prevents complete seating of the P/N 0301245 Barrel Assembly in the bottom of the P/N 205-001-742-001 Body. As necessary, remove lockwire for a clear view.

5. The condition shown in Figure 1, sheet 2, View B, is not acceptable and is cause to replace the affected P/N 205-001-720-001 Cable Assembly.
6. For cable assemblies that fully engage the P/N 0301245 Barrel Assembly and do not exhibit the condition of View B, no further action is required. If lockwire was removed to facilitate inspection, secure barrel assembly and cable connection with new lockwire and make an entry in the helicopter records showing compliance with this ASB.

DETAIL OF INTERFERENCE CREATED BY FALSE CUT IN BODY

1. Replace defective cable assemblies at the next Phase Inspection or 50 flight hours after receipt of this ASB, whichever occurs first, but no later than 31 December 2012 .
2. For defective cable assemblies that are not to be replaced immediately:
