NO O-RING, PLEASE!

Getting oil leakage around the oil strainer on the rear-bearing housing of that T53 Huey engine?

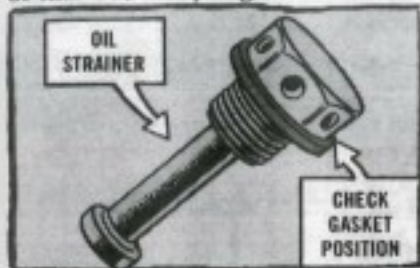
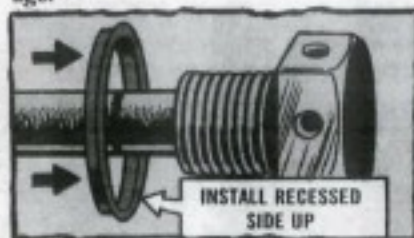
If you find the gasket wrong-side-up on top of an O-ring, put in a new gasket and leave out the O-ring. An inverted gasket can give against the strainer and cause leakage.

Fact is, an inverted gasket and O-ring can lead to a No. 2 bearing oil passage clogged with O-ring particles—which can cause engine failure.

Forget about adding an O-ring. Take a look at the strainer gasket. If it's in wrong, with the recessed side down, get a new gasket. Put it in the right way, recessed side up. That'll stop the leak.

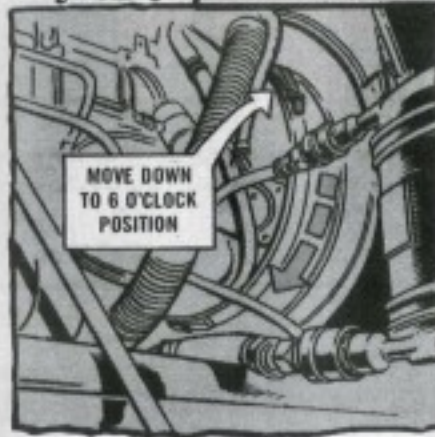
Any other position and trapped water will corrode the magnesium flange on the engine inlet housing.

That means flange replacement, and much bread, at overhaul. You better believe it!

First chance you get, Huey and Cobra mechs, eyeball the V-band coupling that secures the particle separator (Bell Mouth Assembly) to the T-53 engine housing.

The coupling gap has to be at the 6 o'clock position for water drainage.
