*TB 1-1520-210-30-01

DEPARTMENT OF THE ARMY TECHNICAL BULLETIN

MANDATORY RECURRING INSPECTION OF TAIL BOOM VERTICAL FIN SPAR ASSEMBLY FOR ALL UH-1 SERIES AIRCRAFT

Headquarters, Department of the Army, Washington, D. C.
4 November 2005

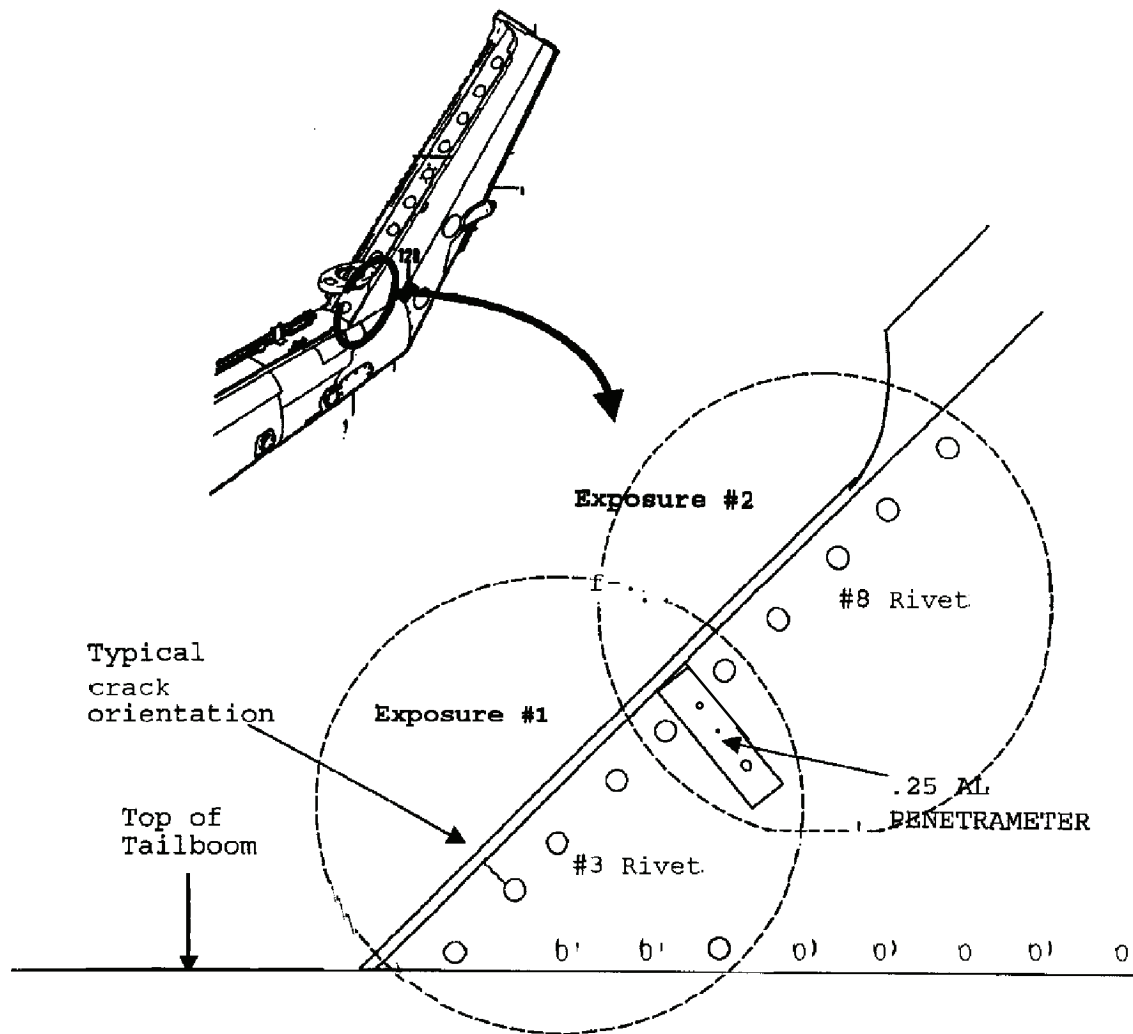
Figure 4: Radiographic Exposures #1 and #2

A crack will appear as a dark, fine, line usually emanating from a rivet hole, and propagating toward the edge of the spar cap in either direction. (See Figure 4) A skin crack will appear similar to a spar crack.

(a) If a crack is indicated remove as many rivets as necessary, so that the skin may be pulled back and secured away from the spar in the area of crack indication. Repeat the radiograph of the spar with the skin removed.

(b) If a crack is still indicated, refer to paragraph 9 for corrective action. If a crack is not indicated, inspect the vertical tail fin skin for cracks. Repair skin cracks as allowable per TM 1-1500-204-23 and TM 55-1520-210-23-1.

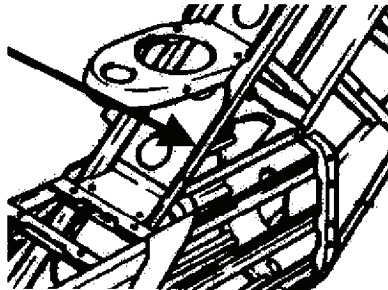
Figure 11: Visual Inspection of Spar.

(2) Using a flashlight, inspect the inboard side of the entire left hand spar cap flange above the tail boom interface for cracks. (See Figure 10) Cracks would usually emanate from a rivet hole and could also be visible on the edge of the spar cap flange doublers (nested angles). Pay particular attention for cracks emanating from the radius where the spar cap flange transitions and intersects the 90 degree gearbox mount. Use a 10x magnifying lens to inspect the following areas (See Figure 11):

(a) The outboard side of the left hand spar cap flange, between the upper most Zeus fastener receptacle and the 90 degree gearbox mount. Pay particular attention for cracks emanating from the radius where the spar cap flange transitions and intersects the 90 degree gearbox mount. If a doubler repair is installed, or has been previously installed in this area, per TM 55-1520-210-23-1, paragraph 2-296.1, figure 2-73.1., visually inspect the underneath/aft side of the spar to detect crack growth using an inspection mirror through the uppermost lightening hole in the spar web.

(1) Cracks on the outboard side of the left hand spar cap flange between the upper most DZUS fastener receptacle and the 90 degree gearbox mount may be repaired using the criteria contained in TM 55-1520-210-23-1, paragraph 2-296.1, figure 2-73.1, however, the crack cannot exceed the repairable length limits specified in the TM.

(2) All other cracks, to include those on the outboard side of the left hand spar cap flange between the upper most DZUS fastener receptacle and the 90 degree gearbox mount that exceed the repairable length limit specified in TM 55-1520-210-23-1, paragraph 2-296.1, figure 2-73.1, shall not be repaired and the tailboom shall be considered discrepant.
