The supply types have a mystery on their hands—the tab on Huey cargo door slider replacements is running over 3 grand a month . . . 'tain't normal!

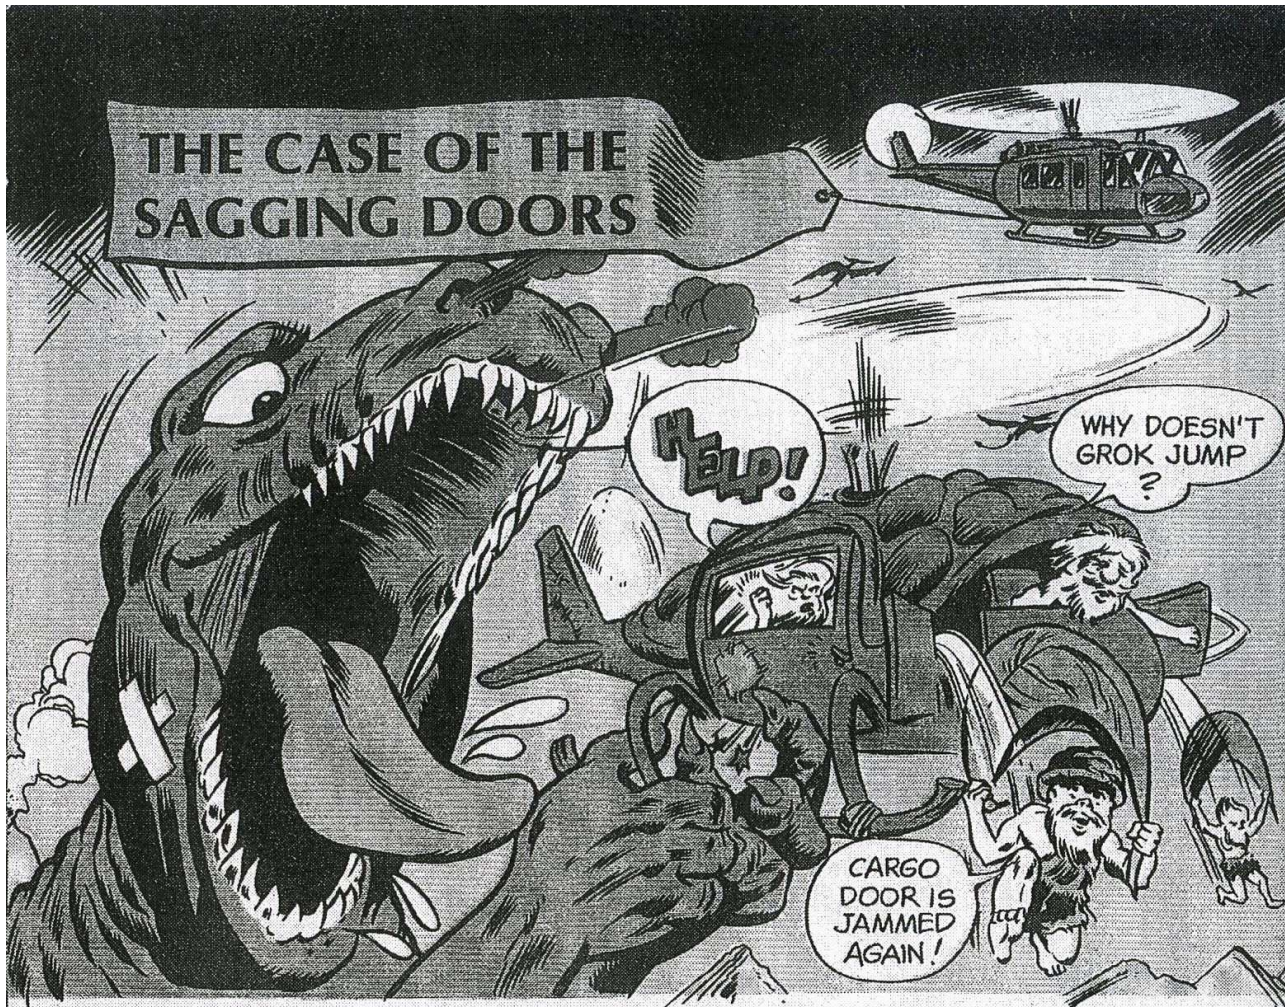
A door out of adjustment causes the slider, rather than the rollers, to carry the load. You get abnormal wear on the slider.

The doors have to be adjusted right to get normal wear out of slider, NSN 1560-00-872-7860. Sure, you can rotate the slider 180 degrees to double

the wear out of it, but that's a temporary fix.

So-o-o-o, follow the detail door adjustment poop in para 4-13e of TM 55-1520-210-20 (Sep 71) during your inspections . . . it's the only solution.
