UH-1 and AH-1 Engines...

Solve This Wrenching Problem

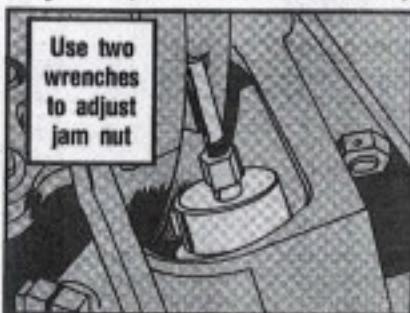
It could be broken because the last time you installed or adjusted the connector assembly you used only one wrench. When you loosen or tighten the jam nut, NSN 5310-00-947-9858,

Otherwise, the force you put on the jam nut will twist and weaken the connector rod. If it doesn't break right away, it will eventually... maybe during a flight. That can cause the engine to lose power—an emergency for sure!

use another wrench to keep a backup force on the self-aligning bearing, NSN 2840-00-904-2475.

So grab two wrenches, next time you adjust the connector assembly.
