HUEY DELTA MODEL...

OIL PRESSURE ZAPPED!

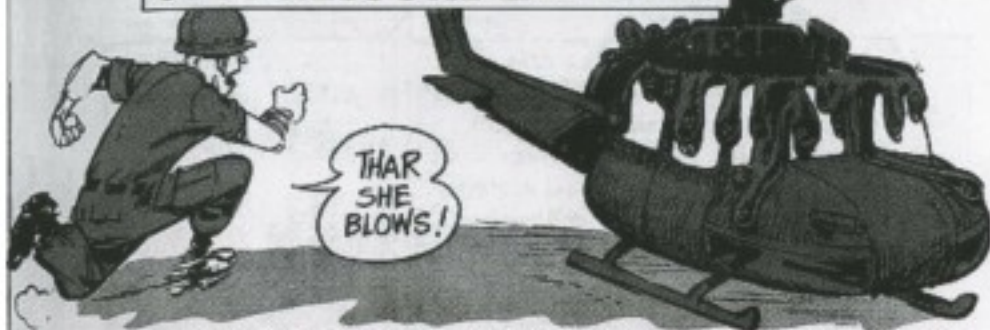
On ground run-up after a PE, a UH-1D pilot got a low-pressure signal on the transmission oil pressure gage. Within 30 seconds oil pressure was zero.

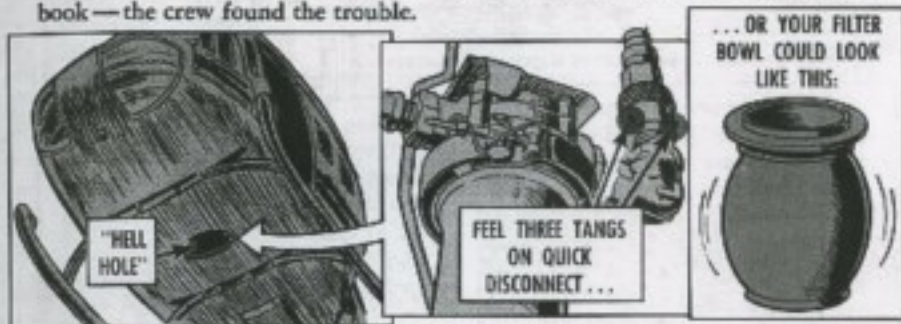
There it was in the "hell hole"—at the transmission inlet oil hose/filter outlet coupling (quick disconnect). A real hard-to-reach item to service and check—and you'd better believe it.

When the external oil filter sump was removed for cleaning and filter replacement—sequence 4.11, TM 55-1520-210-20PMP (Nov 69)—the 3 tangs on the outlet quick disconnect fitting were not checked by hand for full extension. Oil was stopped f-a-s-t . . . by the check valve in the quick disconnect as it came unglued.

With the surge in engine power, the transmission oil pump forced oil thru the line and with no place to go the filter bowl sump cracked and took on a pregnant pumpkin look.
