Ogle Angle Brackets

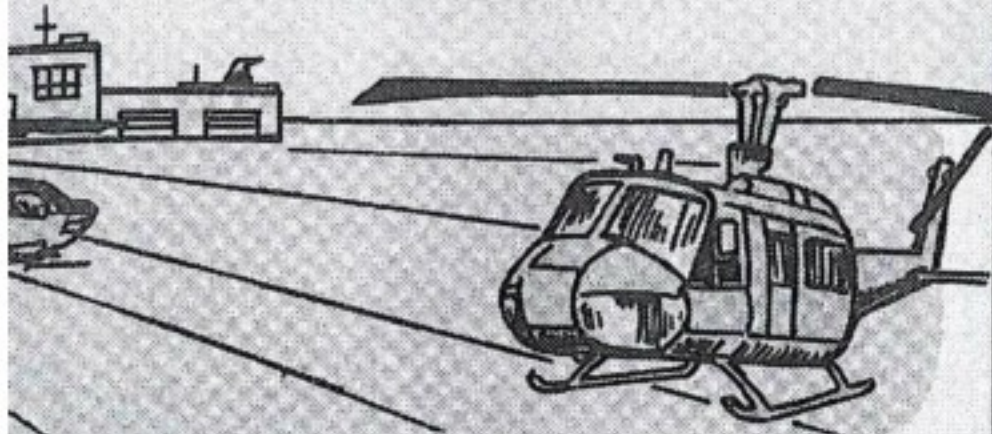
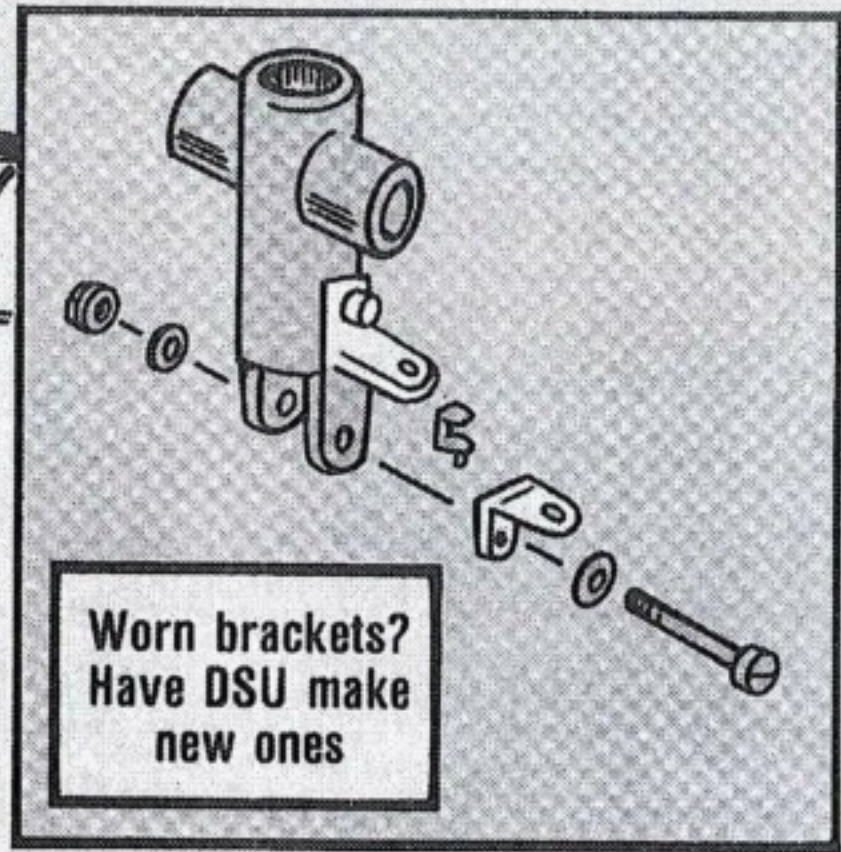
Focus on the Huey tail rotor servo, mechs, during Phase Maintenance. Some cases of elongated bolt holes in the angle brackets have cropped up.

Worn brackets, PN 205-076-230-1 and PN 205-076-118-1 listed in Fig 368, TM 55-1520-210-23P, should be replaced, and an EIR submitted to TSARCOM.

There is no stock number for a

replacement bracket. However, your sheetmetal shop can make it by following the details in Figs D-215 and D-216 of TM 55-1520-210-23.
