Is Your Tang Weak?

Dear Windy,
 Para 5-62.b. of TM 55-1520-210-23-1 makes it clear: "Do not use any device other than the work aid described to spread the housing ears during trunnion removal/installation."

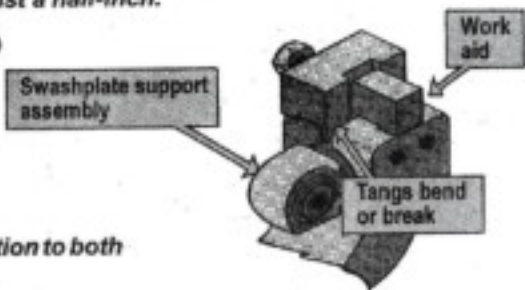
OLD WORK AID DEVICE

But the work aid described in Fig 5-38 has two tang problems. First, the tang where it fits in the trunnion is too thin. It bends, and in some cases, breaks. When that happens, you damage the swashplate trunnion.

Second, the tangs are not equal in surface area. There's an inch pulling against a half-inch.
