*TB 1-1520-210-30-01

DEPARTMENT OF THE ARMY TECHNICAL BULLETIN

MANDATORY RECURRING INSPECTION OF TAIL BOOM VERTICAL FIN SPAR ASSEMBLY FOR ALL UH-1 SERIES AIRCRAFT

Headquarters, Department of the Army, Washington, D. C.
22 March 2000

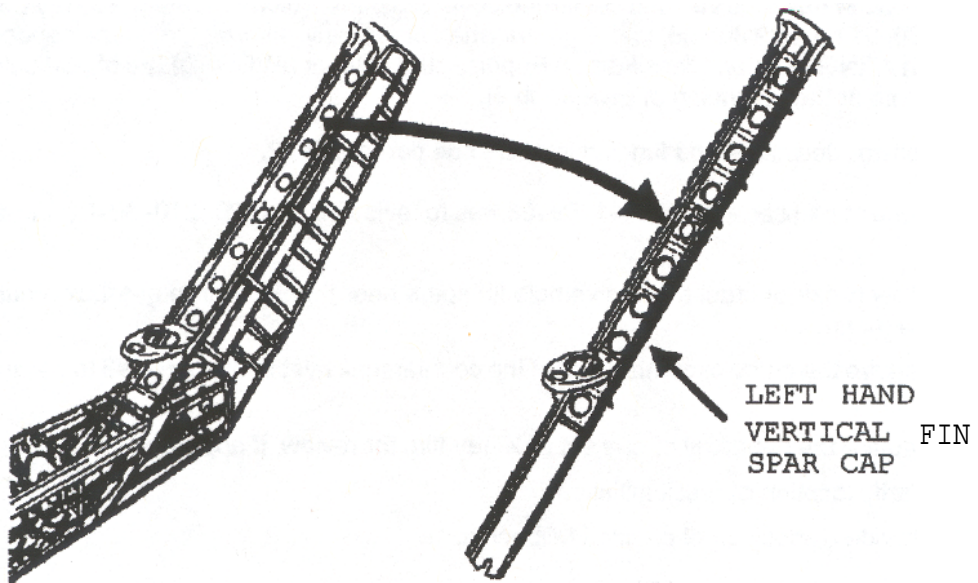
Figure 1: Vertical Fin Spar

a. Tail Boom Fin Spar Assembly, Part Number 205-030-846-(all dash numbers), shall be inspected as specified herein. The area of concern is the Left Hand Vertical Fin Spar Cap shown in Figure 1. These inspections pertain to the left-hand spar cap only.

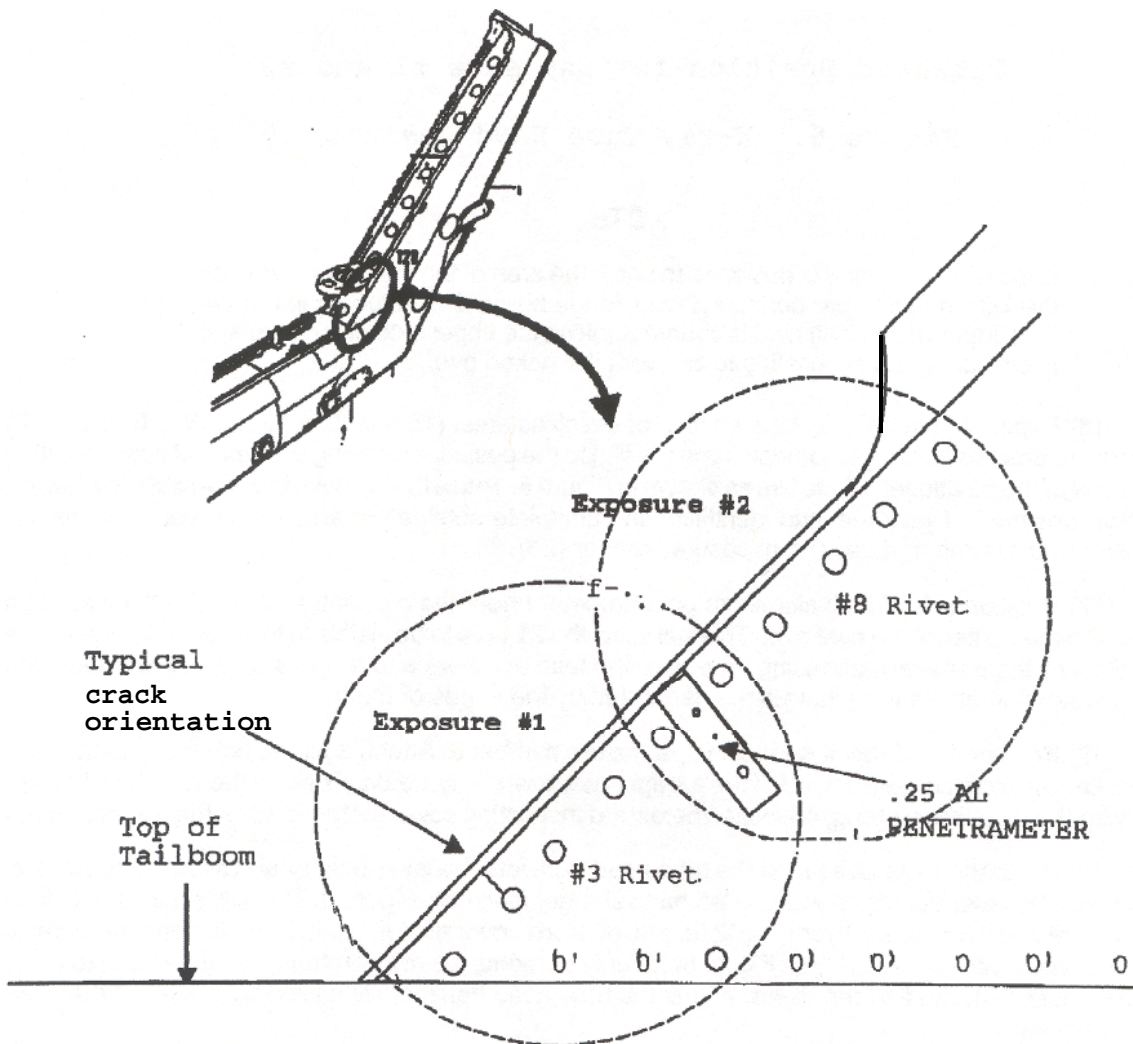
Figure 4: Radiographic Exposures #1 and #2

A crack will appear as a dark, fine, line usually emanating from a rivet hole, and propagating toward the edge of the spar cap in either direction, (See Figure 4) A skin crack will appear similar to a spar crack.

(a) If a crack is indicated remove as many rivets as necessary, so that the skin may be pulled back and secured away from the spar in the area of crack indication. Repeat the radiograph of the spar with the skin removed.

(b) If a crack is still indicated, refer to paragraph 9 for corrective action, If a crack is not indicated, inspect the vertical tail fin skin for cracks. Repair skin cracks as allowable per TM I-1 500-204-23 and TM 55-1520-210-23-I.

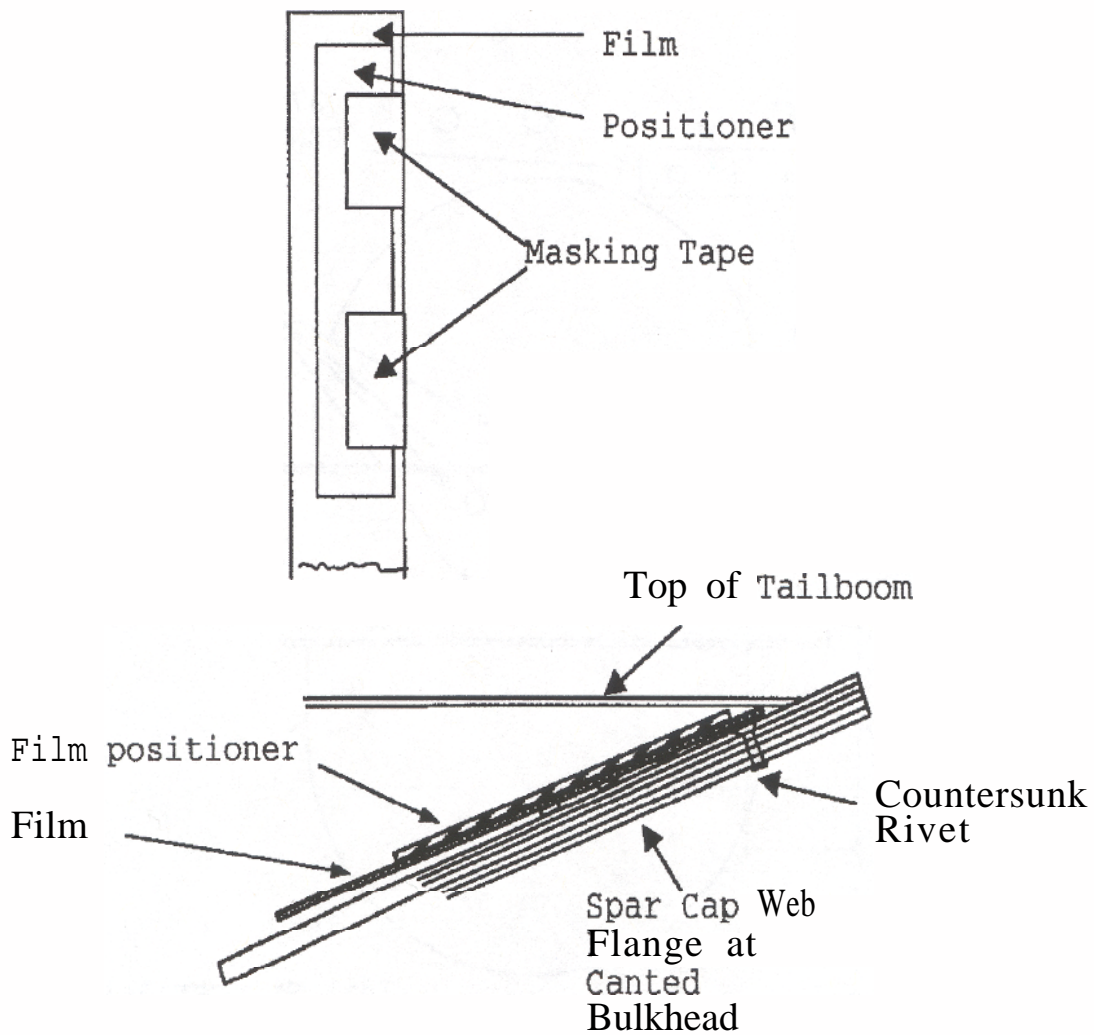
Figure 6. Placement of Film for Exposure 3

Exposure Number 3 is designed to show the area of the first three rivets on the left hand fin spar horizontal web flange below the tail boom interface. The upper most (first) rivet is countersunk on the upper side of the spar and is difficult, if not impossible to see with the naked eye.

NOTE: It is important that the film be placed as far up the spar web flange and as far outboard (into the nested angle) as possible to assure that the first rivet is exposed on the film

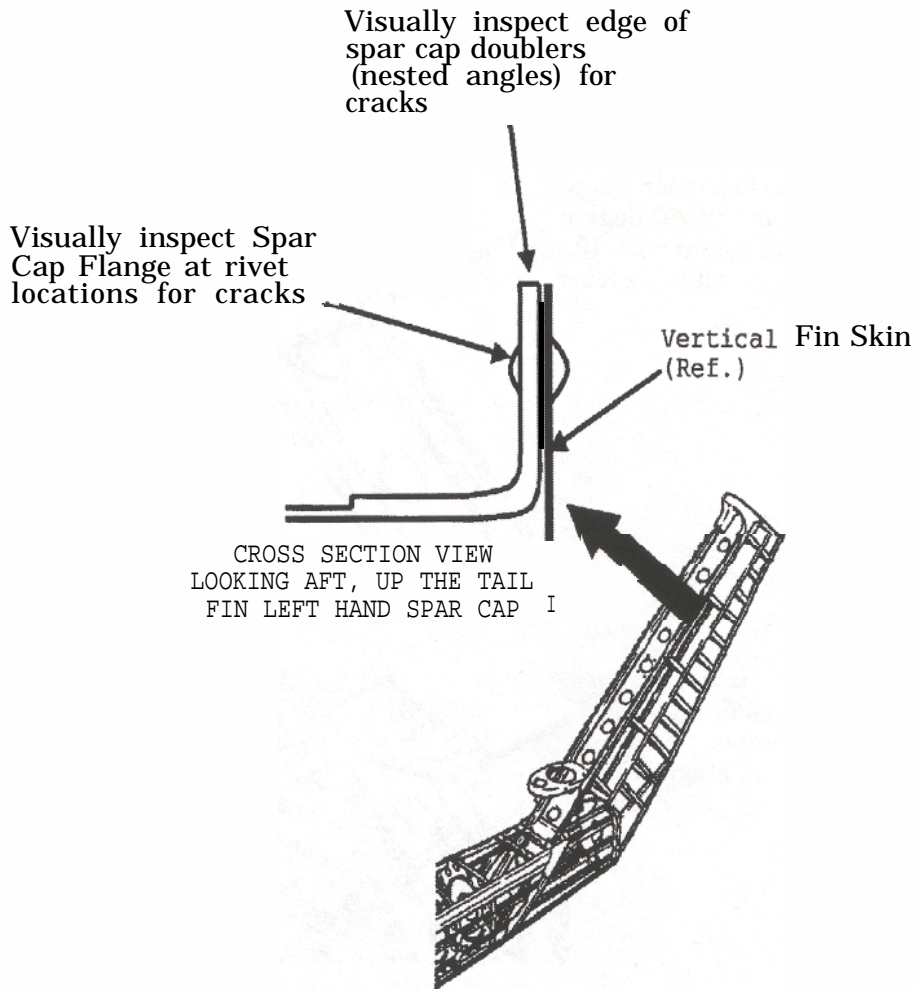
Figure 10: Visual Inspection of Spar

A spar crack will be distinguishable by a hairline crack in the primer.

(2) Using a flashlight, inspect the inboard side of the entire left hand spar cap flange above the tail boom interface for cracks. (See Figure 10) Cracks would usually emanate from a rivet hole and could also be visible on the edge of the spar cap flange doublers (nested angles). Pay particular attention for cracks emanating from the radius where the spar cap flange transitions and intersects the 90 degree gearbox mount. Use a 10x magnifying lens to inspect the following areas (See Figure 11):

(3) If a crack is found, accomplish correction procedures of paragraph 9.

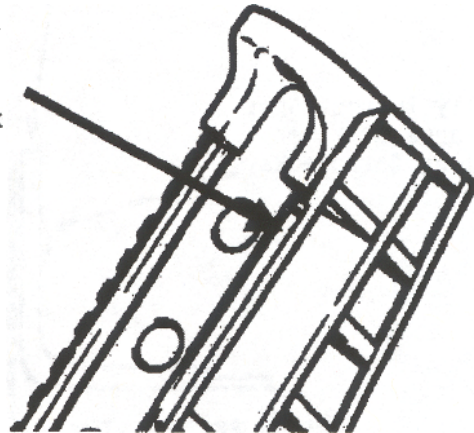
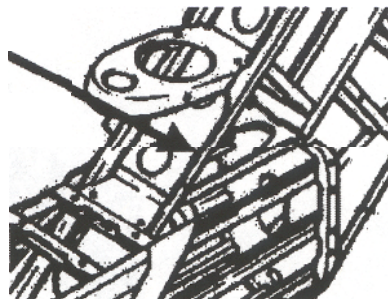
Figure 11: Visual Inspection of Spar.

(a) The outboard side of the left hand spar cap flange, between the upper most Zeus fastener receptacle and the 90 degree gearbox mount. Pay particular attention for cracks emanating from the radius where the spar cap flange transitions and intersects the 90 degree gearbox mount. If a doubler repair is installed, or has been previously installed in this area, per TM 55-1520-21 O-23-1, paragraph 2-296.1, figure 2-73.1., visually inspect the underneath/aft side of the spar to detect crack growth using an inspection mirror through the uppermost lightening hole in the spar web.

Inspect the outboard side of the left hand spar cap flange, between the upper most Zeus fastener receptacle and the 90 degree gearbox mount with 10x magnifying lens.

Inspect first ten rivets above tail fin/tailboom interface in this area with 10x magnifying lens.

(1) Cracks on the outboard side of the left hand spar cap flange between the upper most DZUS fastener receptacle and the 90 degree gearbox mount may be repaired using the criteria contained in TM 55-1520-21 O-23-1, paragraph 2-296.1, figure 2-73.1, however, the crack cannot exceed the repairable length limits specified in the TM.

(2) All other cracks, to include those on the outboard side of the left hand spar cap flange between the upper most DZUS fastener receptacle and the 90 degree gearbox mount that exceed the repairable length limit specified in TM 55-1520-210-23-1, paragraph 2-296.1, figure 2-73.1, shall not be repaired and the **tailboom** shall be considered discrepant.
