[Docket No. FAA-2012-0415; Directorate Identifier 2008-SW-065-AD; Amendment 39-17865; AD 2014-12-04]

Airworthiness Directives; Bell Helicopter Textron, Inc. (BHTI) Helicopters

ACTION: Final rule.

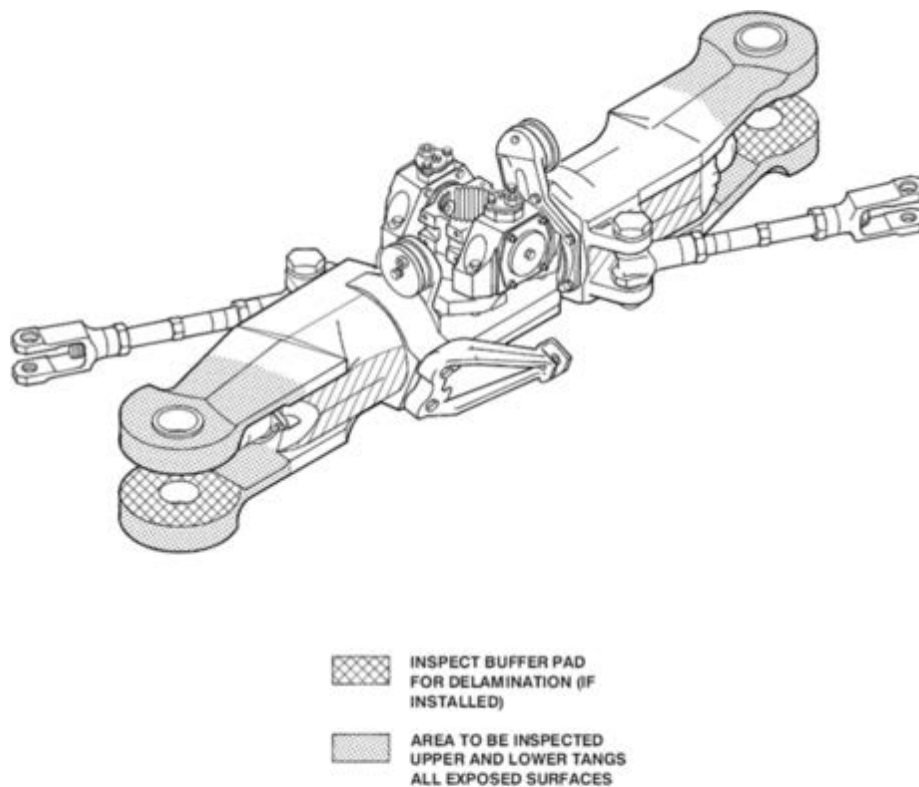
Figure 1 to Paragraphs (f)(2)(ii) and (f)(4)(ii)
Inspection of Main Rotor Hub Grip Tangs

This AD defines the unsafe condition as a crack in the main rotor grip (grip), which could result in failure of a grip, separation of a main rotor blade, and subsequent loss of control of the helicopter.

(ii) Using a 10-power or higher magnifying glass, visually inspect the exposed surfaces of the upper and lower tangs of each grip for a crack. Pay particular attention to the lower surface of each lower grip tang from the main rotor blade bolt-bushing flange to the leading and trailing edge of each grip tang as depicted in Figure 1 to Paragraphs (f)(2)(ii) and (f)(4)(ii) of this AD.

- (i) Remove each main rotor blade, and
- (ii) Inspect each grip buffer pad on the inner surfaces of each grip tang for delamination as depicted in Figure 1 to Paragraphs (f)(2)(ii) and (f)(4)(ii) of this AD. If there is any delamination, remove the buffer pad and inspect the grip surface for corrosion or other damage.

- (i) Replace any cracked grip with an airworthy grip.
- (ii) Replace any grip with any corrosion or other damage with an airworthy grip, or repair the grip if the corrosion or other damage is within maximum repair damage limitations.
- (iii) Replace any grip, P/N 204-011-121-009 or ASI-4011-121-9, which has been in service for 15,000 or more hours TIS.
