[Docket No. FAA-2012-0896; Directorate Identifier 2010-SW-070-AD; Amendment 39-17173; AD 2012-17-10]

Airworthiness Directives; Various Restricted Category Helicopters

2012-17-10 Various Restricted Category Helicopters: Amendment 39-17173; Docket No. FAA-2012-0896; Directorate Identifier 2010-SW-070-AD.

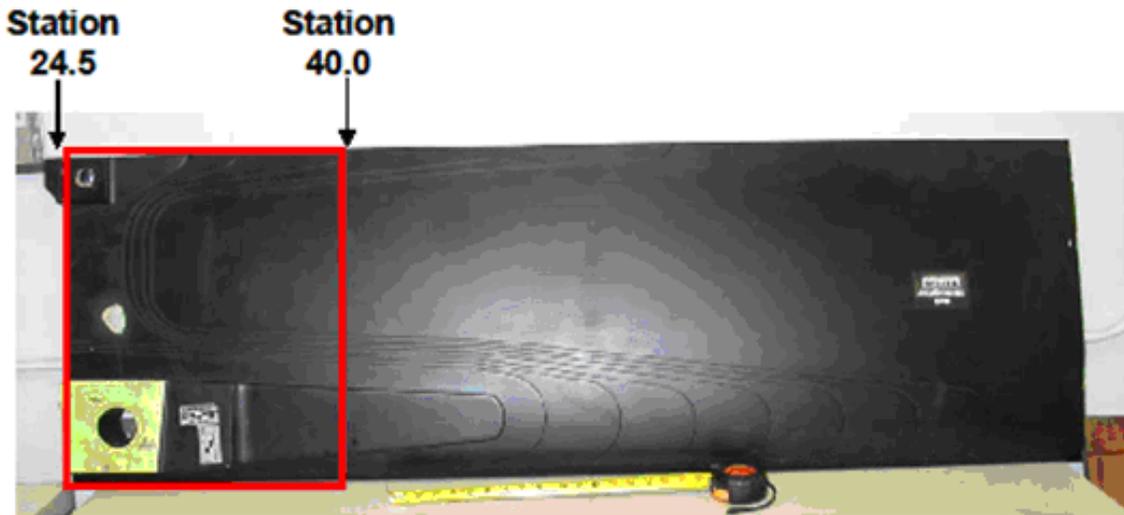
Figure 1 to paragraph (e)(1)(ii)

- (1) Within 25 hours time-in-service (TIS), and thereafter at intervals not to exceed 25 hours TIS:
 - (i) Wash the upper and lower surfaces of each affected M/R blade with a solution of cleaning compound (C-318) and water. Rinse thoroughly and wipe dry.
 - (ii) Using a 3x power or higher magnifying glass and a bright light, on each affected M/R blade, in an area from blade stations 24.5 to 40, including the entire width of the M/R blade chord, as depicted in Figure 1 to Paragraph (e) of this AD:

(A) Visually inspect the upper and lower grip plates and doublers of the M/R blade for an edge void, any corrosion, or a crack.

(B) Visually inspect the remaining upper and lower surfaces of the M/R blade for an edge void, any corrosion, or a crack.

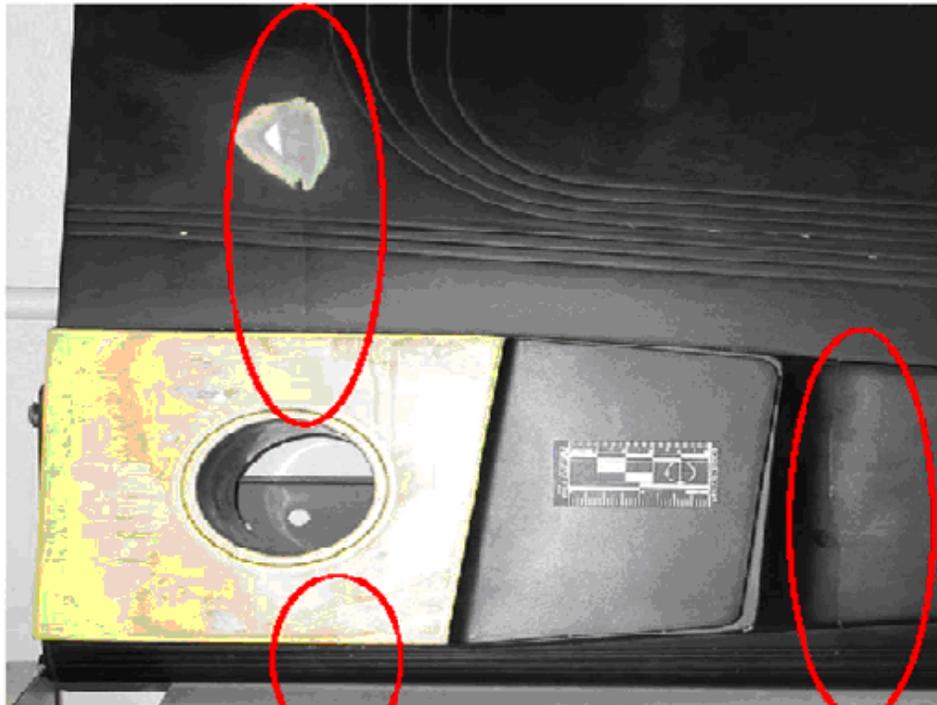
Figure 2 to paragraph (e)(1)(ii)

This AD is prompted by several reports of fatigue cracks on M/R blades installed on Bell Model 212 helicopters. The cracks were found in the lower skin, doublers, and box beam at the M/R blade attachment bolt hole, and through the lower grip plate at blade station (BS) 36. Because the fatigue cracks were discovered on M/R blades installed on the Bell Model 212 helicopters, we issued AD No. 2010-03-03, Amendment 39-16186 (75 FR 5681, February 4, 2010) (AD 2010-03-03) for certain Bell Model 205B and 212 helicopters. That AD required visually inspecting the M/R blades for an edge void, corrosion, or a crack. After issuing that AD, we received another report of a fatigue crack on a M/R blade installed on a Model 212 helicopter. Further analysis by the manufacturer revealed that the inspections required by AD 2010-03-03 needed to be expanded and performed at an increased frequency, and on additional part-numbered M/R blades which can also be installed on other Bell model helicopters. We then issued AD No. 2011-23-02 (76 FR 68301, November 4, 2011) (AD 2011-23-02), which superseded AD 2010-03-03. AD 2011-23-02 retained the requirements of the superseded AD, increased the frequency and scope of the inspections required by that AD, and expanded the applicability to include the Model 205A-1 and 210 helicopters, additional M/R blade part numbers, and all helicopter serial numbers for the affected models.

Note 2 to paragraph (e)(1)(ii): Crack indications on an actual M/R blade are shown in Figure 2 to Paragraph (e) of this AD.

(v) If there is a crack in any grip plate or doubler, replace the M/R blade with an airworthy M/R blade.

(vi) If there is a crack in the M/R blade skin, replace the M/R blade with an airworthy M/R blade, or repair the M/R blade if the damage is within the maximum repair damage limits.
