**ALERT SERVICE BULLETIN
REVISION NOTICE**

**SUBJECT: REVISION "A" TO ALERT SERVICE BULLETIN UH-1H-09-05:
205-030-856-157/-159 ELEVATORS, ONE TIME INSPECTION OF.**

NO. UH-1H-09-05

SUBJECT: 205-030-856-157/-159 ELEVATORS, ONE TIME INSPECTION OF.

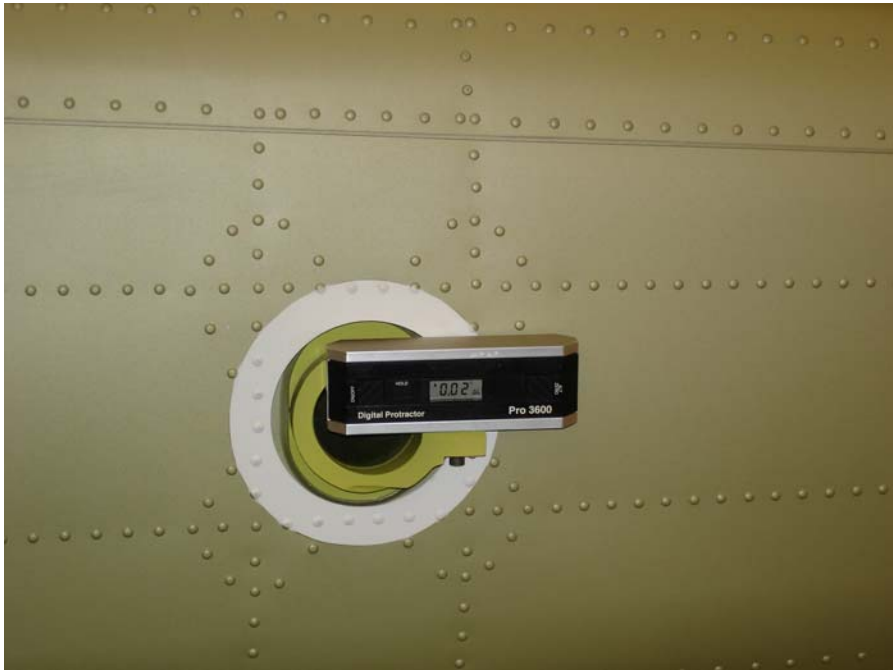
Figure 1
Angle A

1. Prepare helicopter for maintenance.
2. Confirm elevator is within serial number range by referring to its bonded and riveted dataplate near the trailing edge.
3. Remove tailboom access panel just aft of Boom Station (BS) 101.38.
4. Remove L/H Elevator.
5. Place digital protractor on elevator horn fitting, zero protractor and record as Angle "A". (ref Fig.1)

- a. If the difference between Angle "A" and Angle "B" is not within the allowable difference ($2.0^\circ \pm 0.3^\circ$), replace the RH elevator as per Maintenance Manual within the next 100 flight-hours.
 - b. If the difference between Angle "C" and Angle "D" is not within the allowable difference ($3.0^\circ \pm 0.75^\circ$) replace the LH elevator as per Maintenance Manual within the next 100 flight-hours.
10. Make an entry in helicopter historical records indicating compliance of this bulletin.

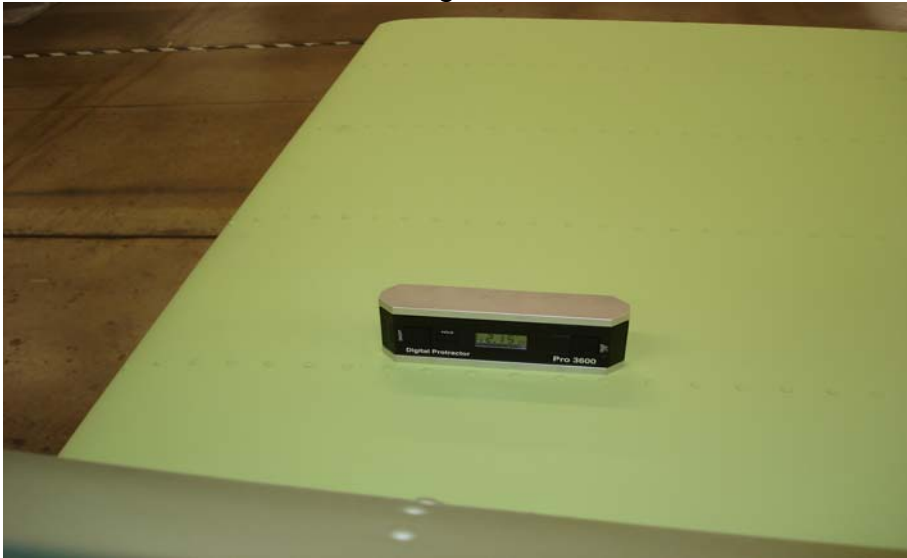
Figure 2
Angle B

6. Move protractor to top skin of RH elevator second rib, edge of protractor should be aligned with the 8th rivet from the leading edge of the elevator. Record relative angle as Angle "B". (ref Fig. 2)
7. Install L/H Elevator per Maintenance Manual.
8. Position protractor to top skin of RH elevator second rib, edge of protractor should be aligned with the 8th rivet from the leading edge of the elevator. Zero protractor and record as Angle "C". (ref Fig. 3)

The allowable difference from A to B = $2.0^\circ \pm 0.3^\circ$

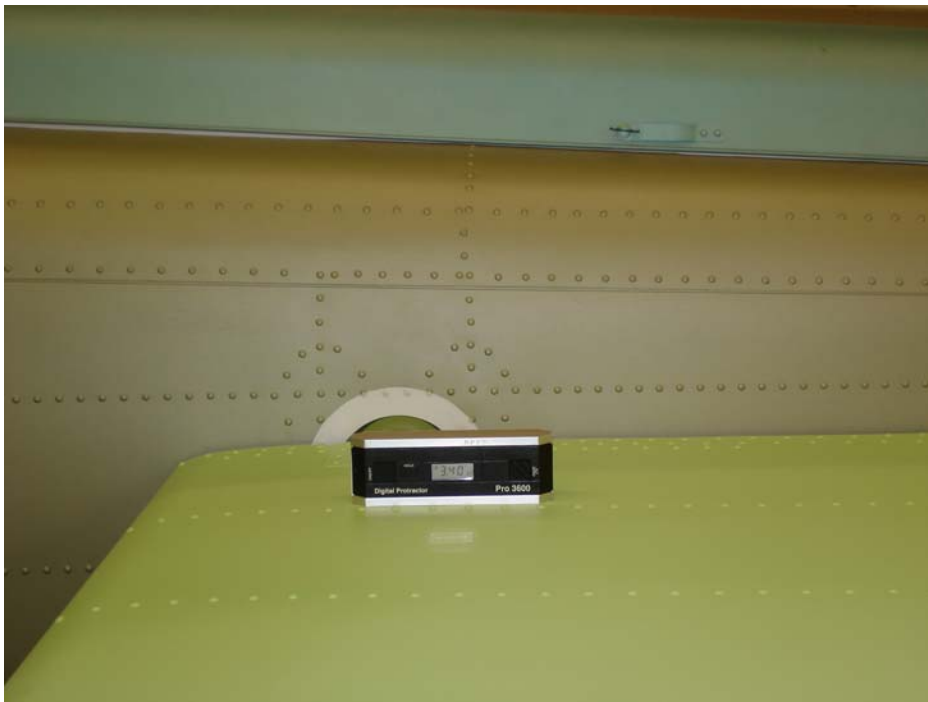
Figure 4
Angle D

9. Position protractor to top skin of LH elevator second rib, edge of protractor should be aligned with the 8th rivet from the leading edge of the elevator. Record relative angle as Angle "D". (ref Fig 4)

The allowable difference from C to D = $3.0^\circ \pm 0.75^\circ$
