It seems this Huey Delta (UH-ID) Murphymec installed the pillow block oil reservoirs, P/N 204-010-191-1, on his bird and added the covers.

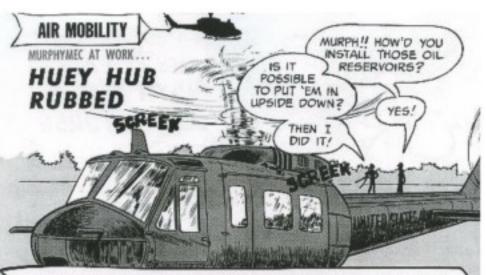
Filling the reservoirs with Mi1-L-7808 oil is a bonafide built-in maintenance check, but when Murphymec added the amber stuff, not a drop got inside one of 'em! It was installed upside down, and Murph didn't notice his booboo, which could have caused the bird to come unglued while airborne, or deadlined her just when she was needed for a Hueyvac mission.

Many aircraft parts are immune to Murphy's Law. And you have checks and bythe-book maintenance to help stamp out this pest. Use 'em.
