IN THE HOT SEAT?

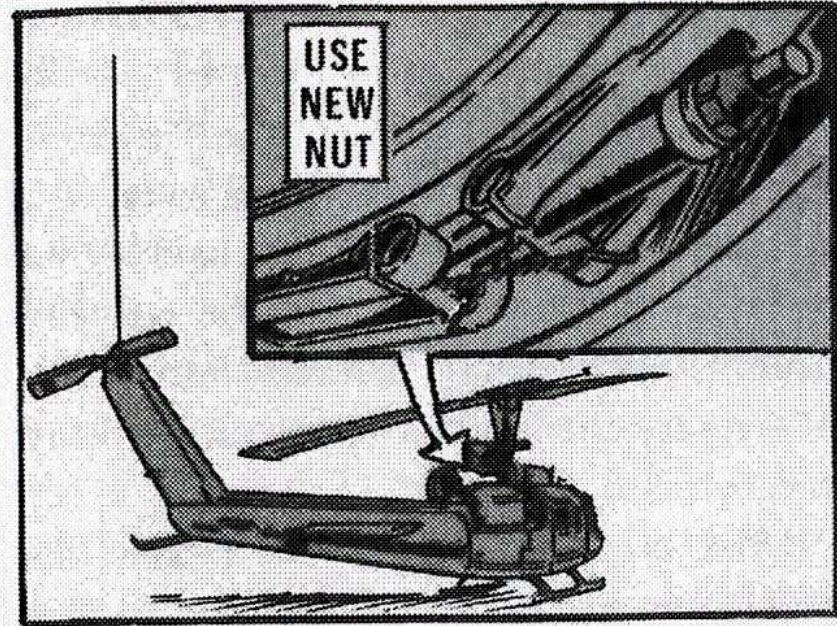
Heat at the T-53 engine tailpipe is enough to weaken re-used V-band coupling clamp nuts, Huey mechs.

The result can be clamp failure and damage to your bird.

Which is why para 5-16e(2) of TM 55-1520-210-20 (Sep 71) calls for using new, steel self-locking nuts when you seat the clamps.
