The Best Surprise Is...

NO Surprise!?!

A lot of Huey and Cobra transmissions are showing up for overhaul without enough protection from moisture.

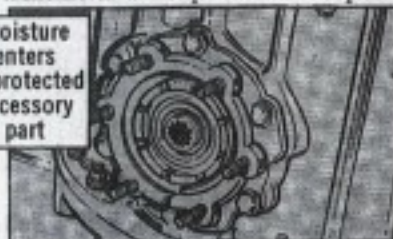
When openings for the generator drive quill and the hydraulic pump and tachometer drive quill are left unprotected,

Moisture enters unprotected accessory part

the moisture villain has an opening.

Remember that the internal magnesium is not protected by oil when the transmission is idle. Add the fact that it can be a long time before that baby is actually worked on at the depot and you have a candidate for the scrap heap.

Save
The new transmission is protected from the weather. Send the old one back the same way. Save the protective covers.

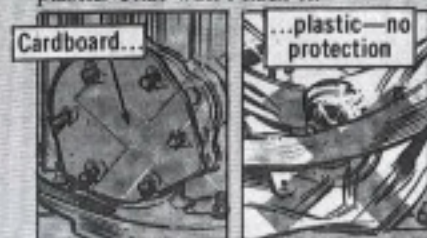
Some mechs are using cardboard or plastic. That won't hack it!
