OPERATION SAFETY NOTICE

GEN-13-46

17 December 2013

**SUBJECT: FLUID LINES FRETTING DAMAGE**

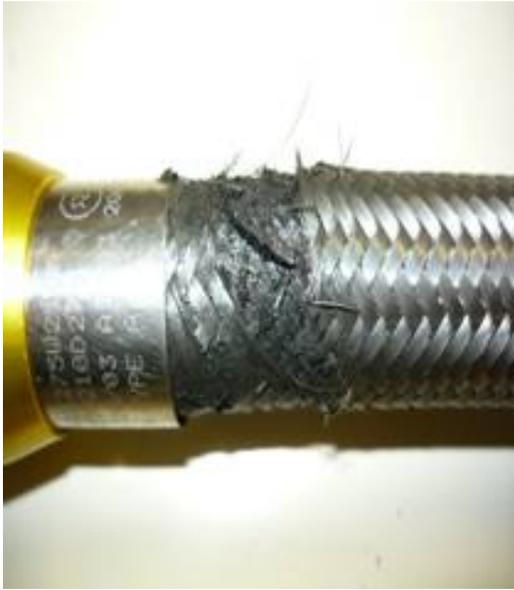
Picture 1

Bell Helicopter continues receiving sporadic reports from the field regarding fluid line damage or failure due to fretting from various sources. Incorrect clamping, poor routing, twisted installation, damaged attaching clamps and fretting with metal identification tags or other components are all possible causes for damage. Recently, two cases were reported where a flexible oil hose for a main transmission suffered failure due to the identification tag fretting into the hose as shown in Picture 1. In these instances, significant dark paste indicating fretting would have been present at numerous inspection intervals before the braid was worn through and subsequently resulting in the hose failure. This OSN emphasizes the importance of paying attention during scheduled inspections to any anomaly and to rectify any potential situation that may cause damage to fluid lines and surrounding components. The following are all conditions that should be verified and rectified as required to avoid fluid line degradation and possible failure.

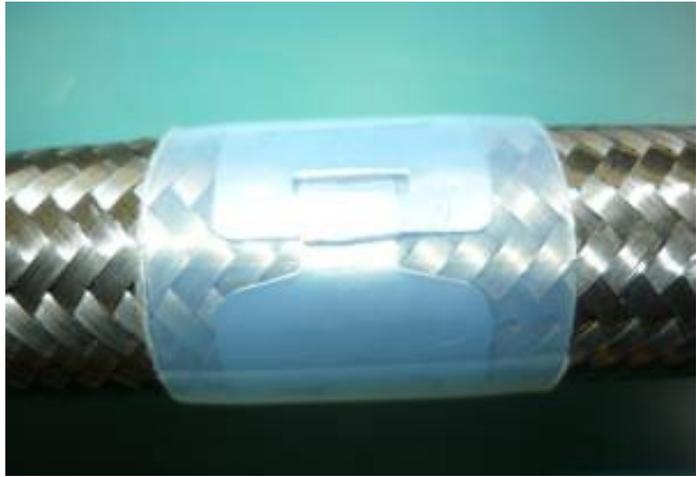
Picture 2

Identification tags used on flexible lines should be properly secured and located in an area that is not in a bend radius. To prevent movement and limit fretting damage, many hoses manufactured after 2005 incorporate a clear heat shrink tubing over the ID tag as shown in Picture 2. Loose identification tag should be properly secured to avoid fretting damage.

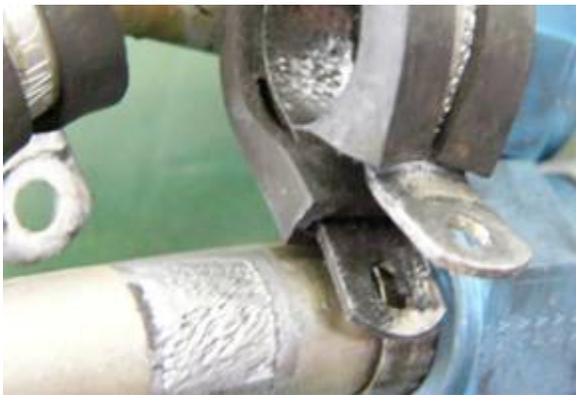
Incorrect flexible line installation involving excessive hose bending or twisting may also result in fretting of the braids and cause their subsequent failure. Damaged attaching clamp, clamp of the wrong size or clamp with worn or missing protective rubber may also cause damage to any fluid line. Picture 3 shows an example of a rigid fluid line damaged by a worn clamp. In all cases, fluid lines should always be properly secured to avoid contact with surrounding components. Picture 4 shows the result of a flex hose contacting the transmission support case. Improperly installed and secured fluid line may also harmonize with inherent airframe vibrations and subsequently fail. Any evidence of fretting characterized by dark paste should always be investigated and rectified as soon as possible. Additional General Practices for fluid lines can be found in the BHT-ALL-SPM Chapter 8.
