OPERATIONS SAFETY NOTICE

OSN 210-10-03

SUBJECT: Tailboom Longeron Inspection Requirements

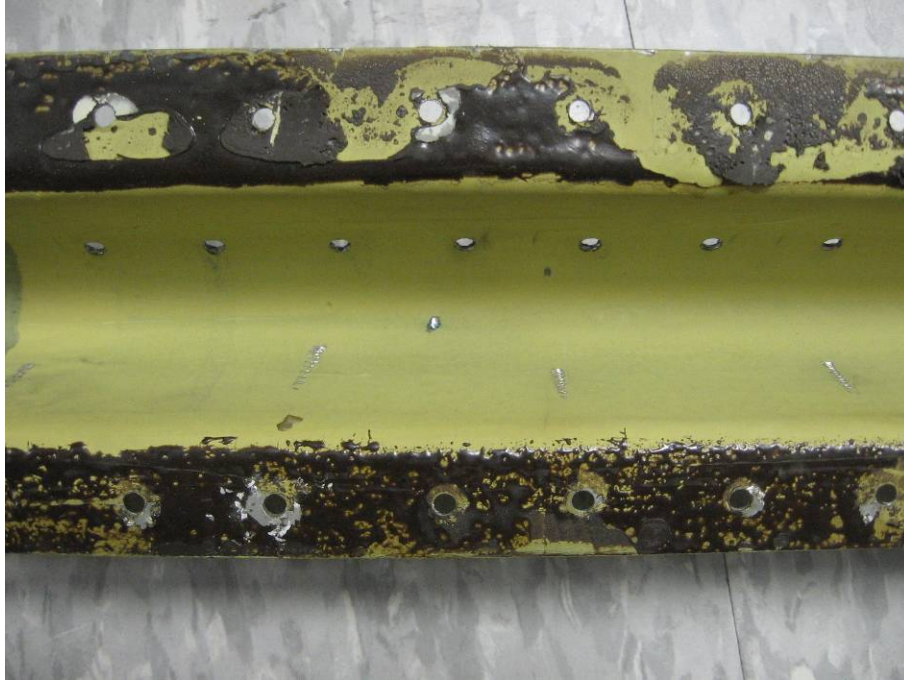
1. Score marks in the interior of the upper longerons caused by drilling operations. Bell Helicopter is not aware of any cracks or failures caused by these score marks. See Figure 1.
2. Cracking of upper and lower left longerons in the area aft of B.S.194.30 bulkhead. See Figure 2

Figure 1
Drill damage to inside of Longeron (Longeron removed)

When carrying out drilling operations where the possibility of damage to underlying surfaces or components exists, a suitable drill stop should be used.

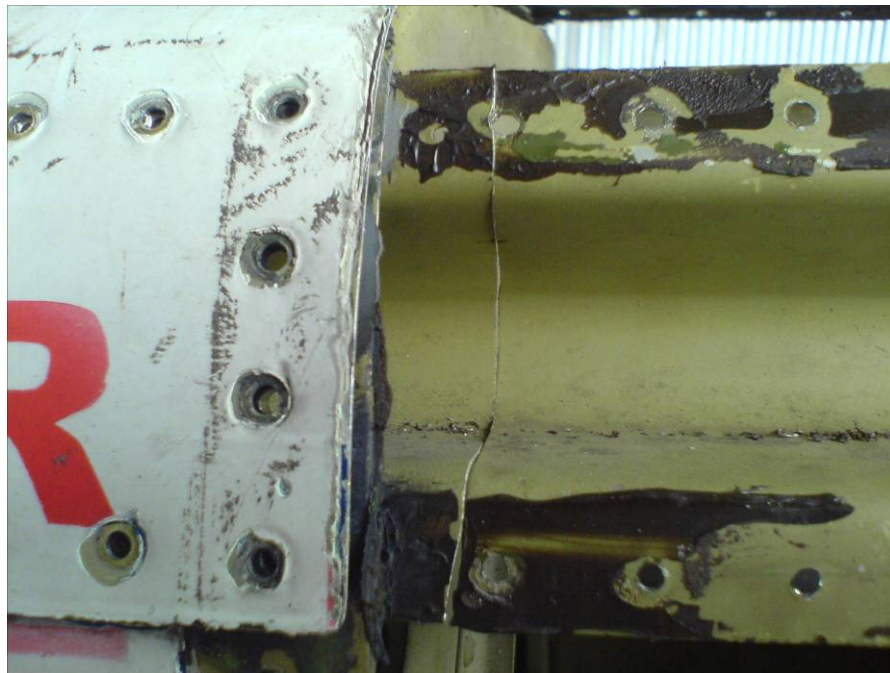
Figure 2
Cracked Longeron (upper skin removed) Aft of B.S.194.30

When carrying out the required Maintenance Manual inspections, ensure adequate bright lighting, mirror and borescope as required are used. Cracked longerons must be repaired or replaced in accordance with the Structural Repair Manual (BHT-MED-SRM-1).
