A Wrenching Problem

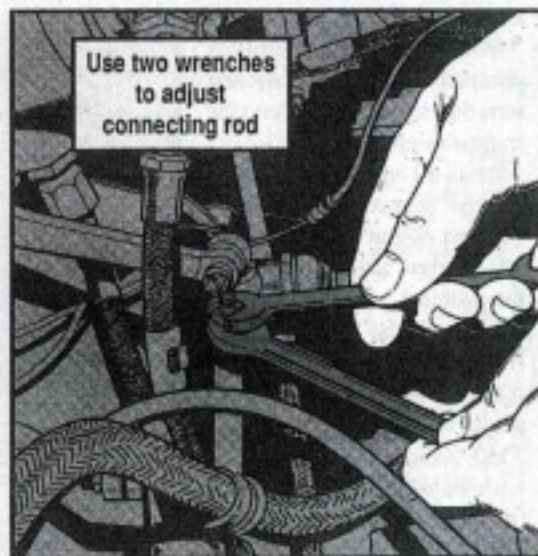
If the N1 is running about 8 percent above normal, and the EGT and torque are OK, the connector rod on the variable inlet guide vane assembly is probably broken.

The vanes won't open and the N1 will run above normal.

If you don't put a backup force on the bearing, the jam nut will twist and weaken the connector rod. Maybe not right away, but it will sooner or later and the rod will break.

Any time you install or adjust the connector rod, use 2 wrenches—one to loosen or tighten the jam nut and the other to keep a backup force on the self-aligning bearing.

So don't take chances. Grab two wrenches next time you install or adjust the connector assembly.
