**ALERT SERVICE BULLETIN**

**UH-1H-17-18**  
13 January 2017

**SUBJECT:** MAIN ROTOR BLADE 204-011-250-005,-113  
INSPECTION OF.

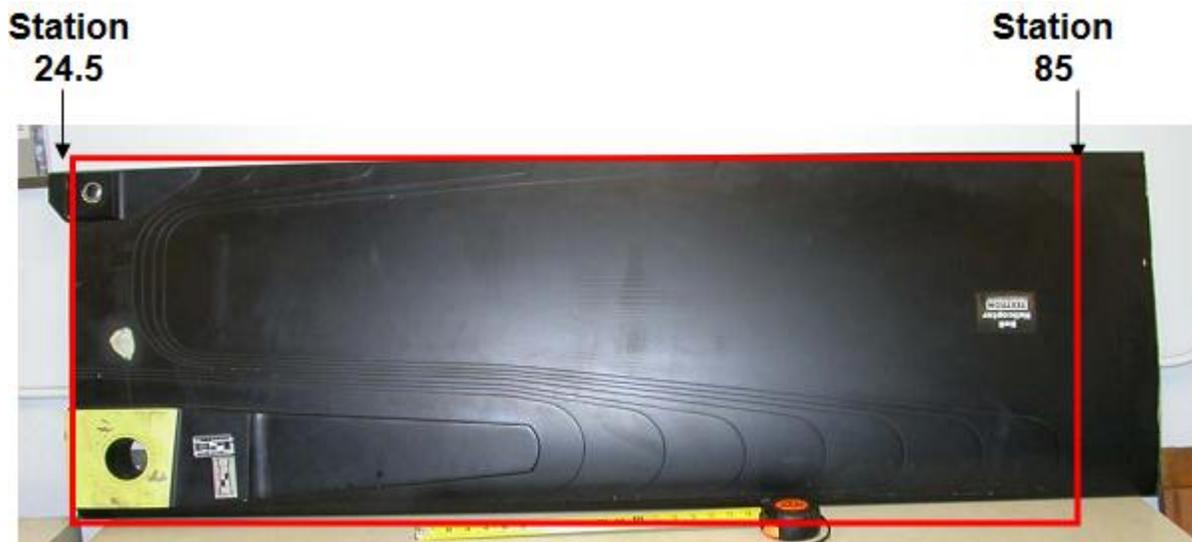
**Figure 1 - Area to be inspected with 3X Power Magnifying Glass (Upper and Lower Surfaces)**

4. Carry out a detailed visual inspection of the top and bottom inspection areas of the blade with a 3X power magnifying glass and a strong light source. Refer to Figure 1. Check for evidence of a dark line between the doublers, grip plates, and skin with excess alcohol bleeding out of possible edge voids. Any cracks in the finish must be investigated further by removing the paint in the affected areas. Sand the affected area in a spanwise direction with an abrasive cloth or paper (C-406) 180 to 220 grit to determine if the grip plate/doublers are cracked or voided. Any crack in the paint finish, which follows the grip plate/doublers outline, may indicate a possible edge void.

6. If cracks in the grip plate/doublers are found, the affected blade must be immediately removed from service. If no cracks are detected, continue with step 7.
7. If edge voids between the grip plate/doublers/skin are found, determine the depth and length with a 0.0015 inch (0.038 mm) feeler gauge. If edge voids are suspected near the outboard tip of the grip plate/doublers, carry out a tap test of the affected area. Refer to the BHT-204B-M&O, Section 2, Para 2-13 for void repair limits and inspection/repair instructions. If no voids are detected, continue with step 8.
8. Touch-up / refinish the sanded area as per the TM 55-1520-210-23.
9. Following the inspection, apply a light coat of preservative oil (C-125) to all surfaces of blade.
10. Make an entry in the helicopter logbook and historical service records indicating findings and compliance with this Alert Service Bulletin.

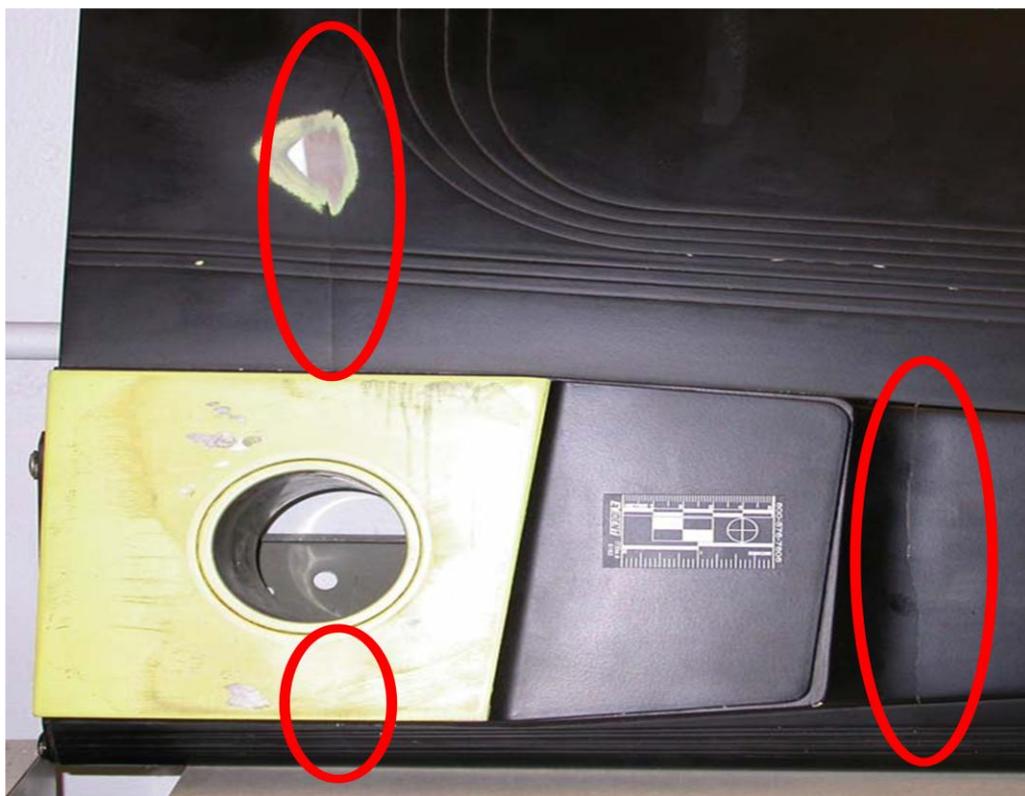
**Figure 2 - Crack indications**

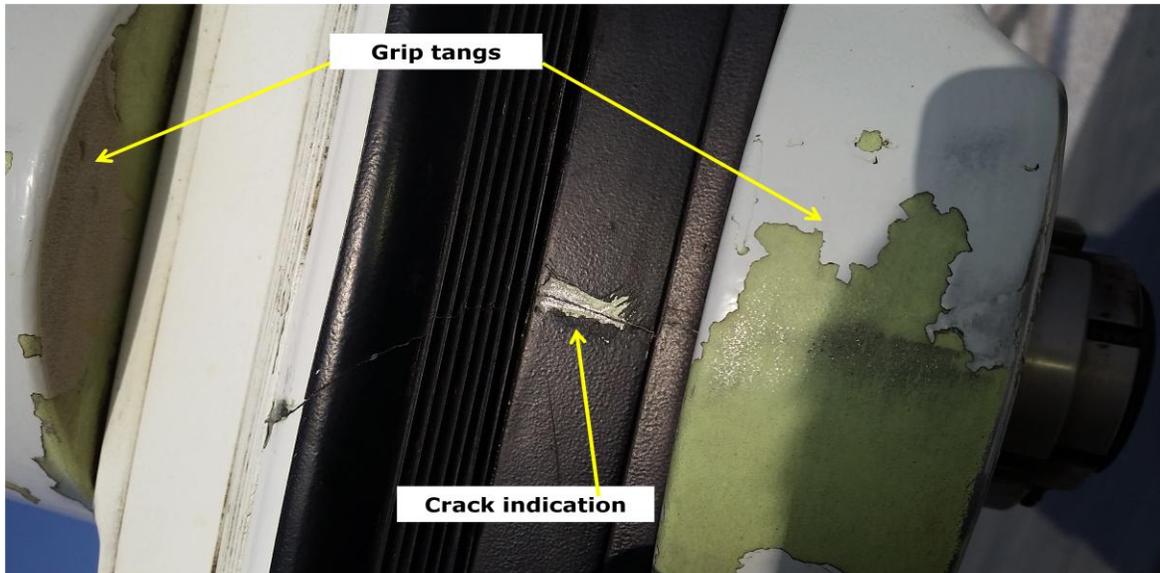
**Figure 3 - Crack indication**

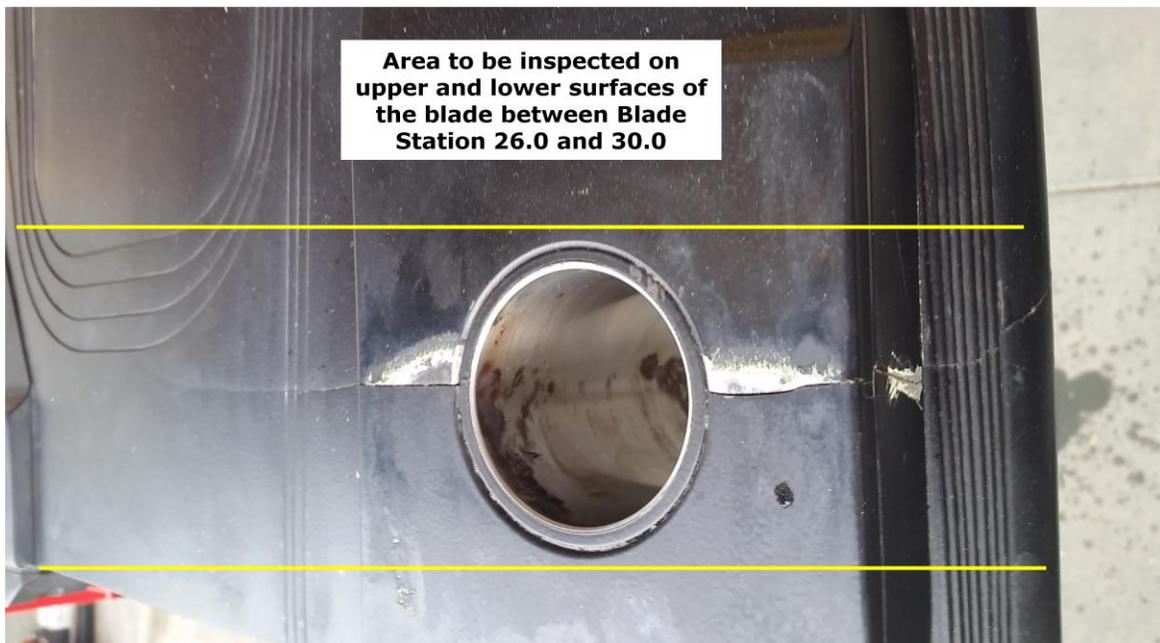
**Figure 4 - Area to be Inspected with a 10X Power Magnifying Glass (Upper and Lower Surfaces)**

5. Carry out a detailed visual inspection of the top and bottom inspection areas in the blade bolt area with a 10X power magnifying glass and a strong light source (Figure 4). Inspect the leading edge and trailing edge sides of the blade at the blade bolt span station for evidence of cracks or dark lines in the grip plates going across the doublers (Figure 3). Any cracks in the finish must be investigated further by removing paint in the affected areas. Sand the affected area in a spanwise direction using an abrasive cloth or paper (C-406) 180 to 220 grit to determine if the grip plate/doublers are cracked or voided.

**Note:** It is not required to remove the blade for inspection. The areas under the grip tangs will not be visible.
