Stop Cold Weather Leak

This certainly holds true with the main rotor damper assembly on your UH-1 Huey.

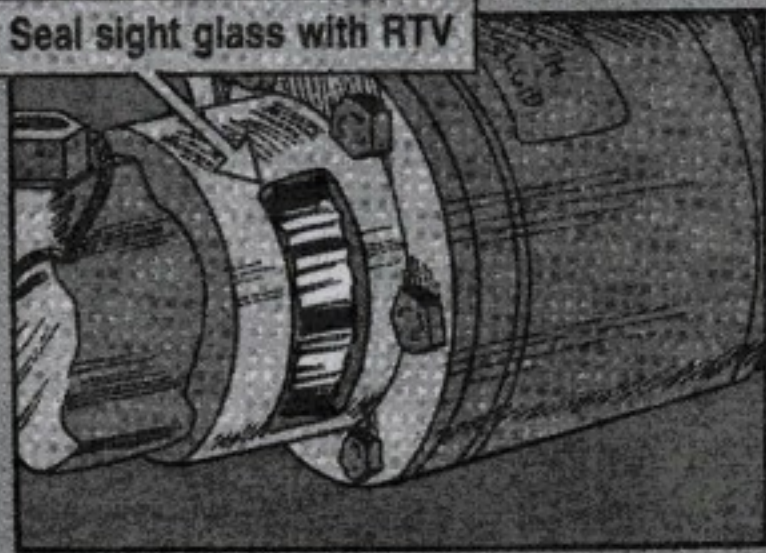
When the temperature really drops — like below 0°F — the assembly's hydraulic fluid sight glass contracts. When it shrinks enough, hydraulic fluid seeps past the glass.

Seal sight glass with RTV

That makes it hard to verify the fluid level and can lead to contamination.

Fix that problem by putting a bead of RTV, NSN 8030-00-251-2312, around the outside edge of the glass. After it cures, the RTV acts as a liquid-tight seal that keeps the hydraulic fluid in its place.

Before applying the RTV, make sure you thoroughly clean the damper assembly. Otherwise, the RTV will not adhere well to the surface.
