ALERT SERVICE BULLETIN

UH-1H-11-06

MODEL AFFECTED: UH-1H

SUBJECT: MAIN ROTOR HEAD INBOARD FITTING 204-012-102-005, INSPECTION OF SPECIFIC SERIAL NUMBERS.

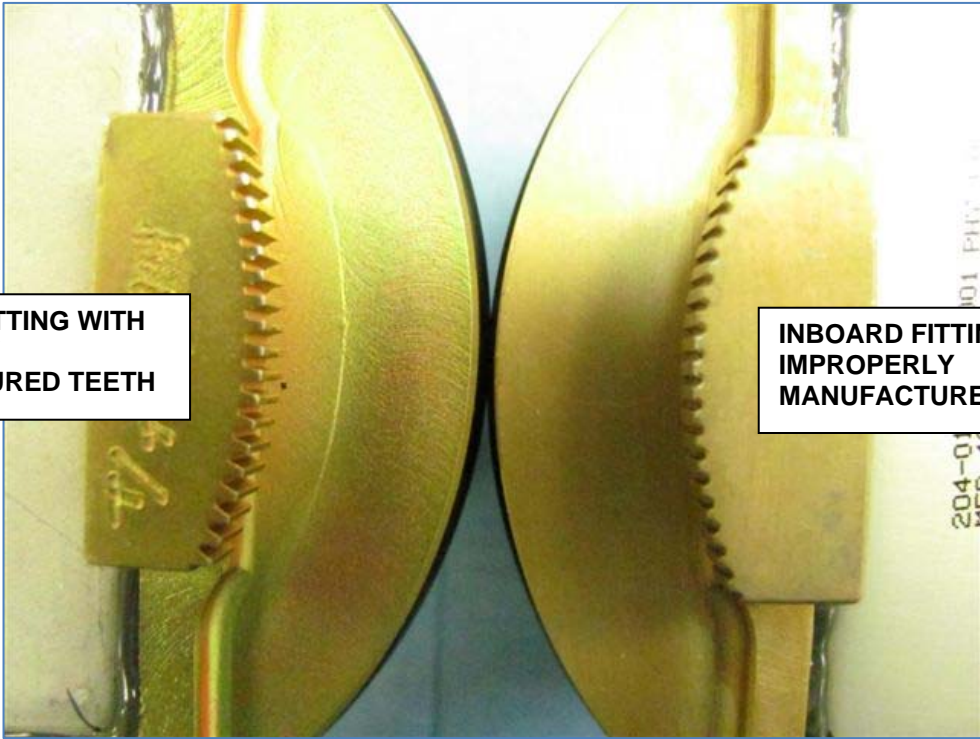
**INBOARD FITTING WITH
CORRECTLY
MANUFACTURED TEETH**

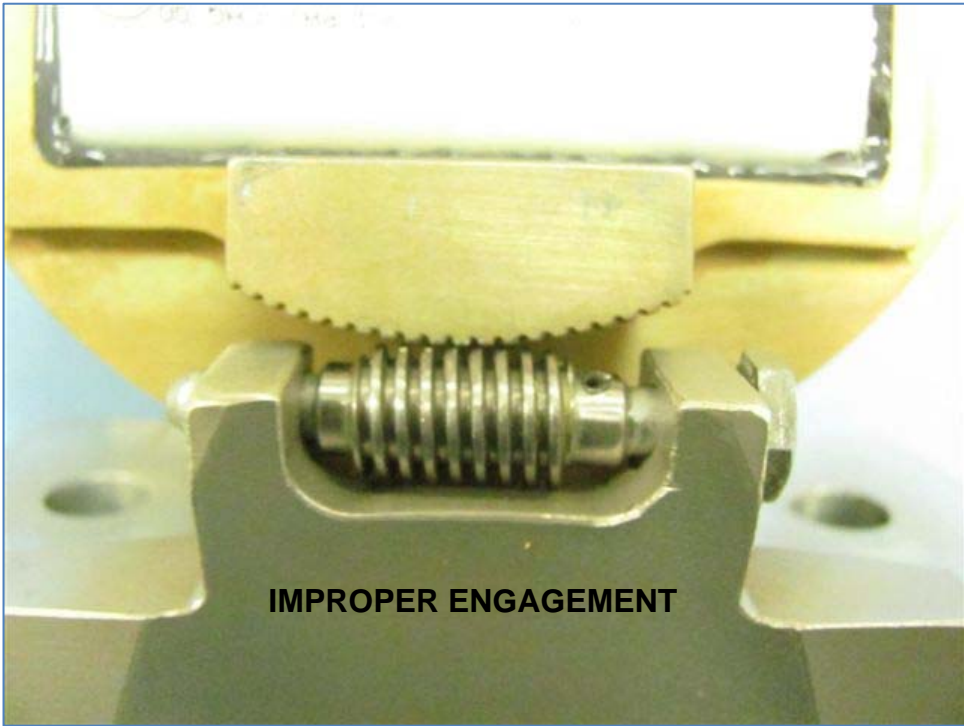
FIGURE 1

Bell Helicopter has discovered that a certain serial number batch of 204-012-102-005 main rotor inboard fittings may have been manufactured with an incorrect thread depth. These threads mate with the worm gear for TT strap adjustment and may not be sufficiently engaged. This ASB is issued to inspect only specific serial number inboard strap fittings for correct thread engagement. Applicability of this bulletin to any spare part shall be determined prior to its installation on an affected aircraft. Any fitting that fails the engagement check is to be removed from service.

**INBOARD FITTING WITH
IMPROPERLY
MANUFACTURED TEETH**

IMPROPER ENGAGEMENT

5. If visual inspection determines the fitting gear is not defective and engages the worm gear per paragraph 4, verify that the worm gear does not turn by placing a torque wrench on the worm gear bolt and apply 10 to 15 inch pounds of torque. The bolt should not turn under the applied torque.
6. Repeat this procedure for the opposite side of the main rotor head.
7. If either the worm gear is not fully engaged or the worm gear turns under the applied torque then the inboard strap fitting is suspect of being dimensionally discrepant in the thread area. All discrepant strap fittings are non-airworthy and are to be removed from service.
8. Replace all discrepant strap fittings with new or serviceable fittings in accordance with DMWR 55-1560-196.
9. Make an entry in helicopter historical service records indicating compliance with this Alert Service Bulletin.
