# Change the Wool!

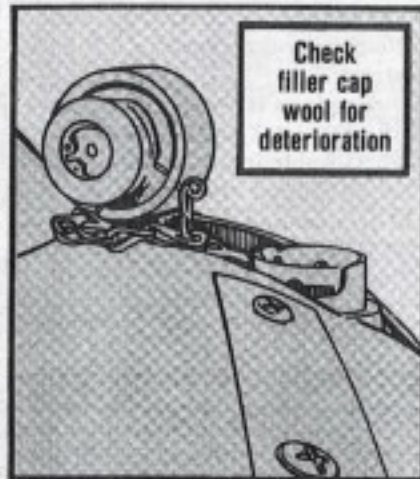
a washer and retaining ring. In time, the wool goes bad and flakes off into the oil to give you a high reading.

It's easy to check out the cap. Lay it on a workbench, upside down. Press in on the washer and then release the pressure. The washer is supposed to spring back against the retaining ring. If it doesn't, the wool is worn out.

So remove the washer and retaining ring. Rub the wool between your fingers and notice how it crumbles... no wonder the oil was contaminated!

and try it again. If the next sample still reads high in aluminum, the filler cap could be the culprit.

There's a bunch of aluminum wool inside the cap, held in place by

Toss out the old wool and clean out the cap. Put in enough new wool, NSN 5350-00-286-4851, to place the spacer under tension and insert the ring. The complete inspection and repair info is in Para 6-193c of TM 55-1520-210-23-1.

Change the oil in the gearbox, fly the bird, and send another sample to the oil lab. Chances are the gearbox is A-OK.
