THE SPLIT CONE BIT

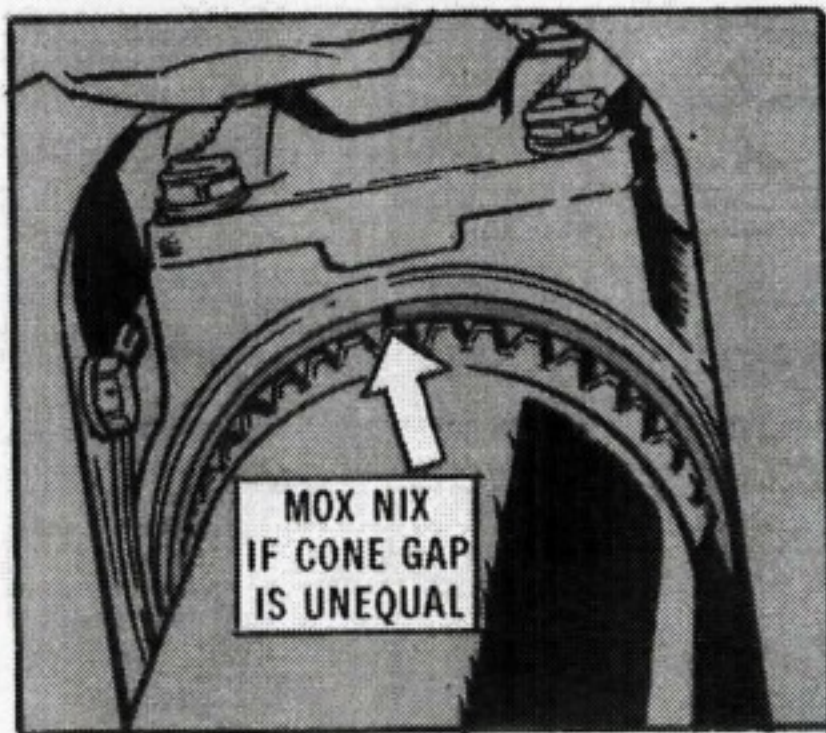
Some Huey and Cobra pitch pullers and knucklebusters get uptight when the split cones supporting the main and tail rotors slip.

Sure, the pubs call for equal spacing of the cone halves during installation. But the pubs don't call for maintaining that spacing during inspections.

So, don't sweat it if the cone gaps are not equal or one half of a cone touches the other half.
