# Grinding the Gearbox

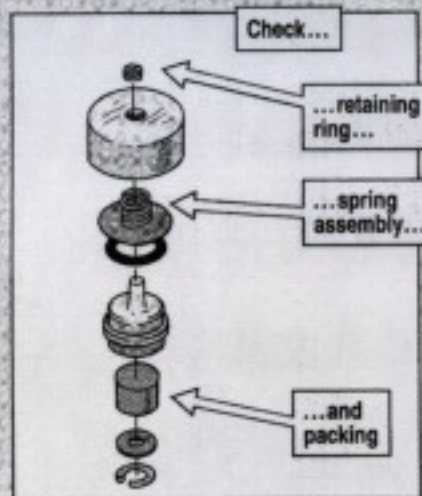
The chip detector tells you there's metal swimming in your Huey's tail rotor gearbox, but the oil sample says it's clean. There's a good chance you're seeing the birth of water-caused corrosion in your gearbox.

Some water gets in through the vented filler cap. When you're cleaning in the gearbox area, make sure no cleaning chemicals or water is sprayed or dripped on the cap.

It's important to keep the cap in top shape, too. It's one of your last lines of

defense in keeping water out of your gearbox. Check the retaining ring, the spring assembly, the chain and pin, the washer and the packing for wear.

a workbench. Press on the washer that holds the packing in place and then release it. If the washer springs back against the retaining ring, the packing is OK. If it doesn't spring back, it's worn out.

Replace the packing with NSN 5350-00-286-4851. Use enough packing to put the washer under tension, then insert the retaining ring. Coat the packing with lubricating oil, NSN 9150-00-985-7099 or NSN 9150-01-209-2684.
