Dear Editor,

The UH-1 sliders take a real beating, guiding the cargo doors. As a result, the plastic wears out and the slider (costing dollars) has to be replaced.

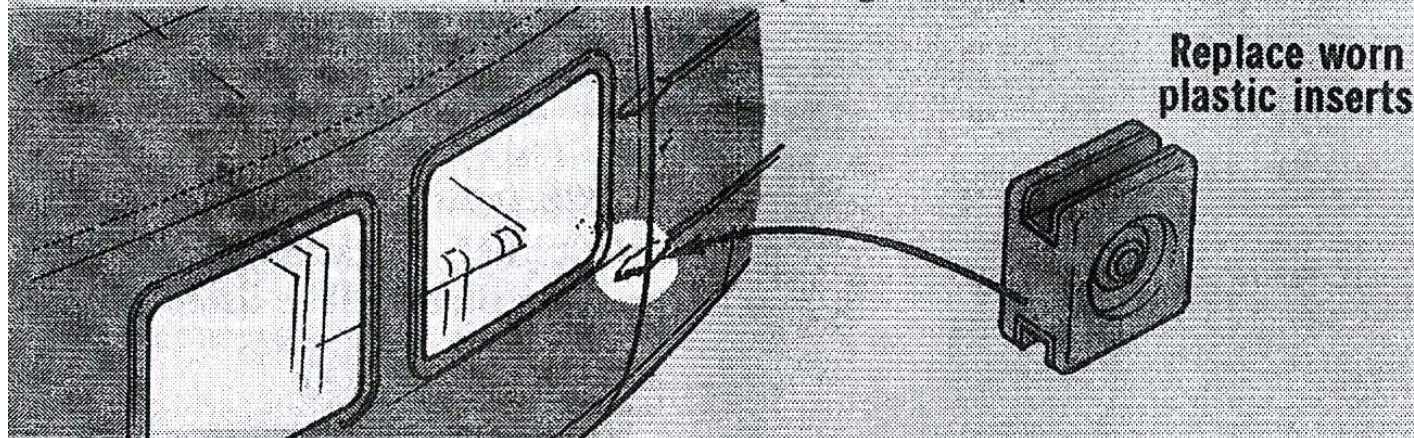
It's just a matter of removing the worn plastic and replacing it with bearing strip, NSN 1560-00-448-5799. The strip is glued in place.

Well, we figured out a way to just replace the plastic inserts at a cost of only pennies.

(Ed Note—Good idea. The head hangar—TSARCOM—is adding your bearing strip to Figs 47 and 48 of TM 55-1520-210-23P.)
