Double Take the Threads

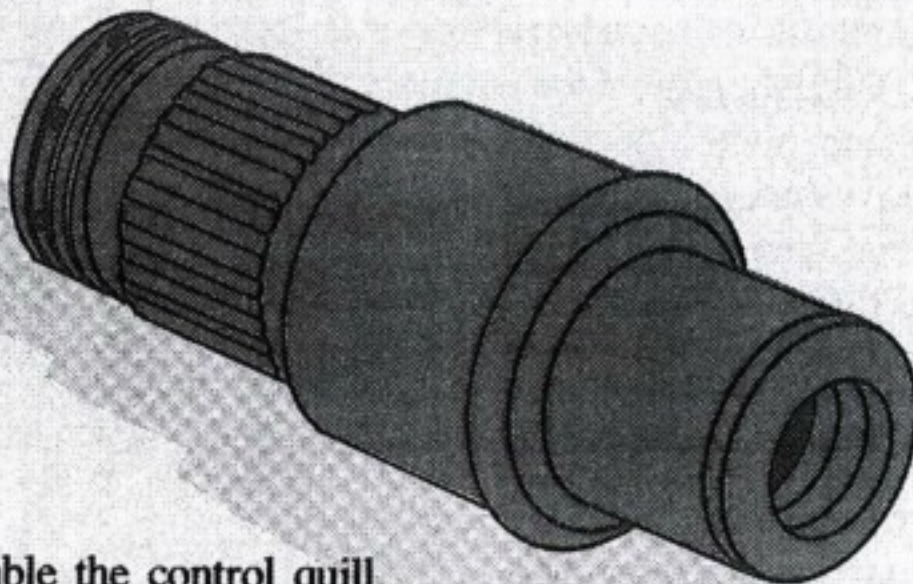
Take a second look at the threads of the control nut (Item 12 in Fig 11-33 of TM 55-1520-210-23-2) next time you reinstall your Huey's tail rotor quill assembly.

Make sure there's no dirt or grit on the threads. When the nut's tightened, dirt, grit or sand can cause it to crack.

**Be sure
control nut
is clean**

Clean all parts of the quill assembly, including the control nut and control tube, with P-D-680 solvent, NSN 6850-00-274-5421. Dry all parts thoroughly with filtered, compressed air.

When you reassemble the control quill, don't overtorque the retaining nut, Item 19 of Fig 11-33 in the -23-2. Torque it to no more than 300 lb-in, like it says in Para 11-152g.
