The nipple, NSN 5975-00-553-6995, on the chip detector of a Huey intermediate or tail rotor gear box, slips down the electrical wire, exposing the connection to the weather.

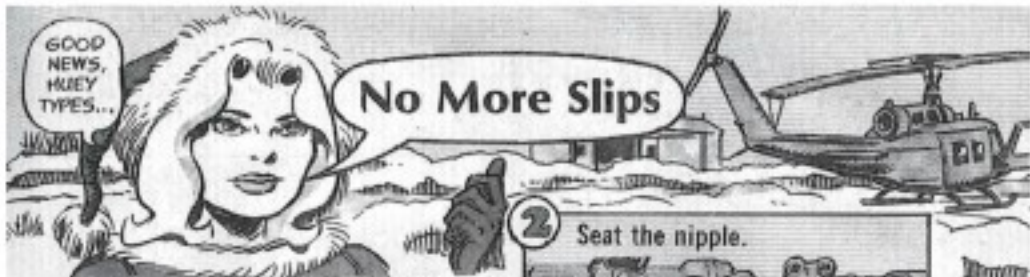
The big end of the nipple is not large enough to fit over the chip detector knurl, which would hold it in place.

So what's the solution? Try this for size:

- 1 Latch on to hand tool, NSN 5120-00-781-7891 or 5120-00-937-5438, and plastic tiedown strap, NSN 5975-00-074-2072.
