You Huey crewchiefs need to take a close look at the closed circuit refueling receiver on your UH-1E, -1H and -1V birds.

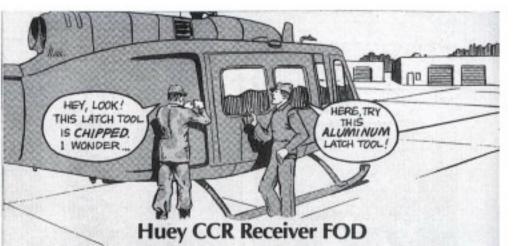
Chips and flakes from the plastic latch tool—Item 7, Fig 329, TM 55-1520-210-23P—have been found in the throat opening.

'Course the chips are flushed into the fuel cell when you refuel. This could stop up a fuel line filter.

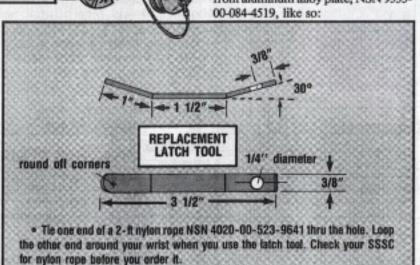
Fabricate a replacement latch tool from aluminum alloy plate, NSN 9535-00-084-4519, like so:

Check the latch tool, too. Toss it if it's chipped or nicked.
