UH-1 Huey...

Draining APU Water

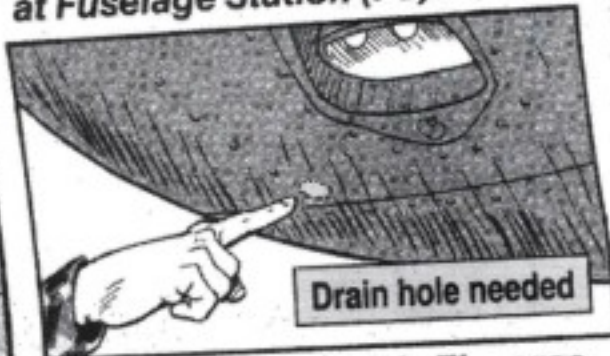
After washing our Hueys, water stands in the forward compartment of the APU connector. If you don't drain it ... **CORROSION!** We solved the problem by drilling a $\frac{7}{32}$ -in hole at Fuselage Station (FS)226 and

Butt Line (BL)11.50L. The area can be found by using the diagrams in Chap 2 of TM 55-1520-210-23-1.

(Editor's note: Battling corrosion is a top priority! AVSCOM OK's your fix. It's good to see another knockout punch delivered.)
