## Stop a Leaking Quill

If your Huey's transmission quill assembly is leaking oil, it could be a sign of a seal problem in the input drive quill.

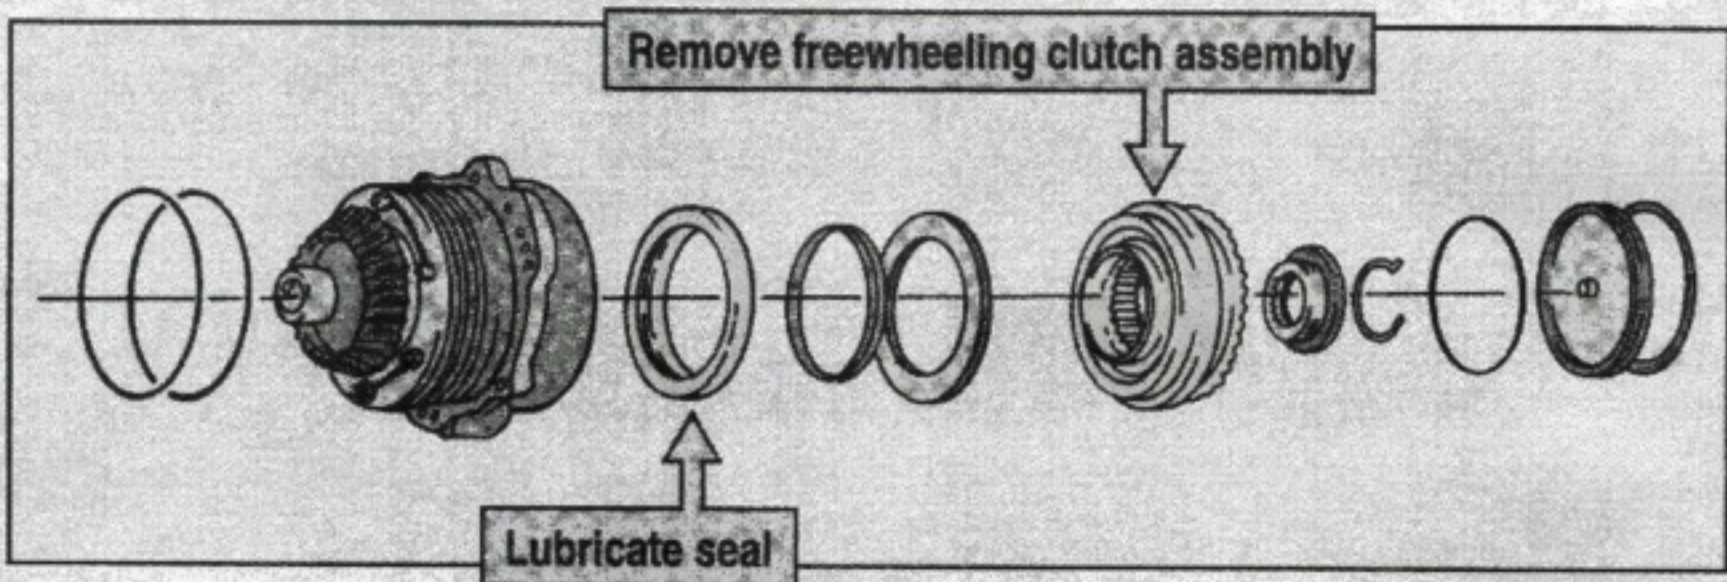
1. Remove the freewheeling clutch assembly (Para 6-103).
2. Lubricate the seal (Item 10 of Fig 6-26), following the info in Para 6-107.

To keep the seal from leaking in the future, do this before you install a new input drive quill (Para 6-108 of TM 55-1520-210-23-1):
