UH-1 Transmission Mount ...

# Lift Link Lowdown

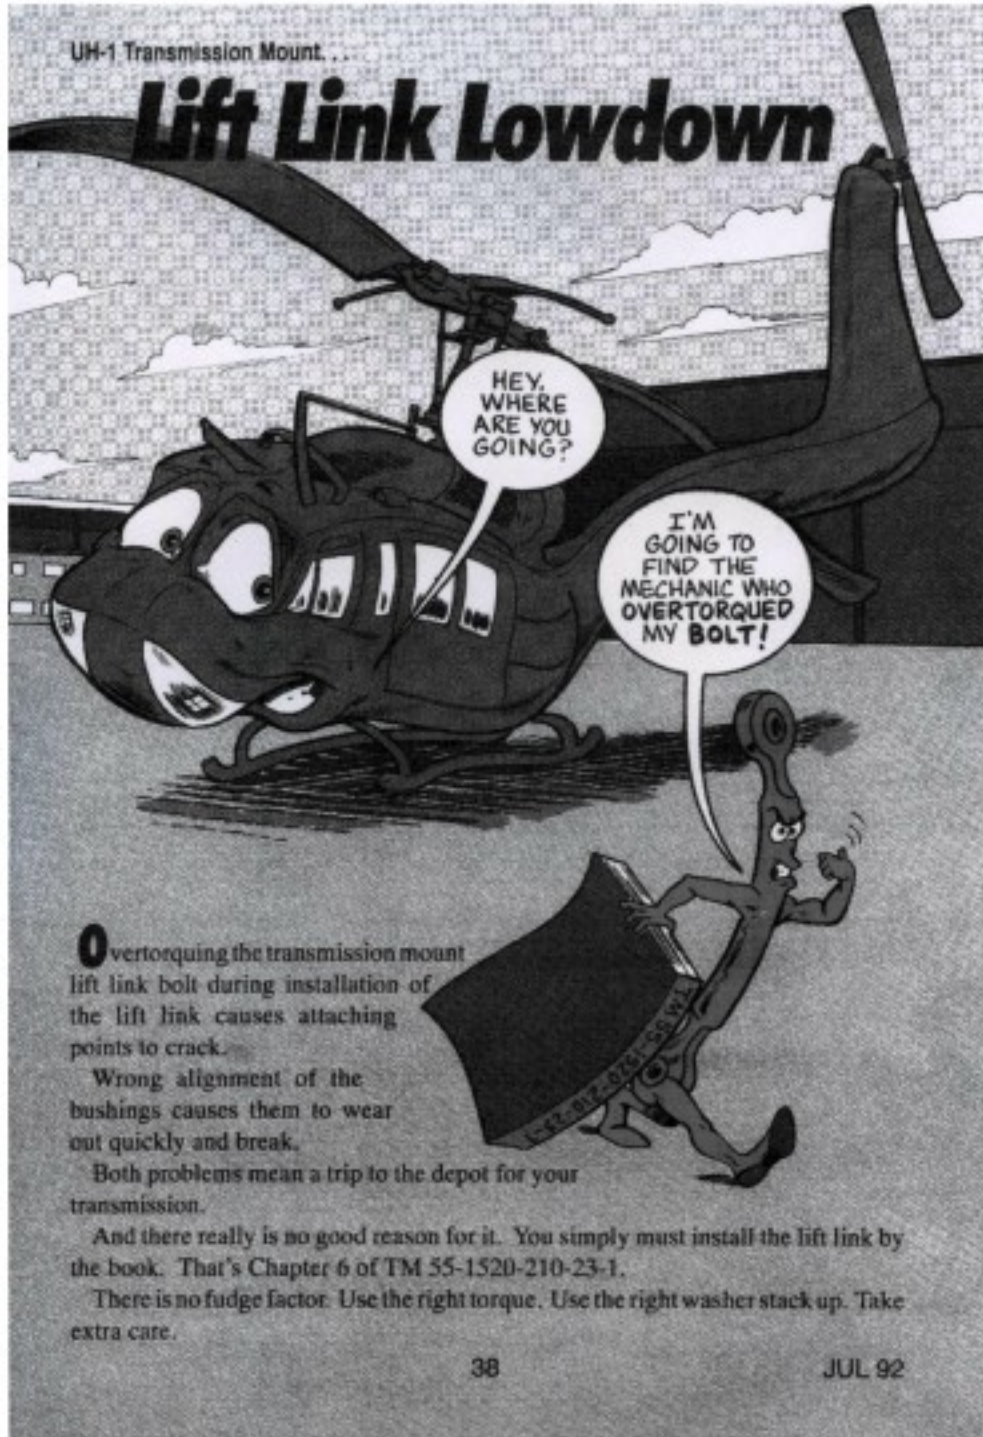
**O**vertorquing the transmission mount lift link bolt during installation of the lift link causes attaching points to crack.

Wrong alignment of the bushings causes them to wear out quickly and break.

Both problems mean a trip to the depot for your transmission.

And there really is no good reason for it. You simply must install the lift link by the book. That's Chapter 6 of TM 55-1520-210-23-1.

There is no fudge factor. Use the right torque. Use the right washer stack up. Take extra care.
