Deciding whether you have a leak in a bearing package of a T-53 engine can create some lively discussions.

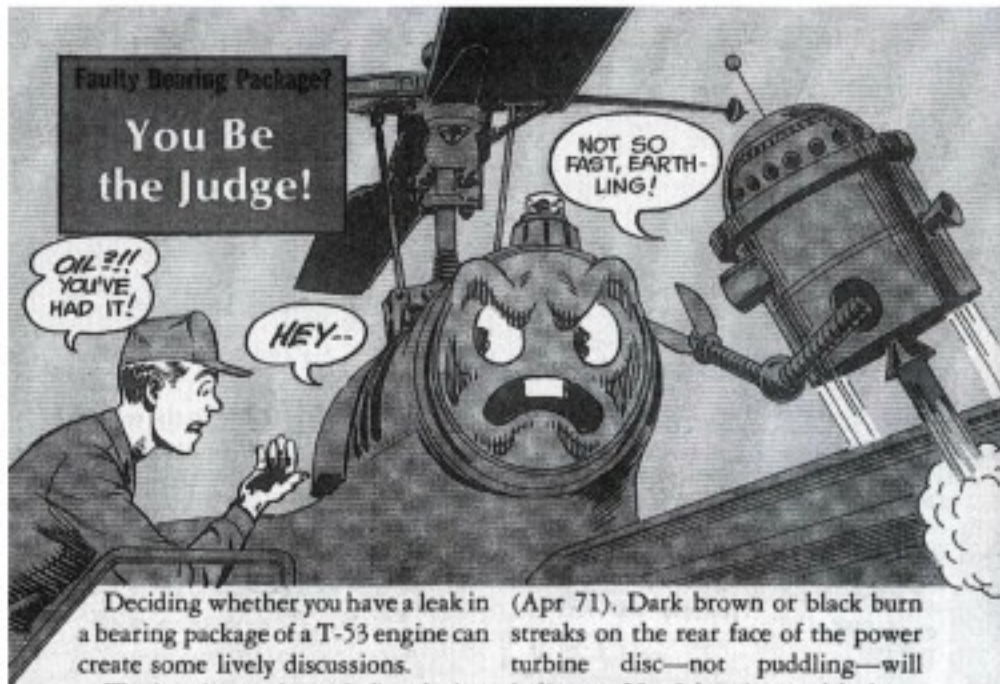
The bearing seals work fine during engine operation. But in a static condition, some oil may drip past the seals and into the tail pipe. So engine smoking is normal when that baby is cranked up.

When is oil leakage excessive? When consumption is more than 2.4 pints per hour, according to Table 4-1—item 28—in TM 55-2840-229-24

(Apr 71). Dark brown or black burn streaks on the rear face of the power turbine disc—not puddling—will indicate a No. 3 bearing seal leak.

To check for excessive leakage, fill up the engine oil tank before a mission of 1 or 2 hours and then take a reading after the flight.

If you do have excessive oil consumption, tho, follow the troubleshooting info in Table 4-1 of the engine manual.
