Huey Gearboxes...

Cover the Chain

UH-1, AH-1 Transmissions...

Don't Hog the Covers!

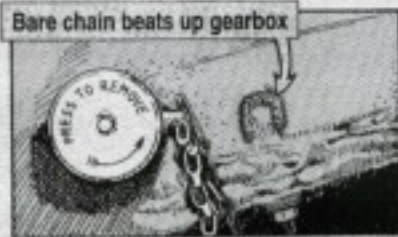
That innocent looking little chain that links the lube fill cap to the retaining pin on the 90-degree and 42-degree gearboxes is the culprit in a whole lot of damage.

The chain beats against the gearbox and takes off the paint. That bare, beaten spot gives corrosion a foothold.

Bare chain beats up gearbox

Solve the problem by sleeving the chain with shrink tubing. NSN 5970-00-812-2967 brings a foot of 1/8-in tubing; NSN 5970-01-169-1723 brings a foot of 3/8-in tubing.

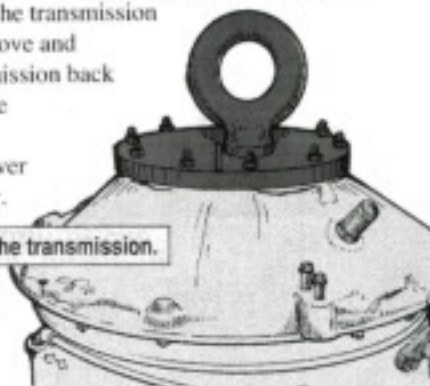
The lifting eye you use to remove the transmission has a second job. It's also a cover that keeps moisture and dirt out of the transmission during shipment. But some mechanics remove and keep that cover before they send the transmission back for repair. Then corrosion turns a repairable transmission into junk.

Smart mechanics leave the lifting eye cover on when they ship a transmission for repair.

You be smart, too. Leave the cover on the transmission.
