Huey Transmission Tool

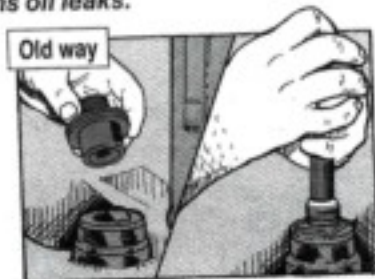
The oil filler neck on the main support case of the Huey transmission is being damaged when mechanics install the filler adapter. Metal particles are shaved from inside the neck and fall into, and contaminate, the transmission oil. In addition, those shavings make a good seal impossible. That means oil leaks.

The damage is caused by the difficulty in seating the spring-loaded adapter. It requires a drift to be inserted into the center of the adapter to depress the spring. At the same time, the adapter must be turned and locked into position on the filler neck.

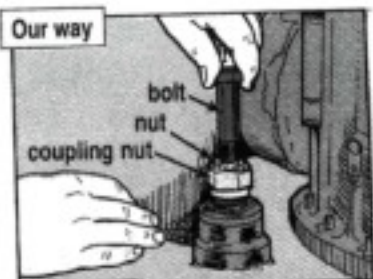
We solved the problem with a coupling nut, a hex nut and a bolt. Here's how:

1. Braze the hex nut to the top of the coupling nut.
2. Attach the coupling nut to the adapter.
3. Screw in the bolt to depress the spring in the adapter.
4. Lock the adapter in place.
5. Remove the coupling nut and bolt.
