When the anti-chafing strip on the bottom of the UH-1 cargo doors wears out, the chatter can drive a crew to distraction!

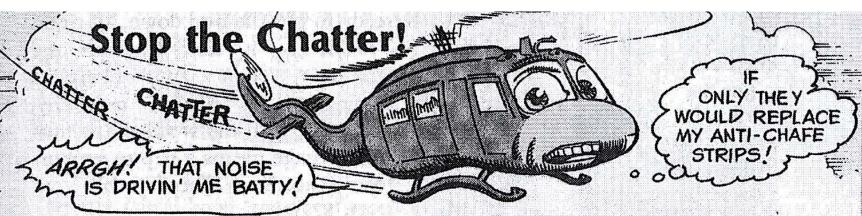
The metal-to-metal contact of the door with the fuselage also wears off the paint, leading to corrosion. That's

Paint worn from door frame?

why you want to change a bad antichafe strip soonest.

Don't look for the strip as part of the door assembly in TM 55-1520-210-23P (Mar 77), tho. It's hidden in the bulk materials list on page 2017.

Ask for Tape, flocked pile. No other tape will hack it. NSN 8315-00-445-4781 will get you an 18-yd roll.
