Reflections on Connections

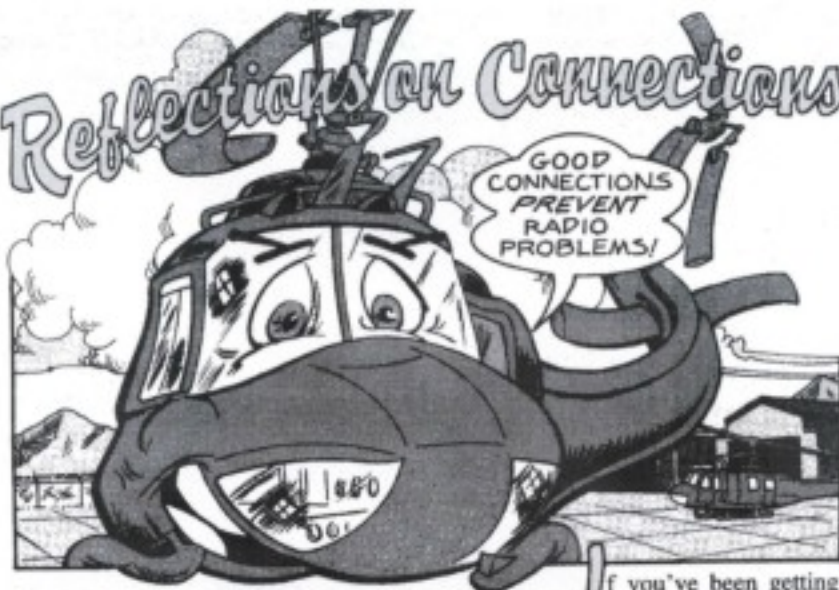
If you've been getting a high voltage standing wave ratio (VSWR) from your No. 1 FM antenna system, it could be due to a grounding problem.

Since the antenna and coupler are mounted on a fiberglass adaptor, you have to make sure your connections are good. Otherwise, too much voltage is reflected back into the FM radio and the result is a high VSWR.

The way to prevent that is to sand all mating surfaces of the adaptor plate and backing plate to bare metal. Then coat the exposed metal with corrosion resistant compound, NSN 8030-00-142-9272, to help prevent corrosion.
