Nobody would haul off and throw rocks at a Huey (UH-1) main rotor blade on purpose, would they?

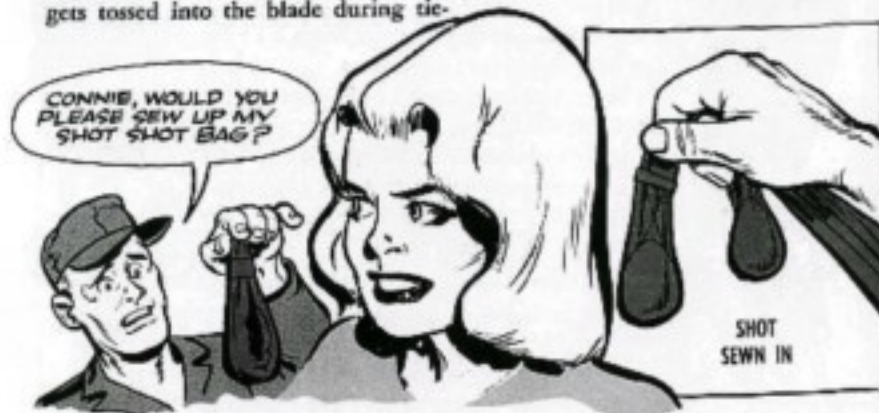
Yet, with some of the shortcut repairs being made to the weight bag at the ends of a tie-down, that's just what's happening.

Some types are stuffing rocks, bolts and other solid pieces of metal into a torn bag and wrapping it with masking tape. When this weight accidentally gets tossed into the blade during tie-

down, the dent it makes can cost five grand—the price of a new blade.

To prevent this type of damage, buckshot is sewn into the bags when the tie-down is made. Then if the weight should happen to hit the blade, the shot takes the blow, not the blade.

So-o-o-o . . . when the weights go, head for the canvas repair shop with a load of buckshot, sand, or some other type of shock absorbing bag filler. Bird blades can't stand rock throwing.
