Just A Few Drops, Please!

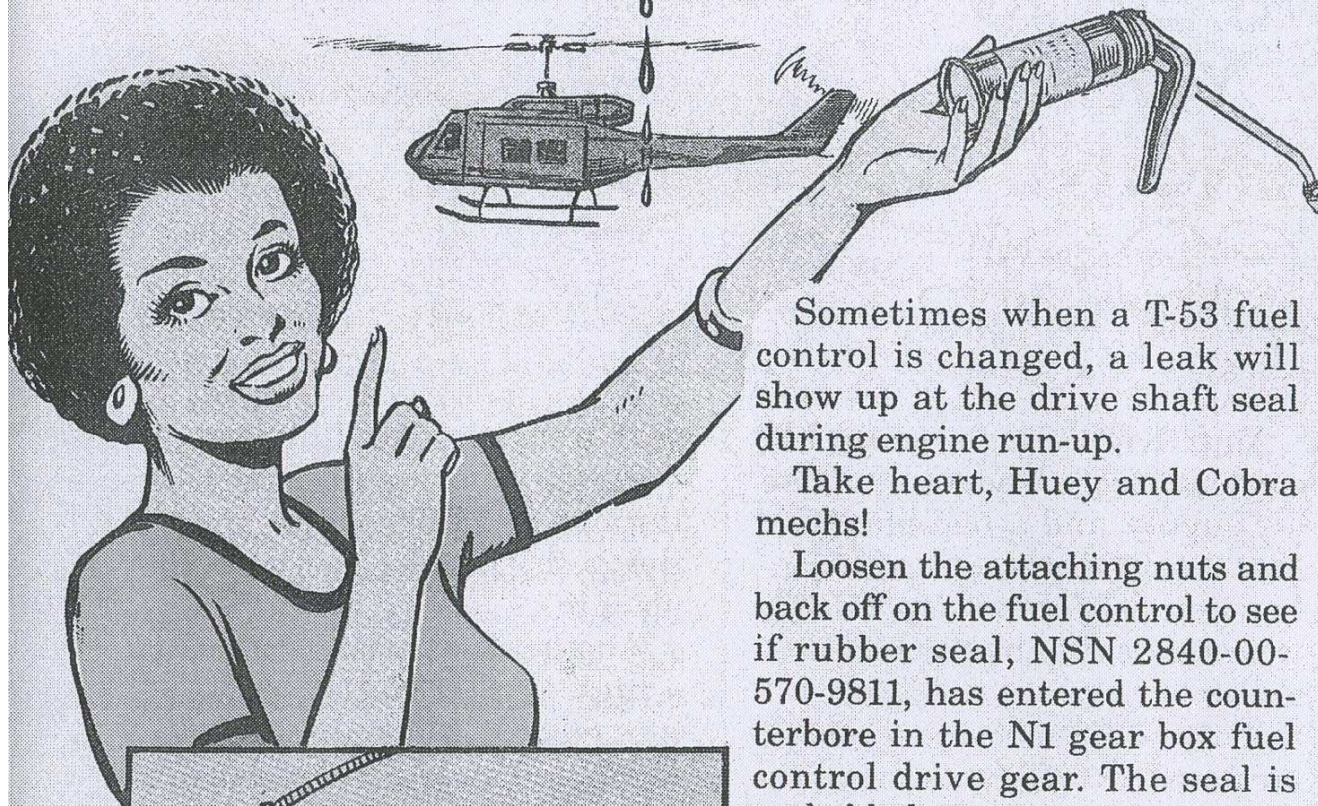
Sometimes when a T-53 fuel control is changed, a leak will show up at the drive shaft seal during engine run-up.

Loosen the attaching nuts and back off on the fuel control to see if rubber seal, NSN 2840-00-570-9811, has entered the counterbore in the N1 gear box fuel control drive gear. The seal is probably hung up.

Lube the seal with turbine engine oil, MIL-L-23699, and start it into the counterbore. The seal will then seat right.

Tighten the attaching nuts and your fuel control won't leak.

On the next fuel control change, use the engine oil on the seal — right-off.
