NO O-RING, PLEASE!

Getting oil leakage around the oil strainer on the rear-bearing housing of that T53 Huey engine?

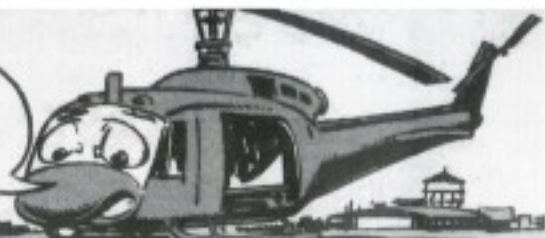
If you find the gasket wrong-side-up on top of an O-ring, put in a new gasket and leave out the O-ring. An inverted gasket can give against the strainer and cause leakage.

Fact is, an inverted gasket and O-ring can lead to a No. 2 bearing oil passage clogged with O-ring particles—which can cause engine failure.

Forget about adding an O-ring. Take a look at the strainer gasket. If it's in wrong, with the recessed side down, get a new gasket. Put it in the right way, recessed side up. That'll stop the leak.
