*TB 1-1520-210-30-01

DEPARTMENT OF THE ARMY TECHNICAL BULLETIN

MANDATORY RECURRING INSPECTION OF TAIL BOOM VERTICAL FIN SPAR ASSEMBLY FOR ALL UH-1 SERIES AIRCRAFT

Headquarters, Department of the Army, Washington, D. C.
4 November 2005

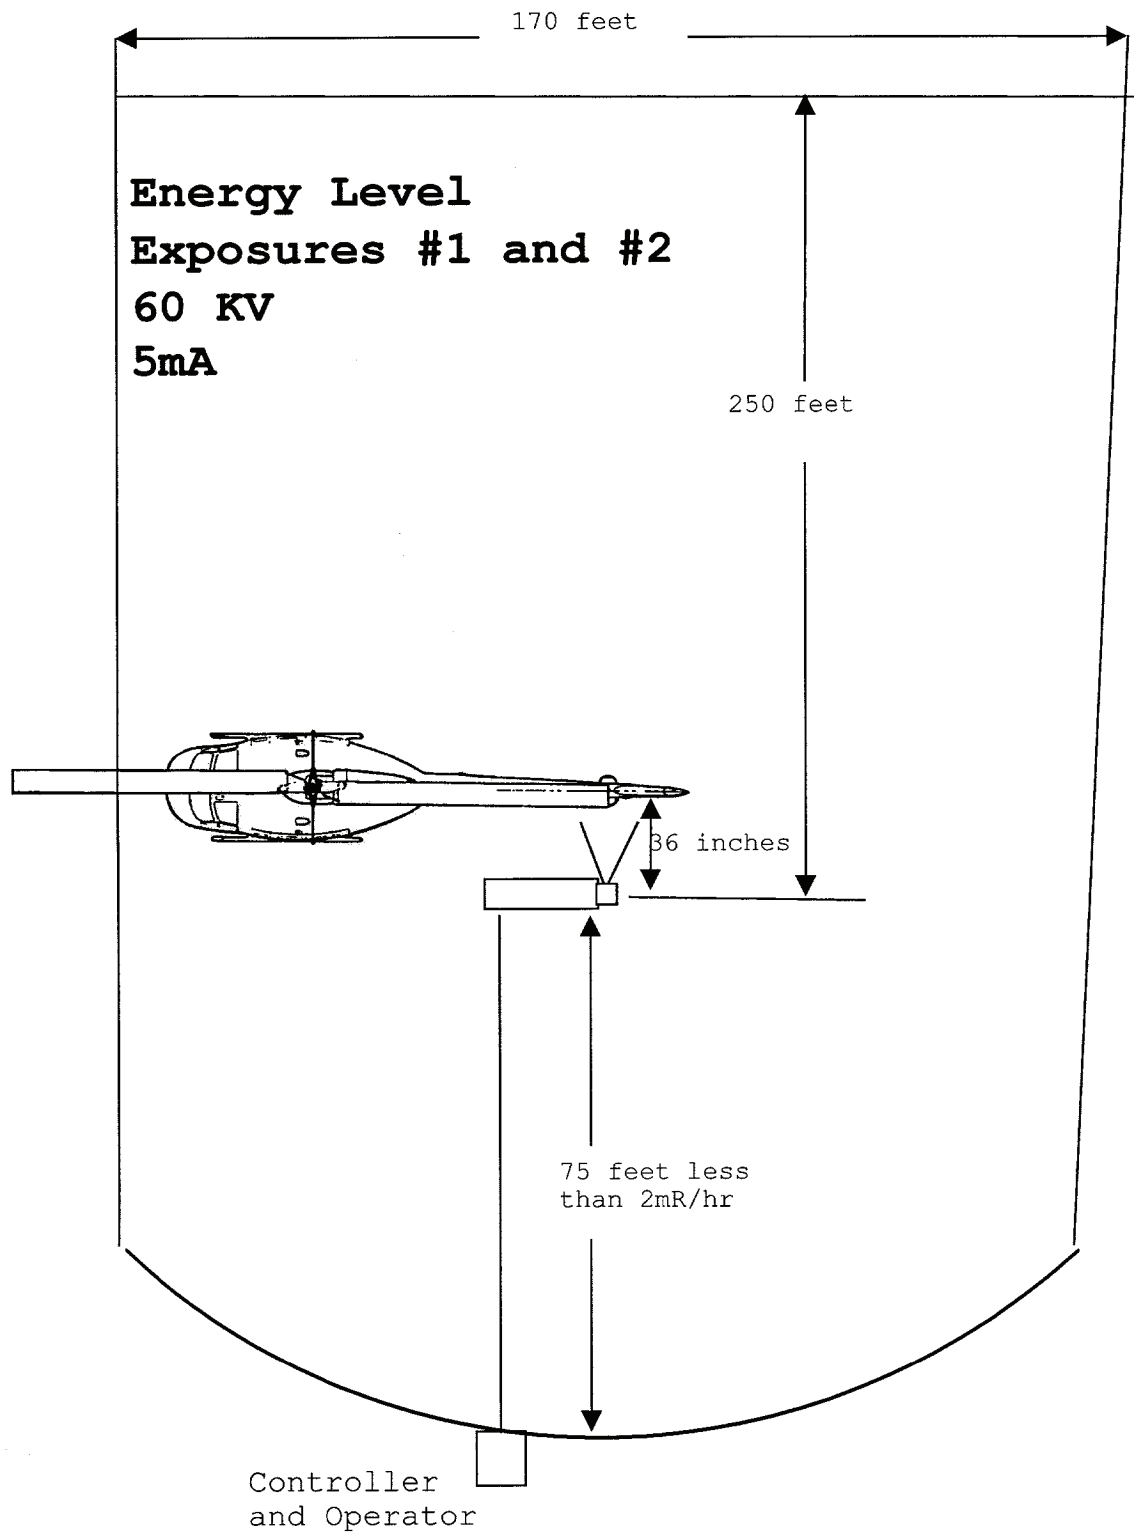
Figure 1A, Safety Zone for Exposures #1 and #2

Assure compliance with all applicable safety precautions set forth in TM 1-1500-335-23 (Nondestructive Inspection Methods manual) listed in table 1.1. A hazard associated with exposure to ionizing radiation is that serious injury can be inflicted without pain, burning, or other sense of discomfort during the exposure period. Radiation protection shall be utilized in accordance with AR40-14/DLAR 1000.28. Safety zones for Exposures #1, #2, and #3 are shown in figures 1A and 1B.

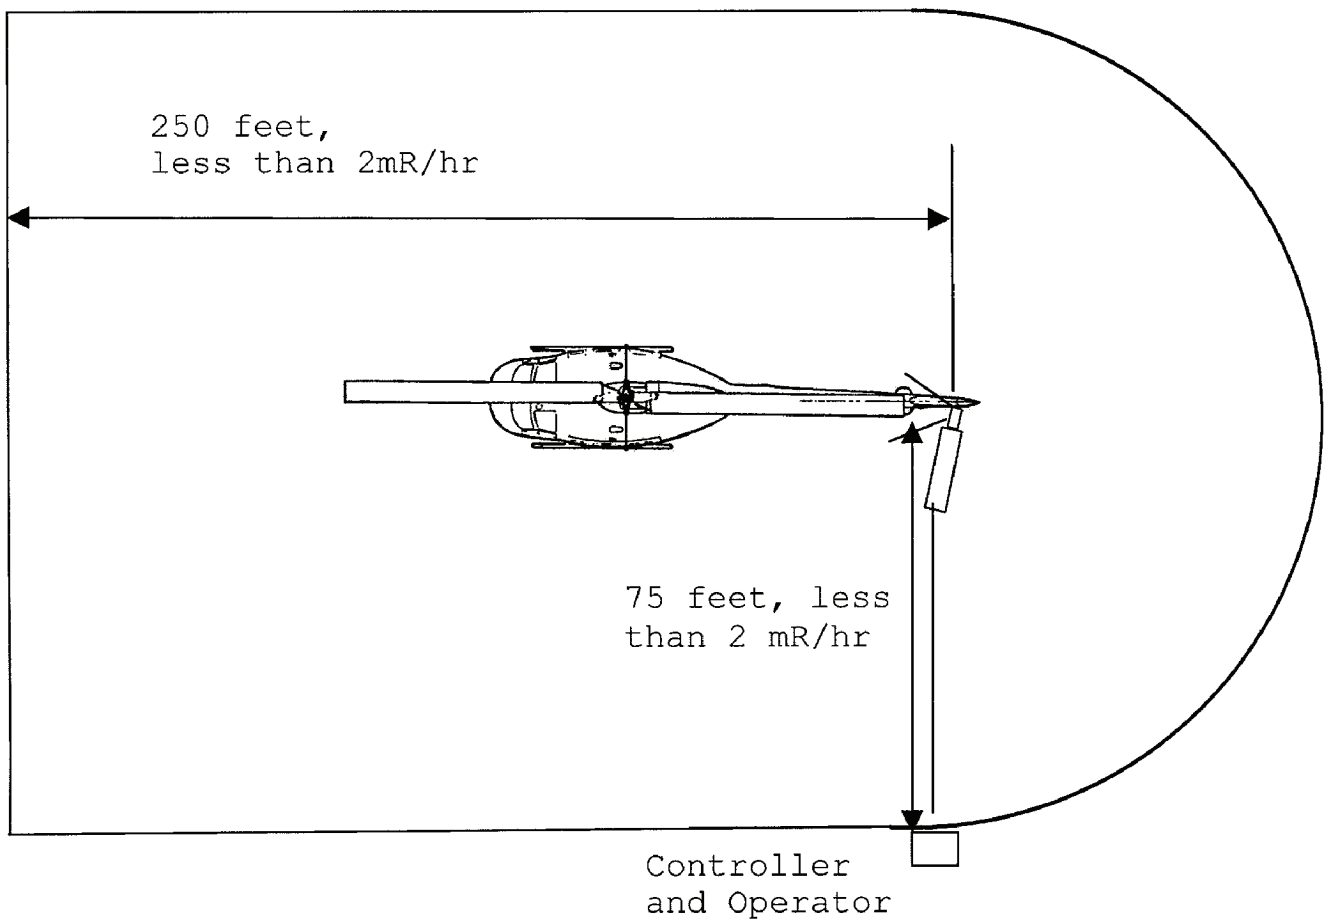
Figure 1B, Safety Zone for Exposure #3

Energy Level
Exposure #3
75 KV
5mA

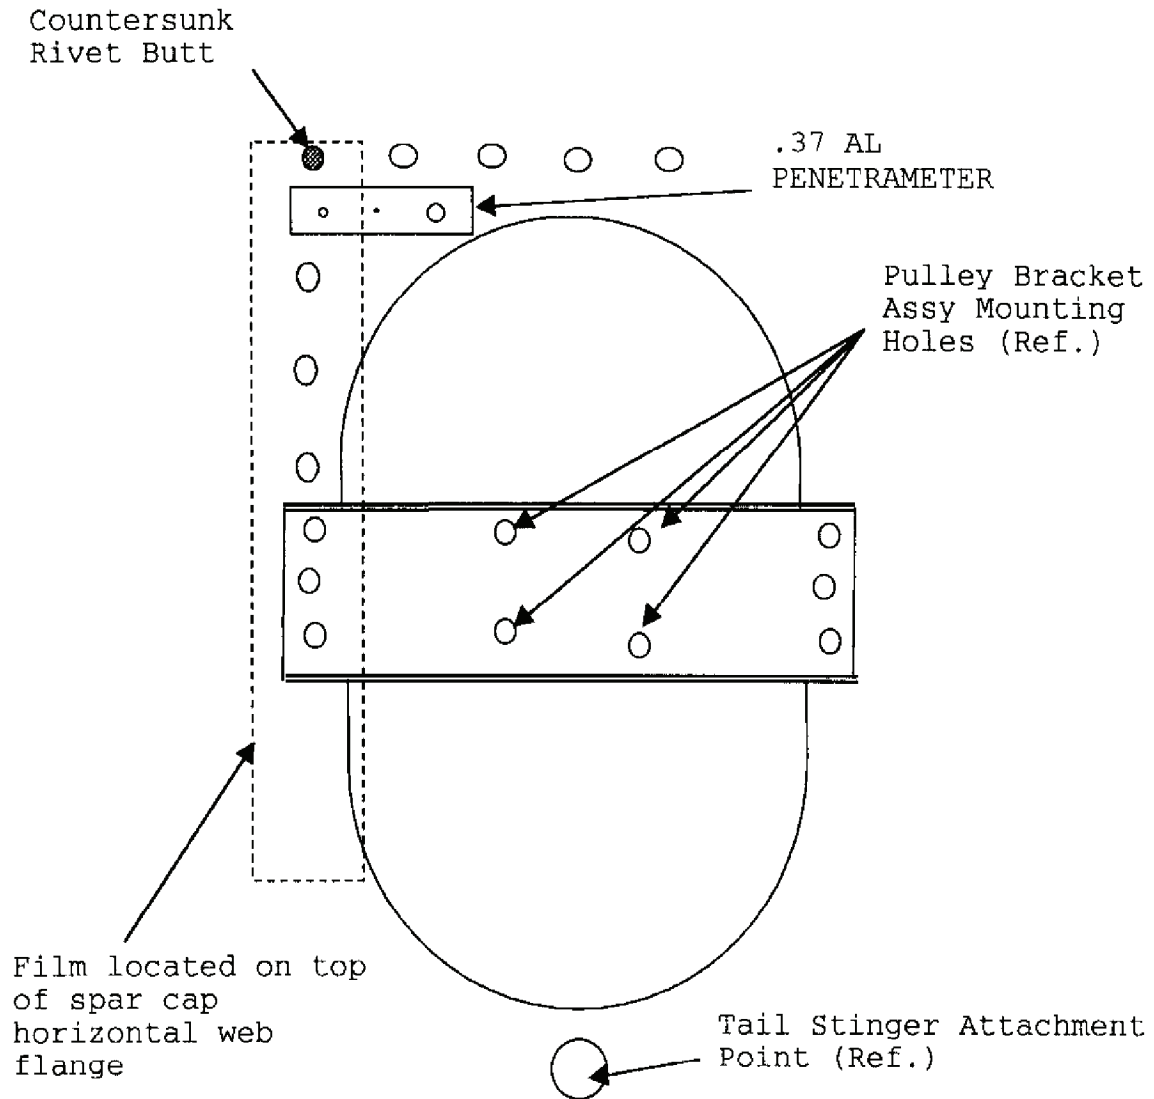
Figure 7: Radiographic Exposure #3

(17) Position a 0.37 inch aluminum penetrameter under the butt of the countersunk rivet. Align the 2T hole with the center of the rivet row. This will allow the 2T hole to be visible in the area of interest (See Figure 7). Secure the penetrameter using tape over the lead numbers and 4T hole only, this will eliminate possible interpretation errors from indications generated by the edges of the tape.

View looking forward at canted bulkhead through inspection panels, Item 124, Figure 16, TM 55-1520-210-23-P1

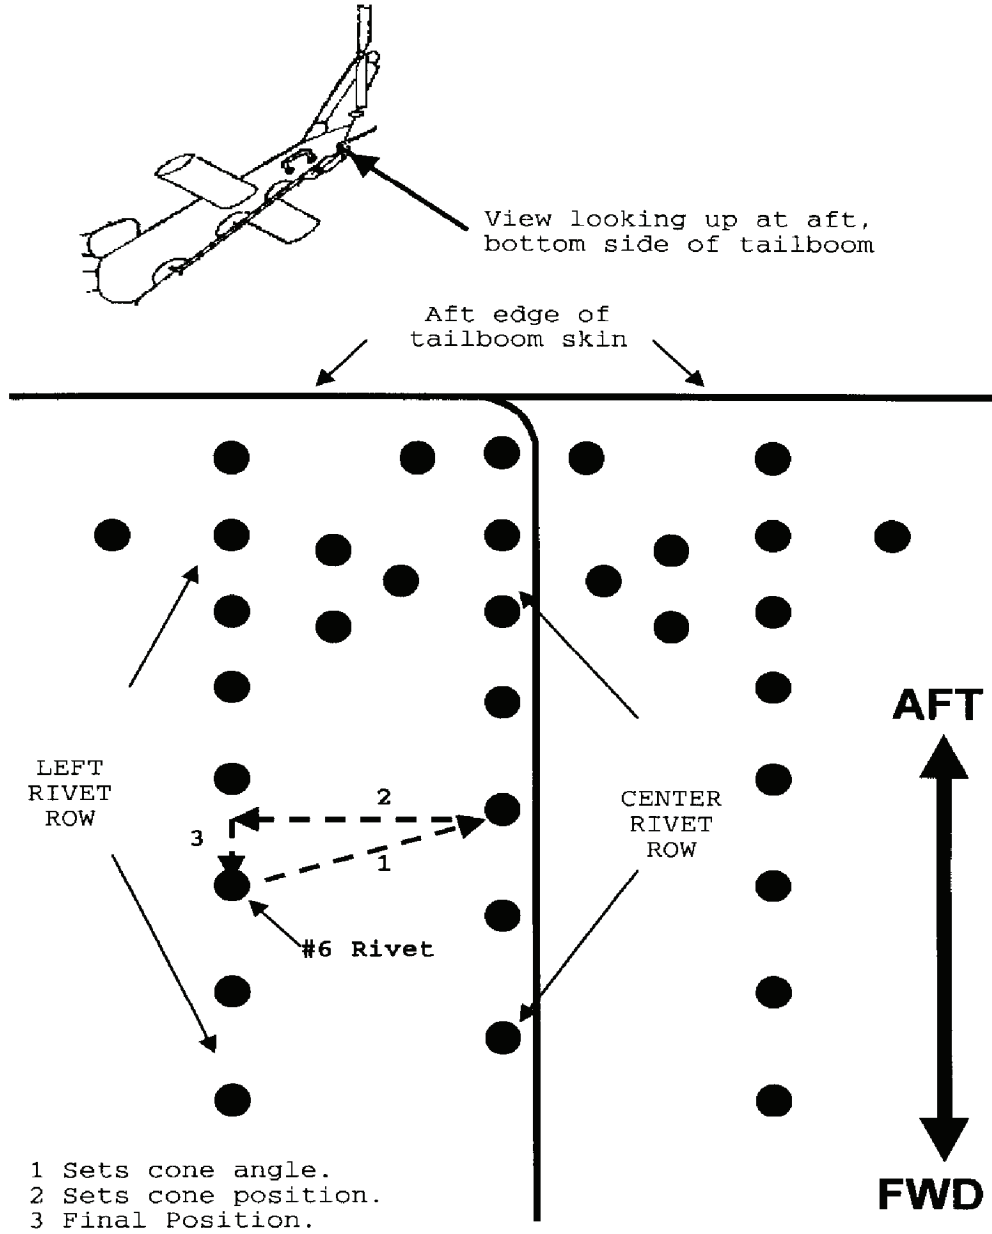
Figure 9: X-ray Tube Head Position for Exposure #3

(19) Place the laser pointer on the tube head. Activate the laser pointer and slide the tube head horizontally until the laser dot aligns with the left hand stringer rivet row, Figure 9. This will achieve a 49 inch source-to-film distance measured from the 42 degree gearbox cover aft, left hand, Zeus fastener receptacle to the center of the X-ray tube head (See Figure 8b). Verify perpendicularity by rotating the tube head to verify the laser dot tracks with the first ten rivets. Adjust the tube head horizontally as required. Center the laser dot on rivet number 6.

(20) Fine tune tube head position as follows: (See Figure 9)
