UH-1 and AH-1 Engines...

Solve This Wrenching Problem

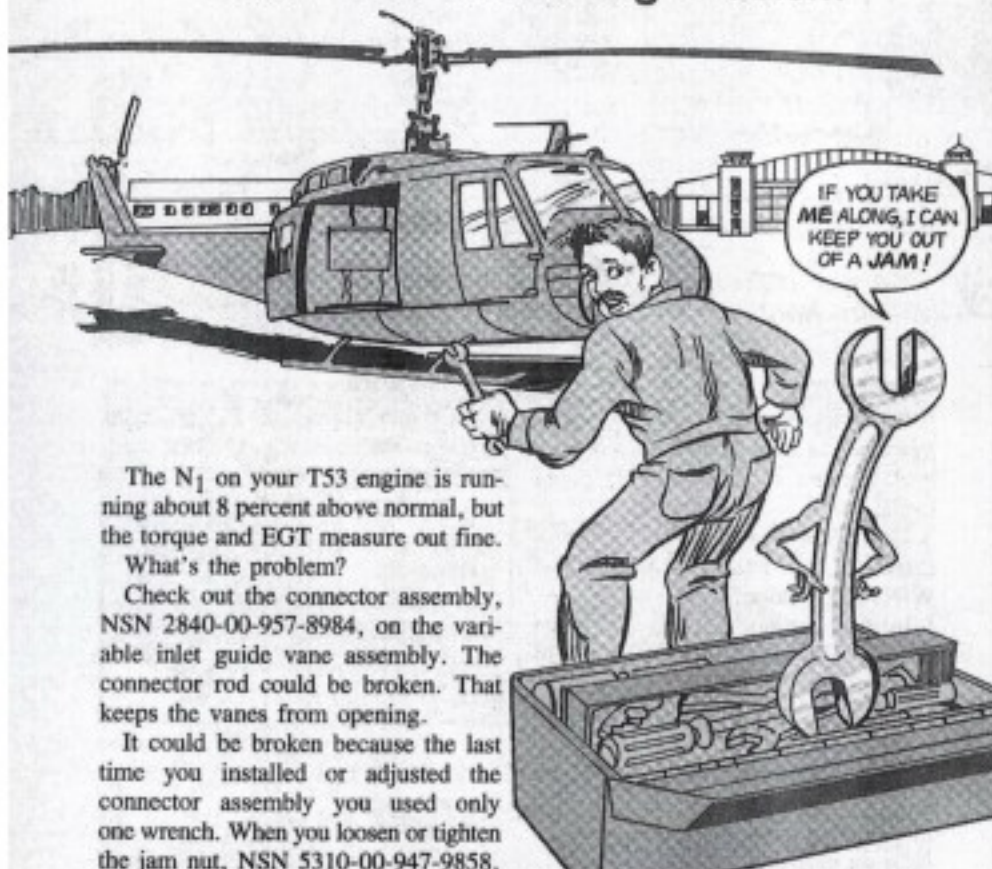
The N_1 on your T53 engine is running about 8 percent above normal, but the torque and EGT measure out fine.

Check out the connector assembly, NSN 2840-00-957-8984, on the variable inlet guide vane assembly. The connector rod could be broken. That keeps the vanes from opening.

It could be broken because the last time you installed or adjusted the connector assembly you used only one wrench. When you loosen or tighten the jam nut, NSN 5310-00-947-9858,

Otherwise, the force you put on the jam nut will twist and weaken the connector rod. If it doesn't break right away, it will eventually... maybe during a flight. That can cause the engine to lose power—an emergency for sure!

use another wrench to keep a backup force on the self-aligning bearing, NSN 2840-00-904-2475.

So grab two wrenches, next time you adjust the connector assembly.
