SHOCK MOUNTED SCREEN

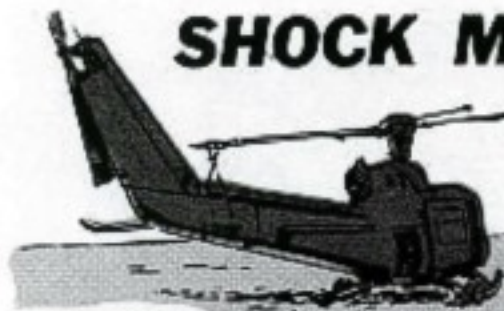
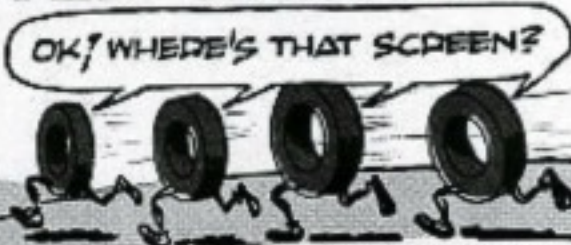
We had a problem with oil cooler screen, P/N 204-060-577-1, which was put in our Huey's (UH-1A) by MWO 55-1520-207-34/40 (29 May 62). They were breaking left and right, due to vibration.

It seemed to us that the trick was to separate the metal-to-metal contact of the screen against the housing flange, by using some sort of a rubber shock absorber.

So, after a quick check of TM 55-1520-207-20P (19 Mar 62), we came up with grommet, AN 931-5-9, FSN 5325-249-6340. It fit neatly over the screen retaining bolt, between the screen and the housing flange.

Putting one grommet on each of the four screen retaining bolts has dampened out the vibration for real.

(Ed Note—Sounds like a good little repair if screen cracking is a problem. Of course, a CO's permission is needed on a deal like this. An improved screen, P/N 204-060-577-3, is going on new birds, and will be supplied as future spares.)
