*TB 1-1520-210-30-01

DEPARTMENT OF THE ARMY TECHNICAL BULLETIN

MANDATORY RECURRING INSPECTION OF TAIL BOOM VERTICAL FIN SPAR ASSEMBLY FOR ALL UH-1 SERIES AIRCRAFT

Headquarters, Department of the Army, Washington, D. C.
22 March 2000

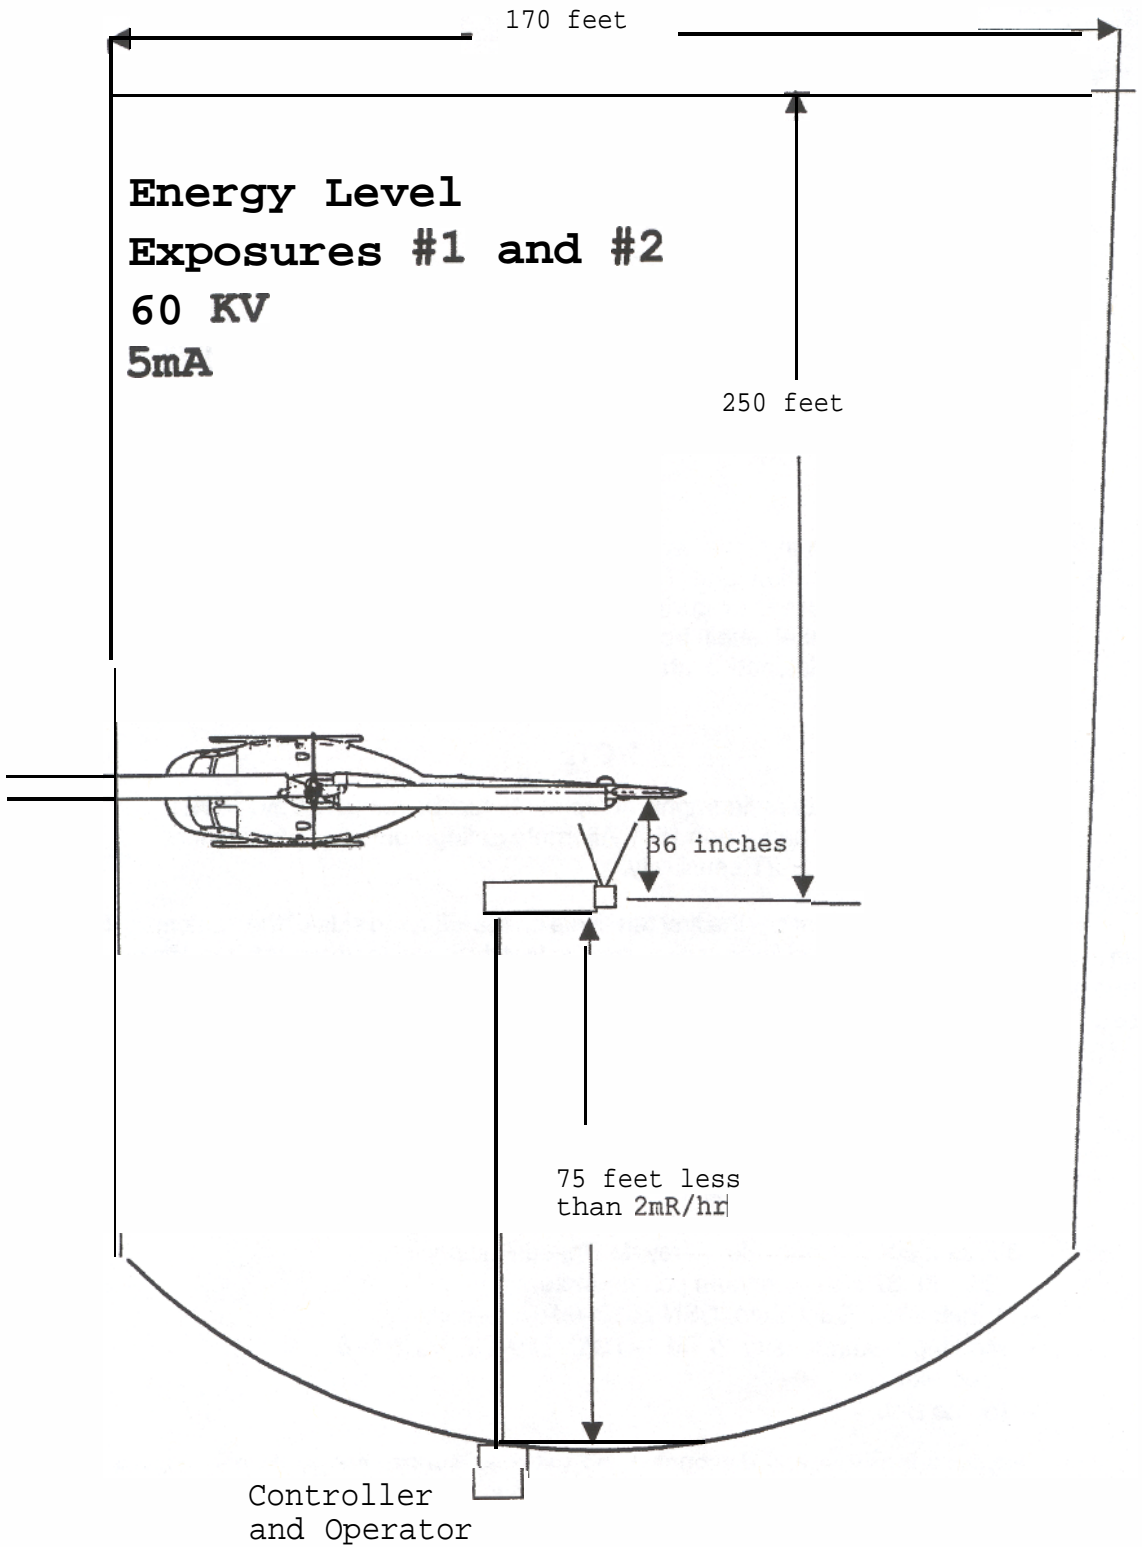
Figure 1A, Safety Zone for Exposures #1 and #2

Assure compliance with all applicable safety precautions set forth in TM 1-1 500-335-23 (Nondestructive Inspection Methods manual) listed in table 1 .I. A hazard associated with exposure to ionizing radiation is that serious injury can be inflicted without pain, burning, or other sense of discomfort during the exposure period. Radiation protection shall be utilized in accordance with AR40-14/DLAR 1000.28. Safety zones for Exposures #1, #2, and #3 are shown in figures 1A and 1 B.

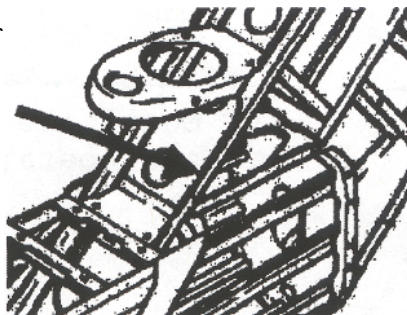
Figure 3: Placement of Film for Exposures 1 and 2

(8) Position film on the inboard side of the vertical fin spar cap leg (See Figure 3) with the "correct side facing the radiation source". Place the lead identification nameplate outside the area of interest. Include the complete aircraft tail number and rivet numbers being viewed (Rivets 1-5 or 6-10).

Position Film on
 Inboard side of
 Vertical Fin Spar
 Cap for Exposures
 #1 and #2.

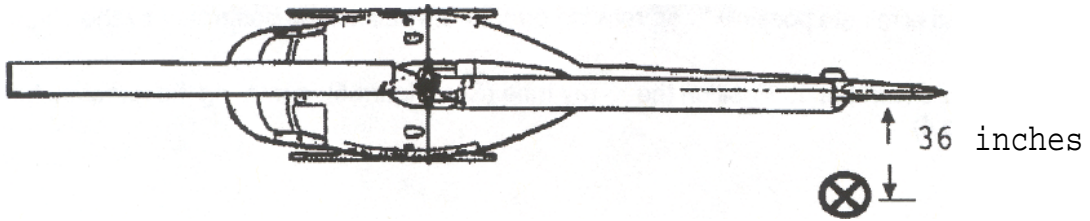
Figure 5: x-ray Tube Head Position

(10) Exposure Number 1: Position the X-ray tube (See Figure 5), centering the radiation beam on rivet #3 (See Figure 4).

(14) Exposure Number 2: Reposition the X-ray tube head centering the radiation beam on rivet #8. (See Figure 4).

Tubehead Position for Exposure #1 and #2

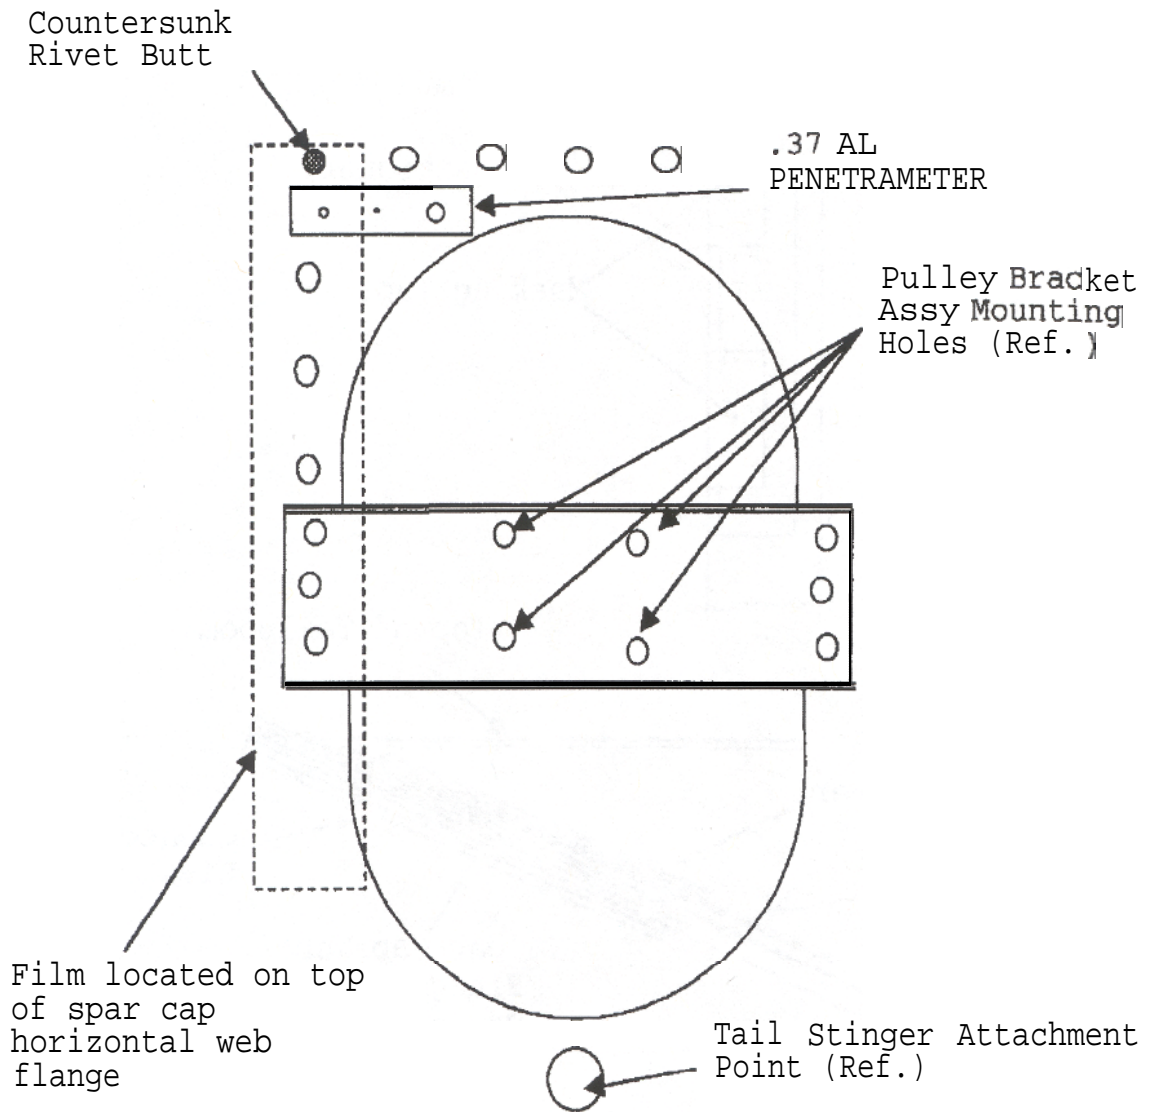
Figure 7: Radiographic Exposure #3

(17) Position a 0.37 inch aluminum penetrameter under the butt of the countersunk rivet. Align the 2T hole with the center of the rivet row. This will allow the 2T hole to be visible in the area of interest (See Figure 7). Secure the penetrameter using tape over the lead numbers and 4T hole only, this will eliminate possible interpretation errors from indications generated by the edges of the tape.

View looking forward at canted bulkhead through inspection panels, Item 124, Figure 16, TM 55-1520-210-23-P1

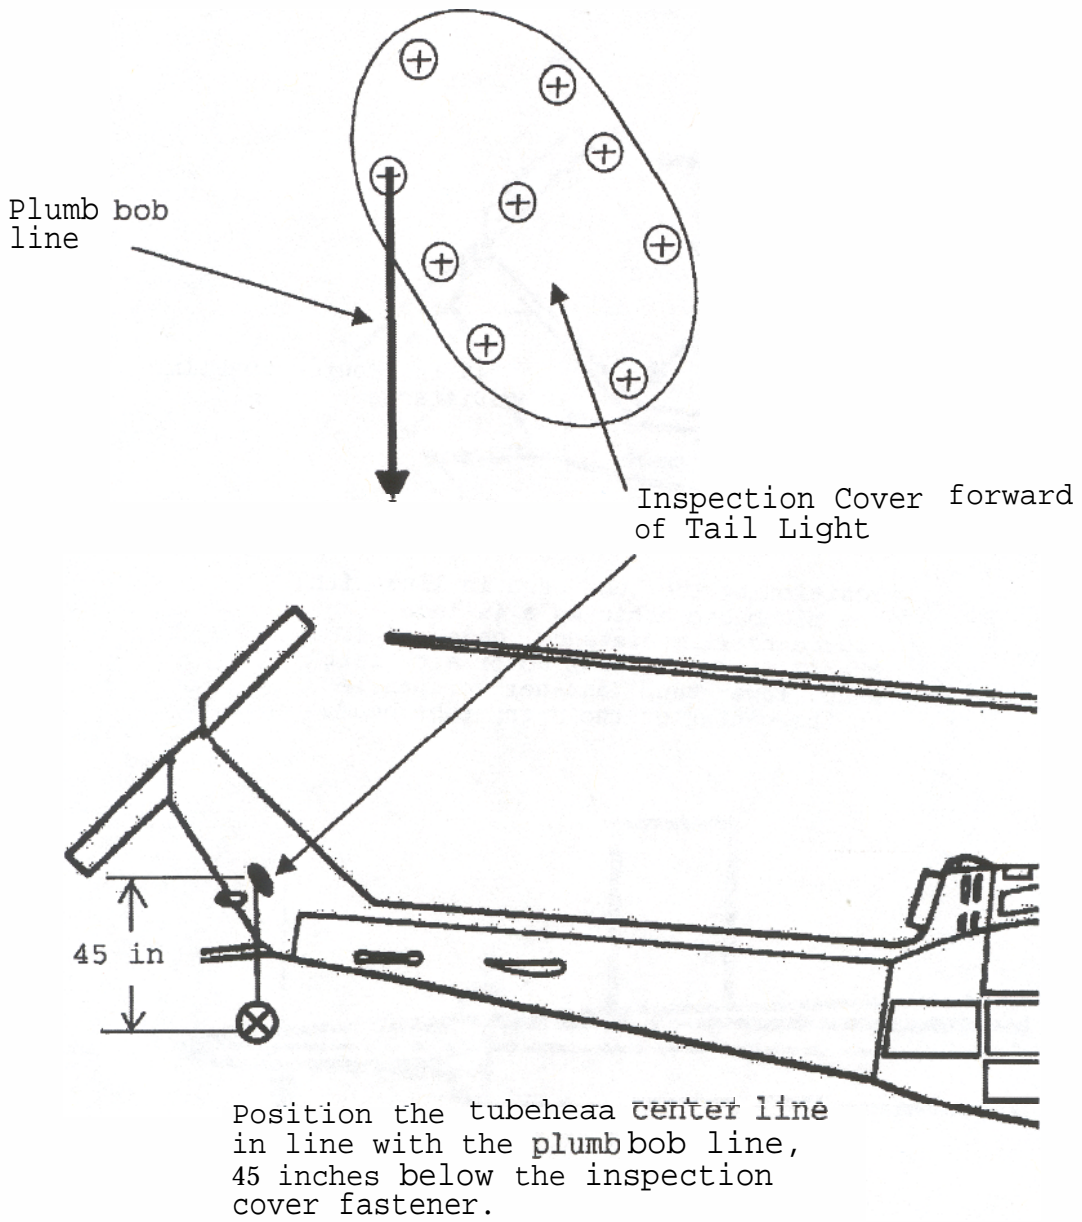
Figure 8a: X-ray Tube Head Position for Exposure #3

(18) Position the X-ray tube head for exposure number 3. Attach a plumb bob string to the right side vertical fin inspection cover forward of the tail light as shown in figure 8a. Position the tube head center line in line with the plumb bob string, 45 inches below the inspection cover fastener. (See Figure 8a and 8b)

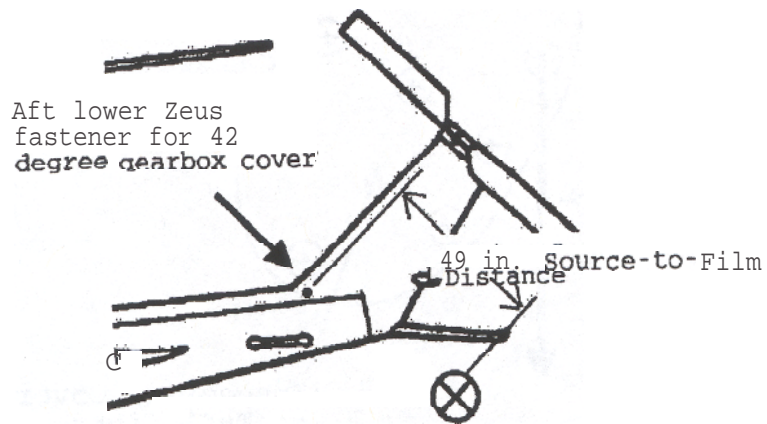
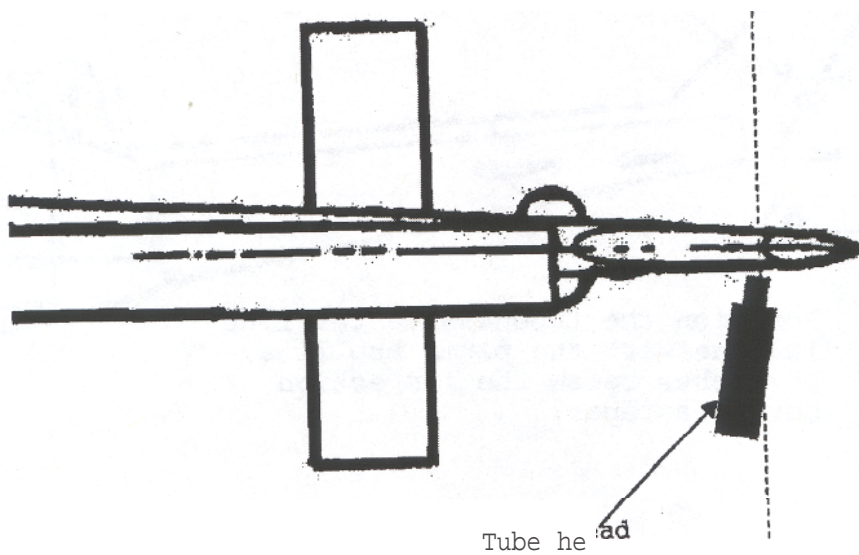
Figure 8b: X-ray Tube **Head** Position for Exposure #3

Positioning the tube head in line with the **plumb** bob achieves a 49 inch source-to-film distance, measured from the 42 degree gearbox cover aft, left hand, lower Zeus fastener receptacle to the center of the x-ray tube head.

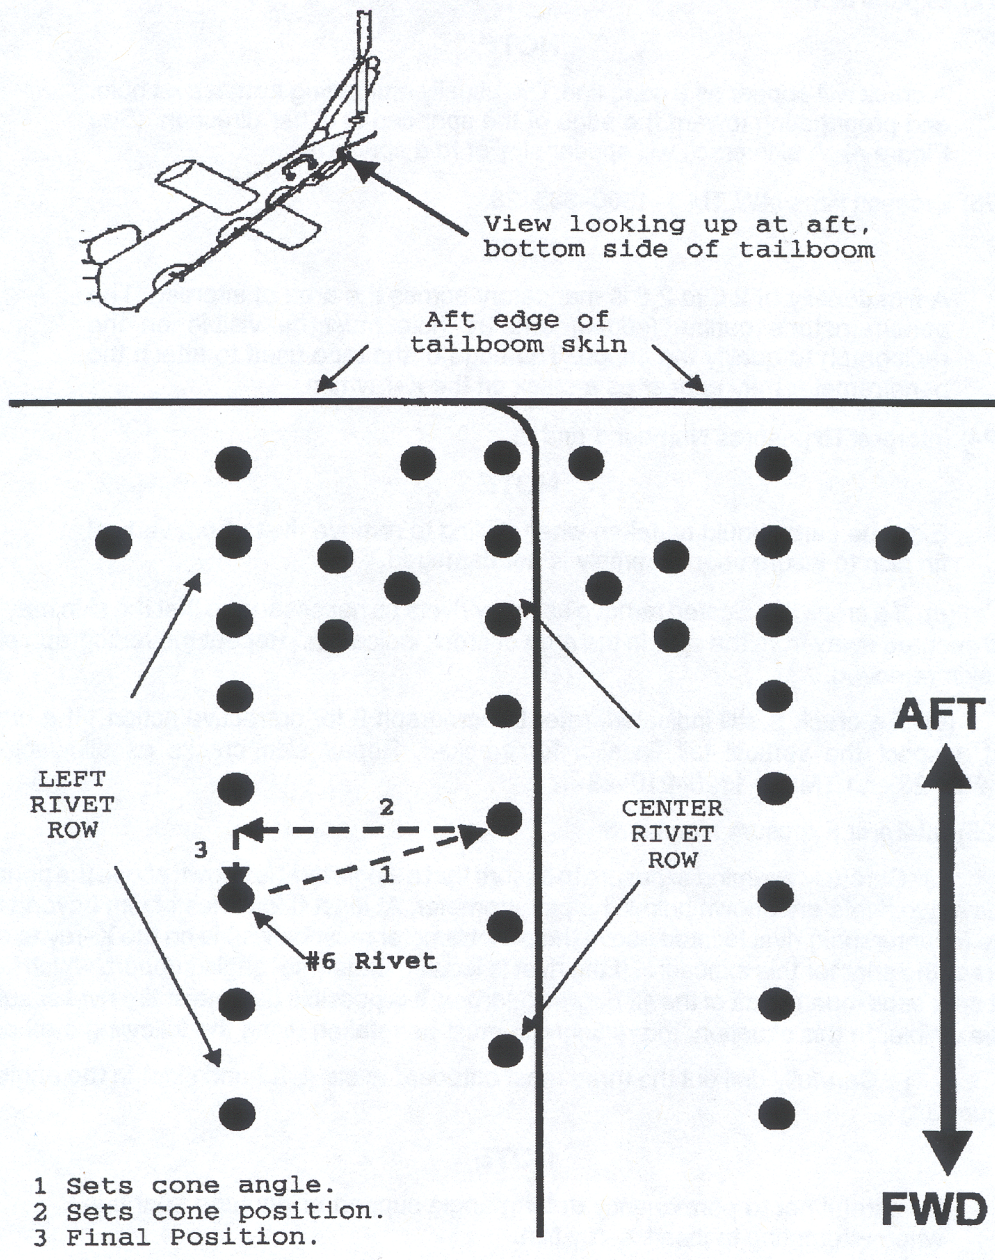
Figure 9: X-ray Tube Head Position for Exposure #3

(19) Place the laser pointer on the tube head. Activate the laser pointer and slide the tube head horizontally until the laser dot aligns with the left hand stringer rivet row, Figure 9. This will achieve a 49 inch source-to-film distance measured from the 42 degree gearbox cover aft, left hand, Zeus fastener receptacle to the center of the X-ray tube head (See Figure 8b). Verify perpendicularity by rotating the tube head to verify the laser dot tracks with the first ten rivets. Adjust the tube head horizontally as required. Center the laser dot on rivet number 6.

(20) Fine tune tube head position as follows (See Figure 9):
