# Grinding the Gearbox

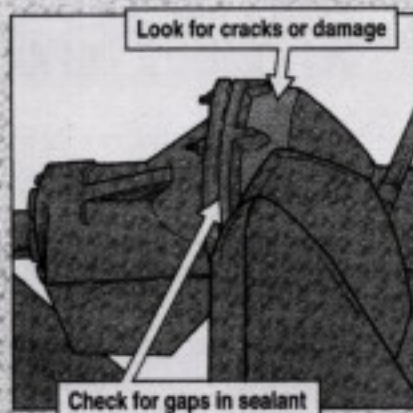
Now take a close look at the gearbox case for cracks, corrosion or damage. Check where the sleeve assembly mates to the case. Look for gaps in the sealant around the studs. Check the predrilled holes in the sleeve assembly to make sure they're sealed right.

Most jobs around the tail rotor gearbox are done at AVIM level, but preventing water intrusion and corrosion is an AVUM job.
