A Wrenching Problem

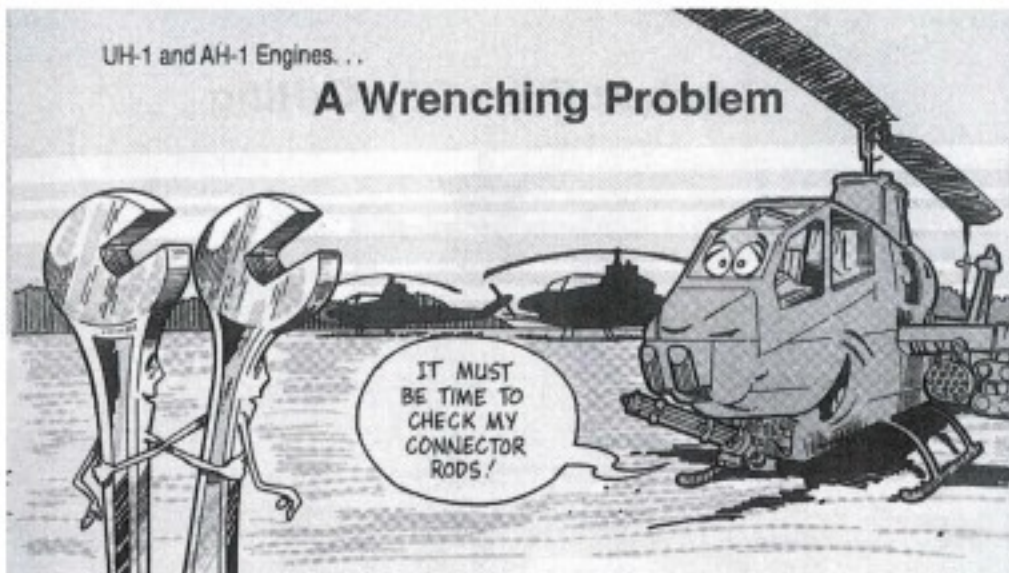
Could be a broken connector rod. Check the N1 on the T53 engine.

If the N1 is running about 8 percent above normal, and the EGT and torque are OK, the connector rod on the variable inlet guide vane assembly is probably broken.

The vanes won't open and the N1 will run above normal.

If you don't put a backup force on the bearing, the jam nut will twist and weaken the connector rod. Maybe not right away, but it will sooner or later and the rod will break.

Any time you install or adjust the connector rod, use 2 wrenches—one to loosen or tighten the jam nut and the other to keep a backup force on the self-aligning bearing.

So don't take chances. Grab two wrenches next time you install or adjust the connector assembly.
