# Change the Wool!

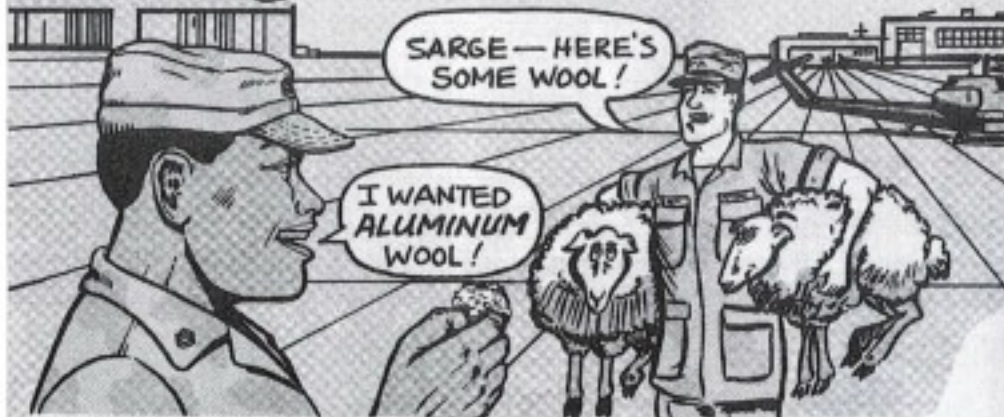
When the oil lab says you have high aluminum wear in a Huey or Cobra tail rotor driveshaft gearbox, you may be asked to flush, reservice,

a washer and retaining ring. In time, the wool goes bad and flakes off into the oil to give you a high reading.

It's easy to check out the cap. Lay it on a workbench, upside down. Press in on the washer and then release the pressure. The washer is supposed to spring back against the retaining ring. If it doesn't, the wool is worn out.

So remove the washer and retaining ring. Rub the wool between your fingers and notice how it crumbles... no wonder the oil was contaminated!

and try it again. If the next sample still reads high in aluminum, the filler cap could be the culprit.

There's a bunch of aluminum wool inside the cap, held in place by

Toss out the old wool and clean out the cap. Put in enough new wool, NSN 5350-00-286-4851, to place the spacer under tension and insert the ring. The complete inspection and repair info is in Para 6-193c of TM 55-1520-210-23-1.

Change the oil in the gearbox, fly the bird, and send another sample to the oil lab. Chances are the gearbox is A-OK.
