# JOINT OIL ANALYSIS PROGRAM MANUAL

## VOLUME III

### LABORATORY ANALYTICAL METHODOLOGY AND EQUIPMENT CRITERIA (AERONAUTICAL)

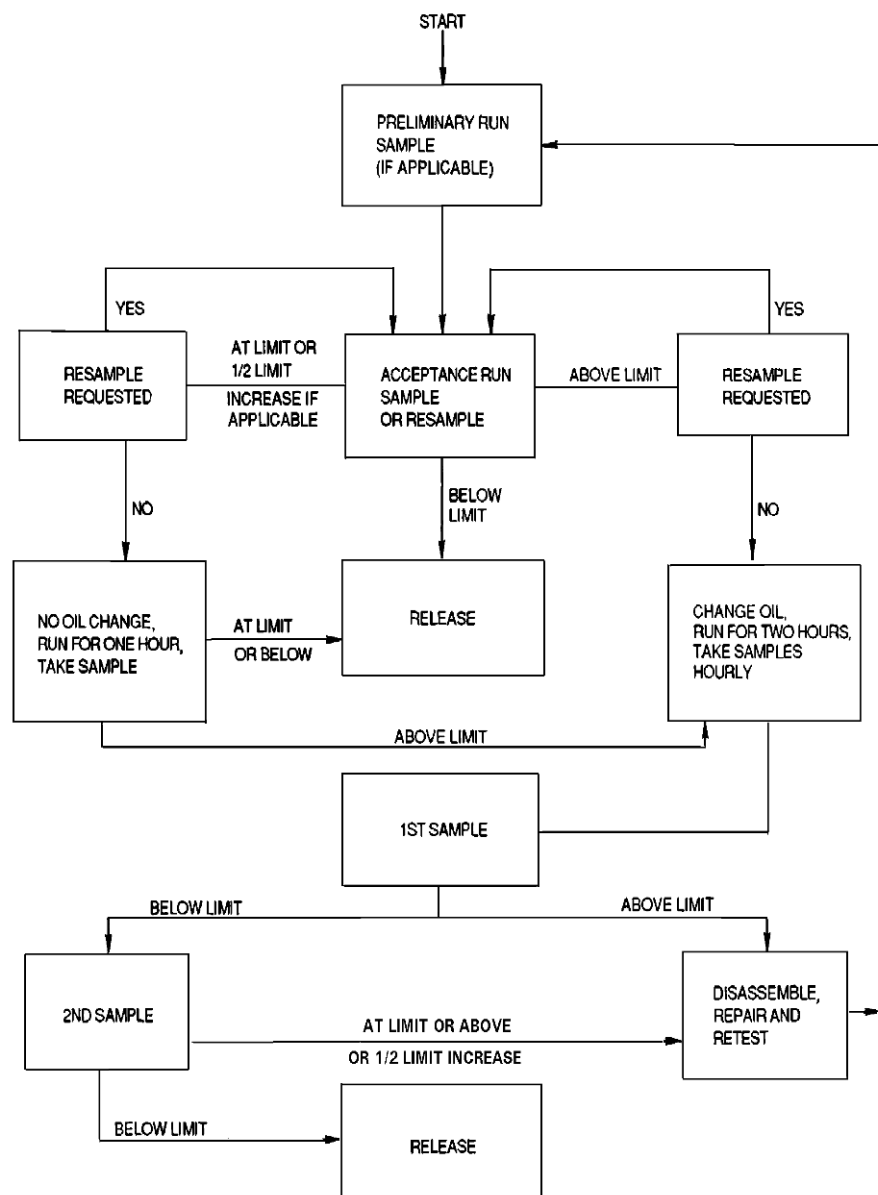
1. Refer to Volume I WP 005 00 for the Standard Lab Recommendation Codes
2. Air Force ALC Depot Decision Logic Flow Chart

\*DO NOT CHANGE OIL FOR T56 OR G56 AT SA-ALC UNLESS REQUIRED

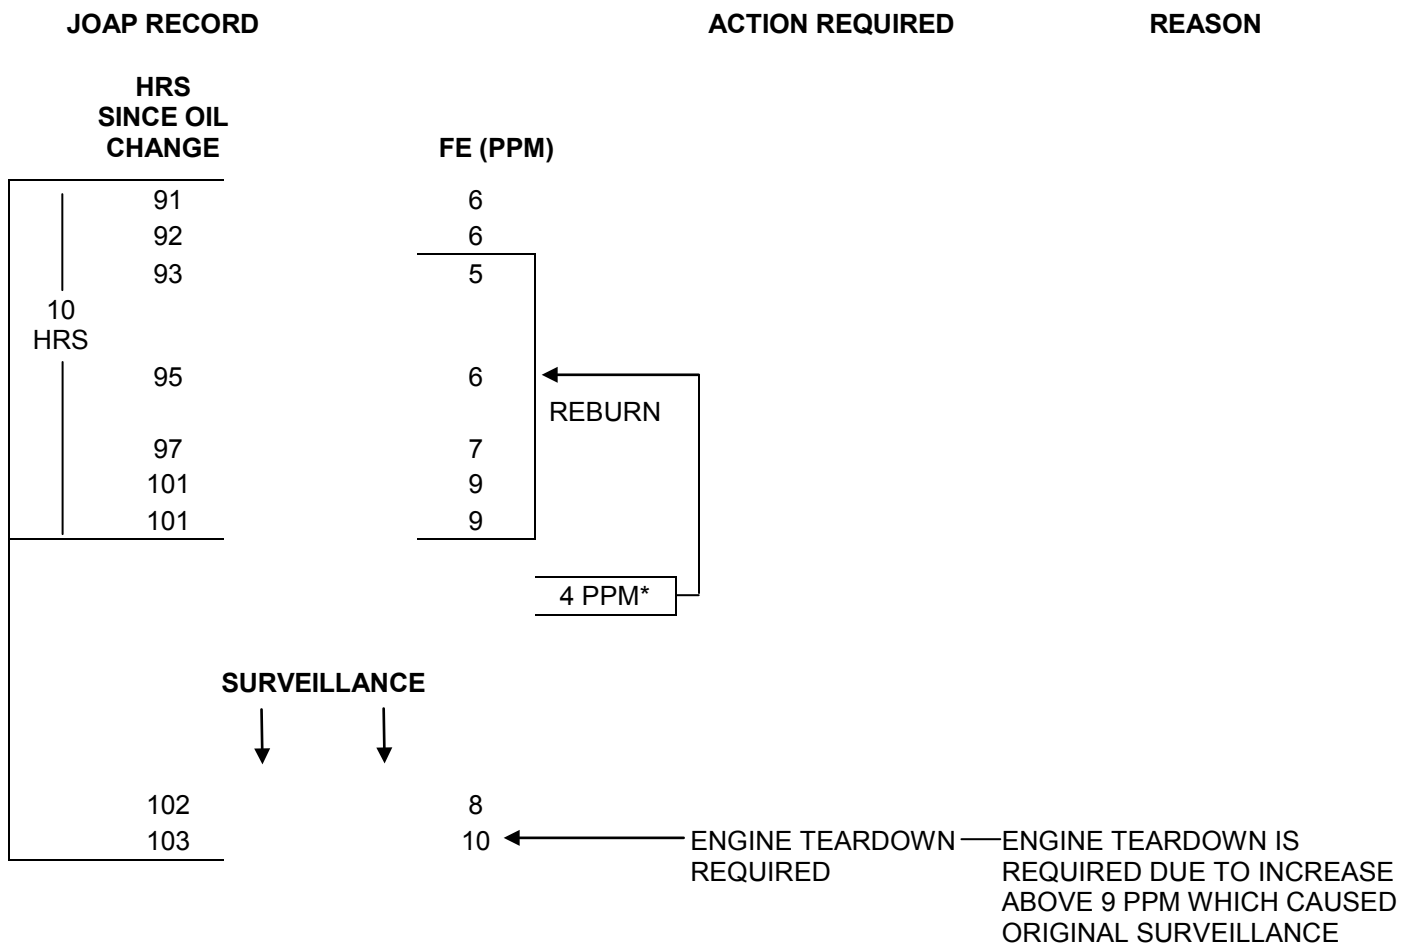
\* 4 PPM or greater using JOAP Atomic Emission.

EXAMPLE: PRIOR TO SURVEILLANCE  
 (FOR FE INCREASE IN 10 ENGINE HOURS)

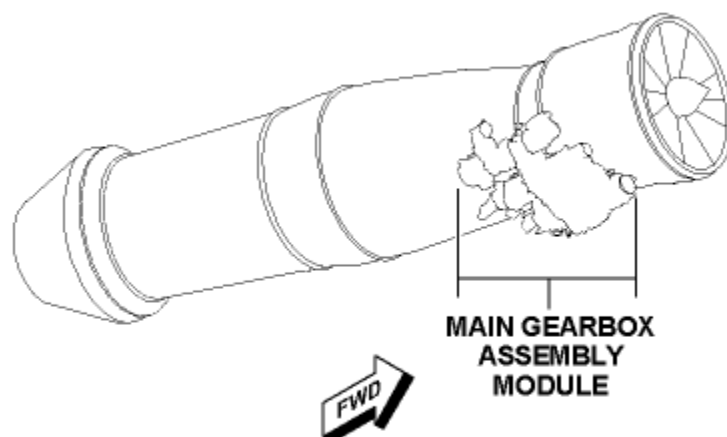
G-P7310180000-P002-001-1

Figure 1. Main Gearbox Assembly Module General Locator

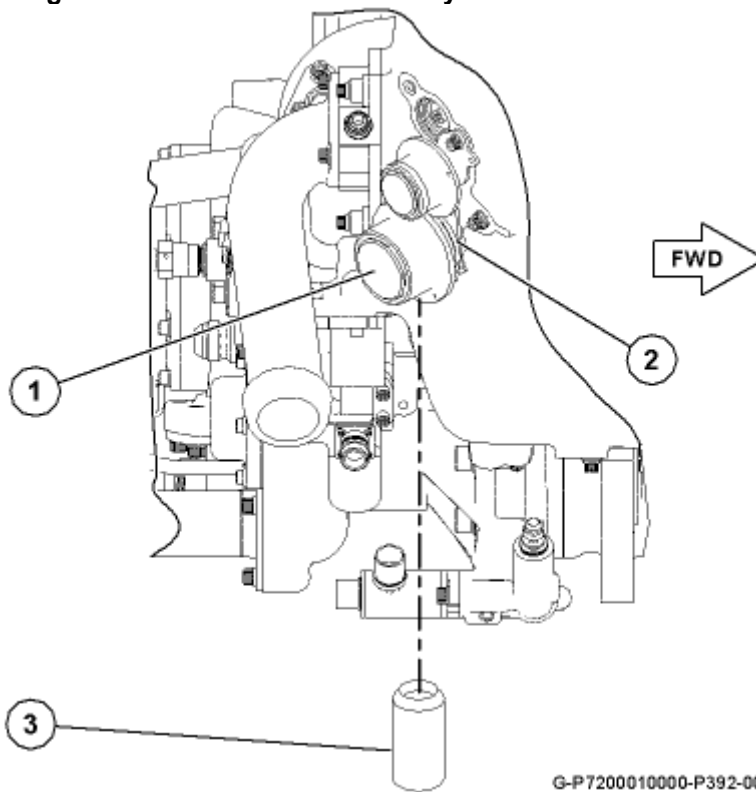
G-P7200010000-P392-001-1

Figure 2. Oil Overflow / Sample Port

1. Remove quick disconnect cap (item 1, Figure 2) from overflow/oil sample port (2).

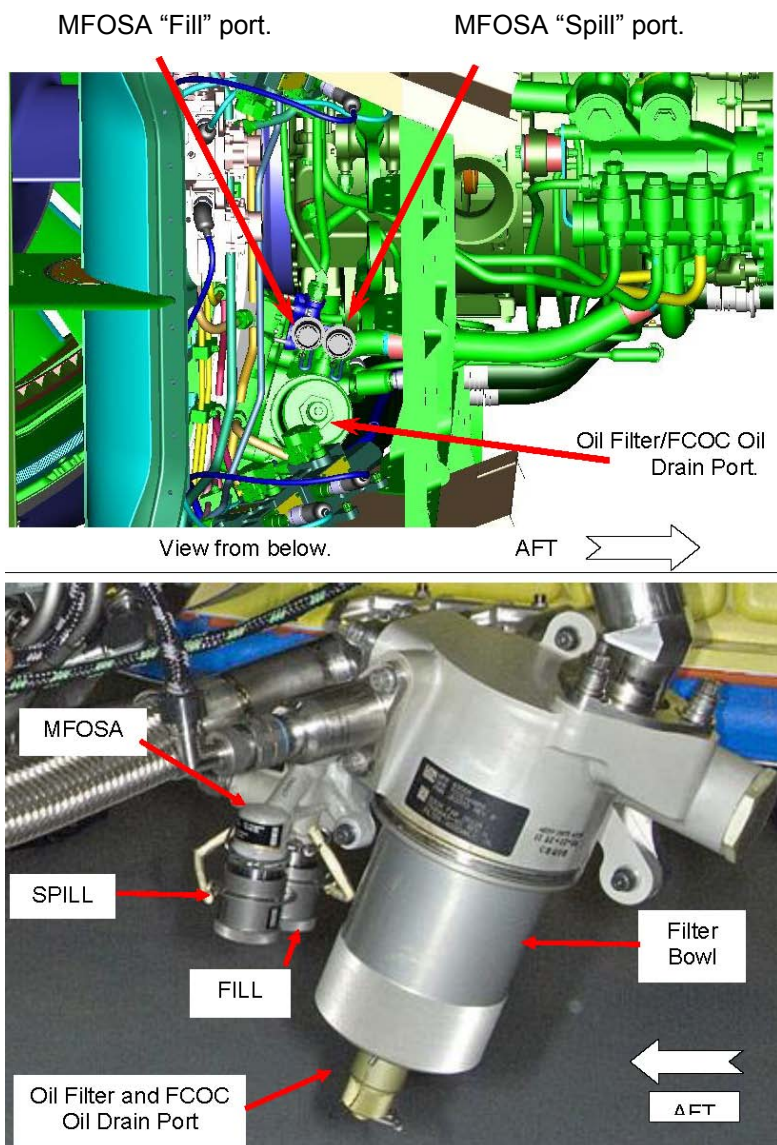
Figure 1. F-35B LiftSystem Servicing Point, General Views

- 1) Place suitable container / drip tray under work area to catch any waste oil.
- 2) Remove the Spill coupling protective cap located on the left side of the Multi Function Oil Servicing Adaptor (MFOSA). Refer to Figure 1.
- 3) Use an absorbent cloth and wipe off MFOSA and Oil Spill Drain Hose/Collector couplings, before connection, to prevent any contamination.
- 4) Remove the Fill coupling protective cap located on the right side of the MFOSA.
- 5) Use an absorbent cloth and wipe off MFOSA and Oil Sample Adaptor Bottle couplings, before connection, to prevent any contamination.

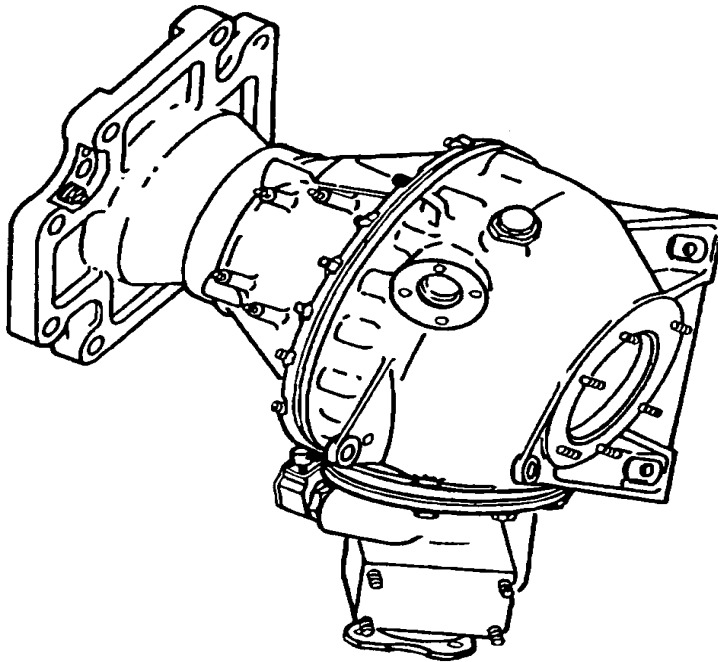
**FIGURE 1. Tail Rotor Gearbox**

1. The BLACK HAWK tail rotor gearbox changes the speed and angle of drive from the tail drive shaft to the tail rotor blades and pitch control mechanism. See Figure 1. The major components of the tail rotor gearbox include the housings (input, center, and output), the input bevel pinion and the output bevel gear, four (4) tapered roller bearings, an input flange, an inboard retention plate, and input and output seals. See Figure 2 for the location of the major components. The tail rotor gearbox is operated with the tail rotor servo and pitch control shaft installed into the gearbox. See Figure 3.

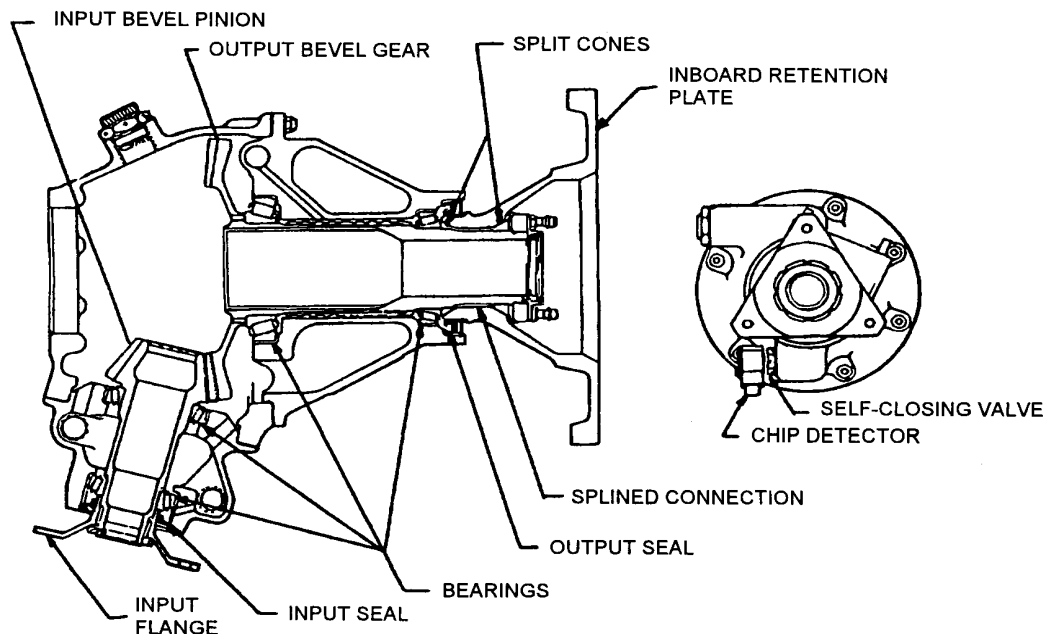
FIGURE 2. Tail Rotor Gearbox Nomenclature

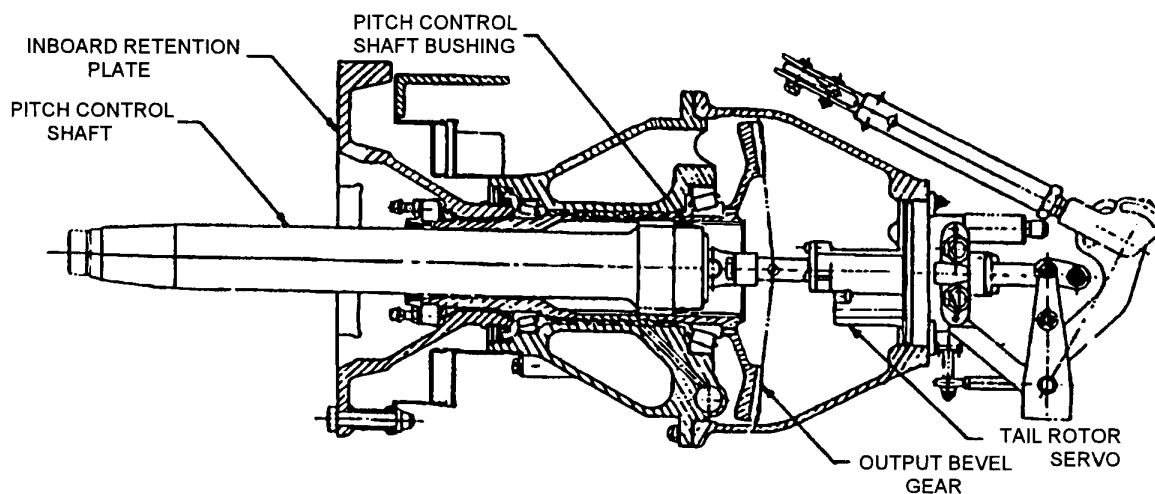
FIGURE 3. Tail Rotor Gearbox, Tail Rotor Servo, & Pitch Control Shaft Assembly

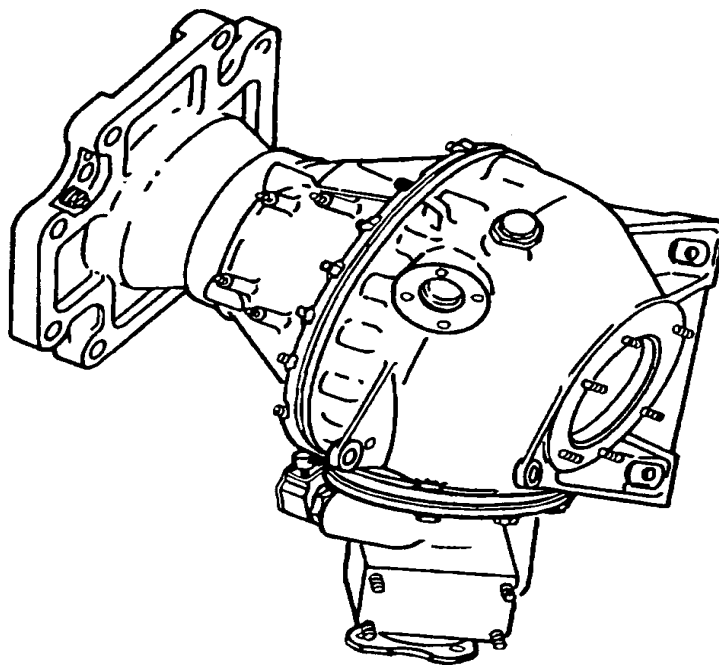
Figure 1. Tail Rotor Gearbox

1. The VH-60N tail rotor gearbox changes the speed and angle of drive from the tail drive shaft to the tail rotor blades and pitch control mechanism. See Figure 1. The major components of the tail rotor gearbox include the housings (input, center, and output), the input bevel pinion and the output bevel gear, four (4) tapered roller bearings, an input flange, an inboard retention plate, and input and output seals. See Figure 2 for the location of the major components. The tail rotor gearbox is operated with the tail rotor servo and pitch control shaft installed into the gearbox. See Figure 3.

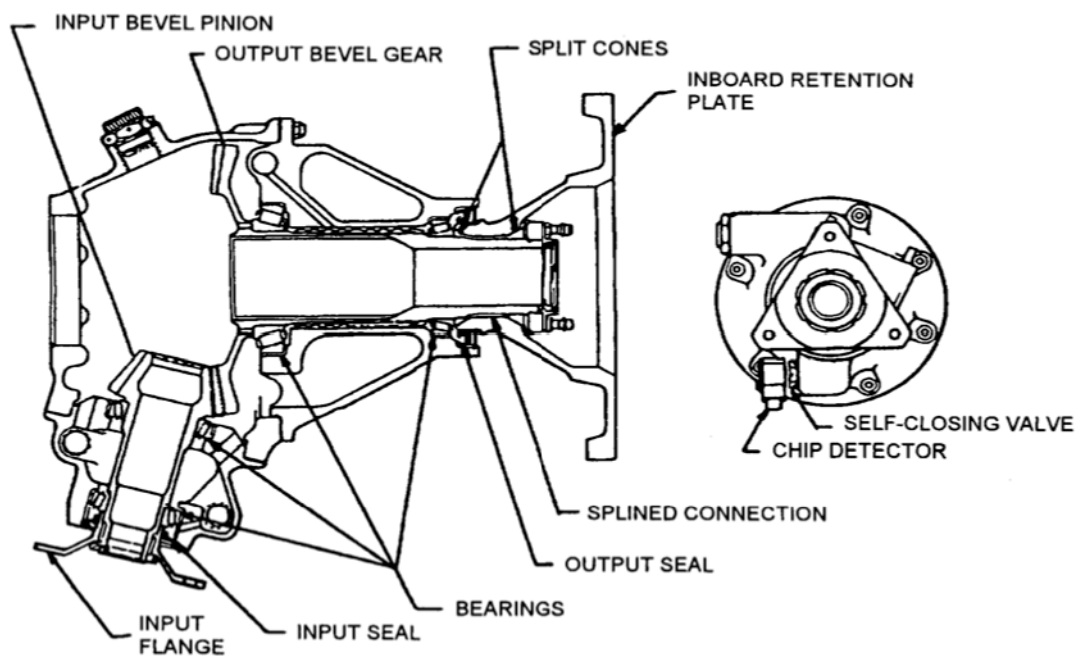
Figure 2. Tail Rotor Gearbox Nomenclature

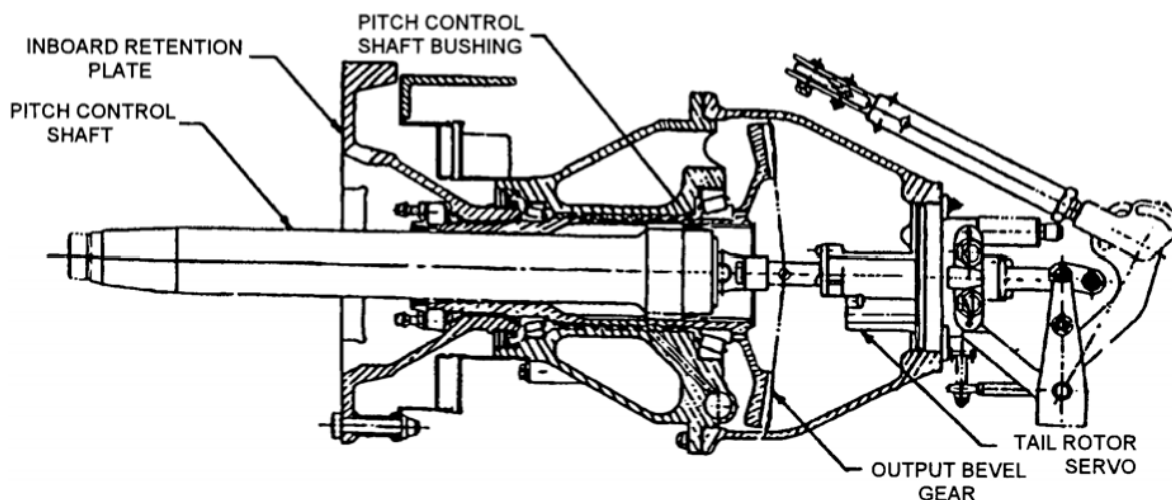
**Figure 3. Tail Rotor Gearbox, Tail Rotor Servo, & Pitch Control Shaft Assembly**
